AIRCRAFT ACCIDENT REPORT 1/97

**ACCIDENTS INVESTIGATION DIVISION**

Report on the Incident to  
Airbus A320-231 VR-HYU  
at Hong Kong International Airport  
on 6 June 1994

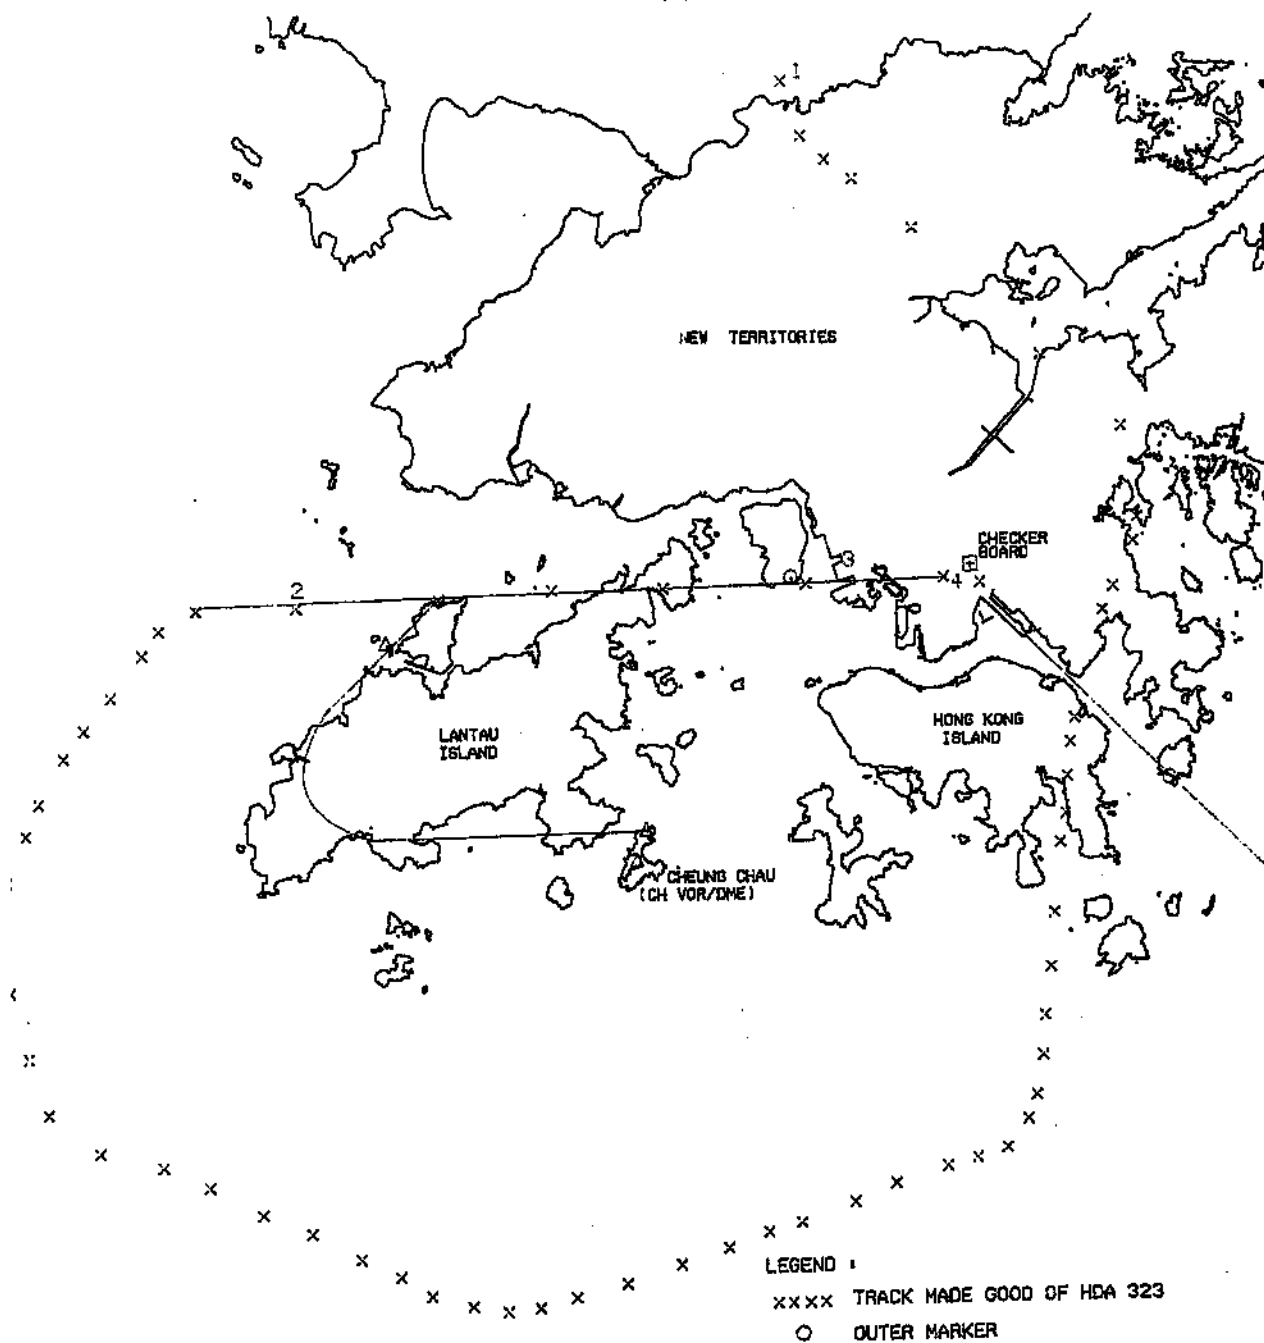
**HDA 323 1st Approach (Runway 13)**

<u>Event No</u>	<u>Time (UTC)</u>	<u>Event</u>
1	0806	HDA 323 entered Hong Kong airspace and was provided with radar service by the Hong Kong Approach.
2	0827	Aircraft established IGS at 4500 ft.
3	0833	Aircraft fully configured for landing runway 13 (ie Flaps at 40° and slats at 27° landing gears extended).
4	0834	Aircraft encountered a severe gust, flaps were locked at CONFIG FULL. The Captain immediately carried out the standard MAP and the flap selector was raised to UP position in stages by the Co-pilot.

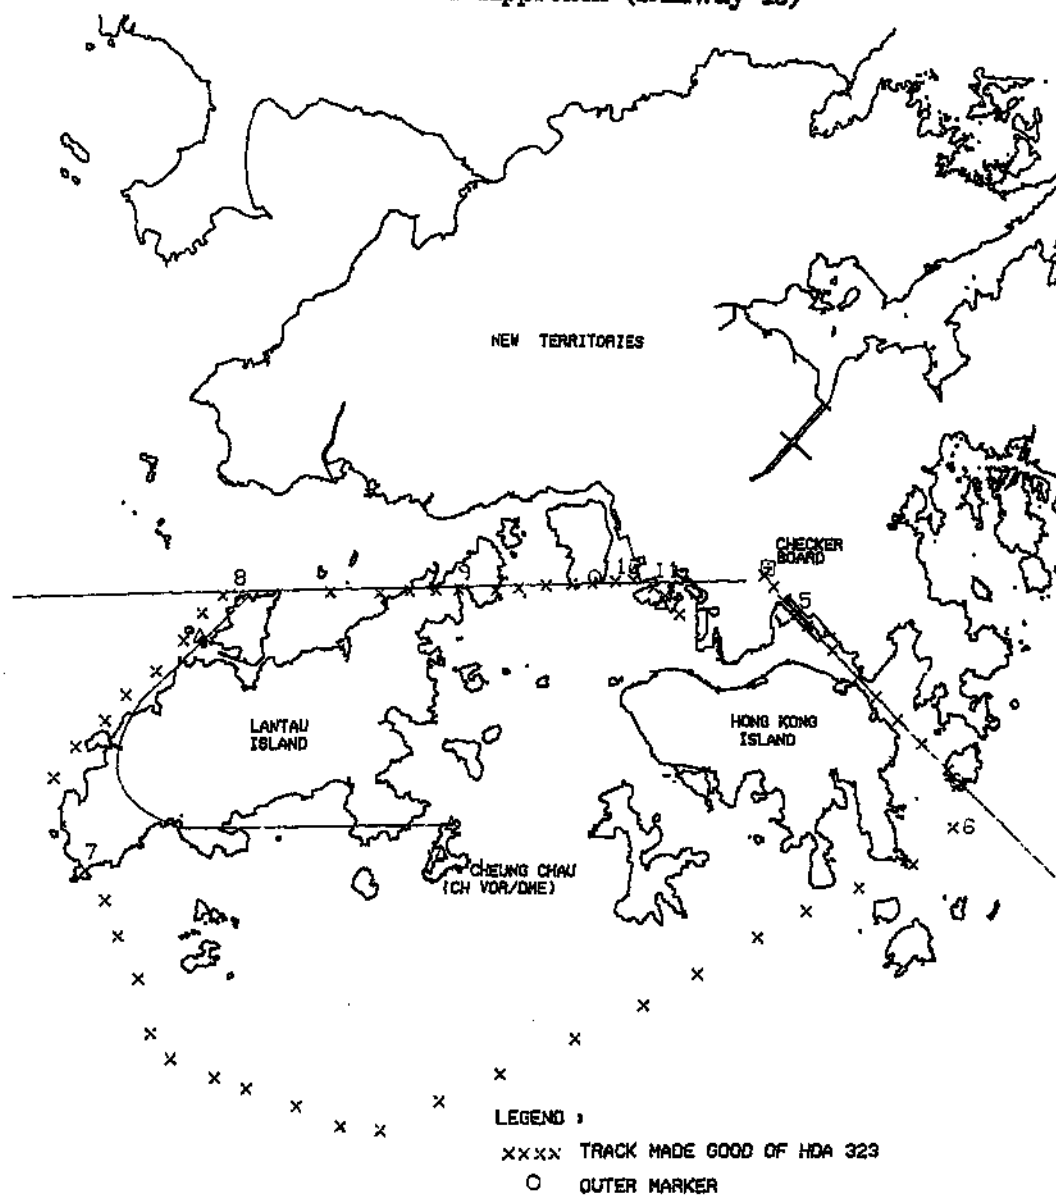
## HDA 323 2nd Approach (Runway 18)

<u>Event No</u>	<u>Time (UTC)</u>	<u>Event</u>
5	0835	Standard MAP runway 13.
6	0838	Aircraft maintained 4,500 ft and the Captain notified ATC that they have a flight control problem.
7	0844	Beginning of CVR taped conversations.
8	0848	Aircraft established IGS for its second approach.
9	0850	Landing gears were extended and roll oscillations began. Captain initiated the MAP.
10	0852	HDA 323 request runway 31 and radar assistance.
11	0852	Aircraft turned onto a south-easterly heading and climbed through 4,500 ft.

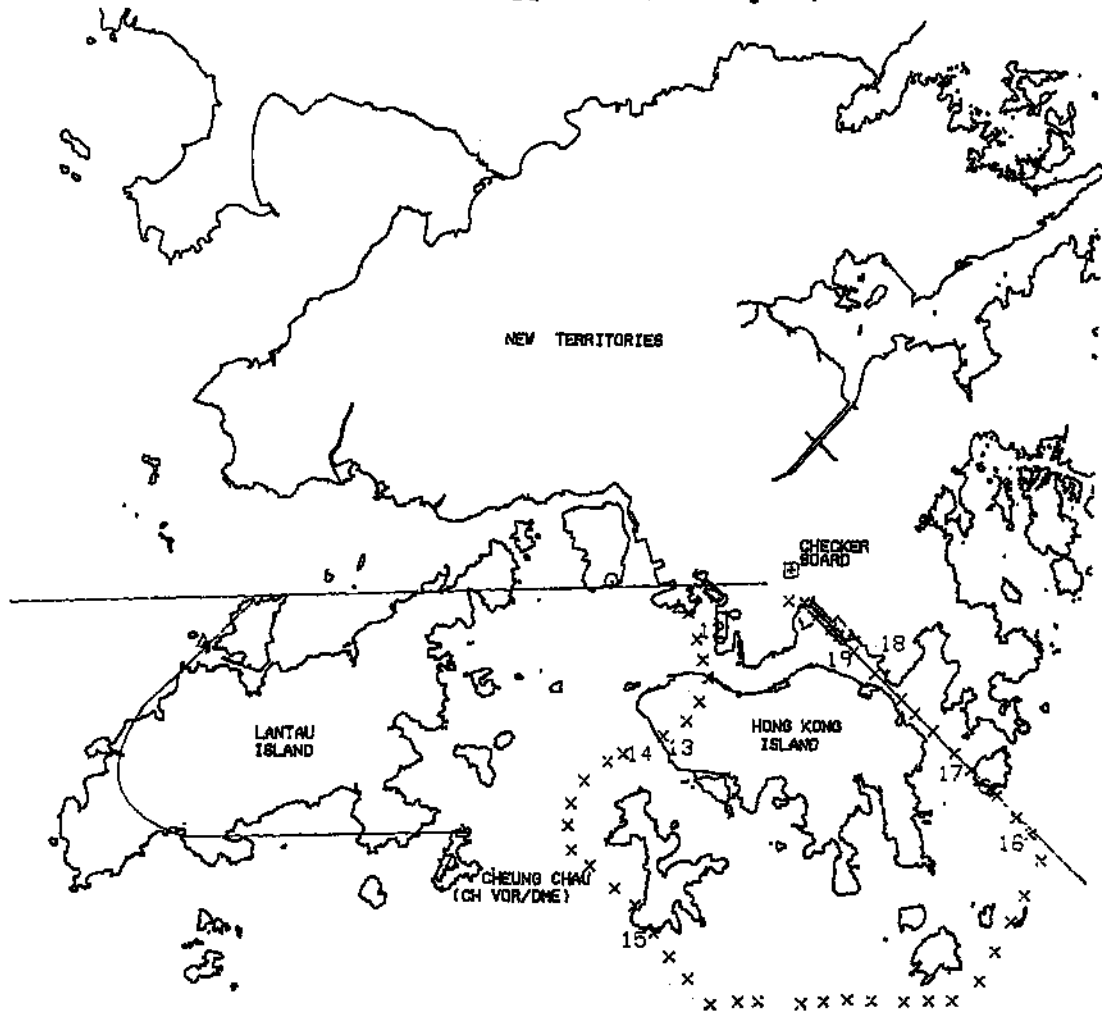
## HDA 323 3rd Approach (Runway 31)

<u>Event No</u>	<u>Time (UTC)</u>	<u>Event</u>
12	0852	HDA323 was cleared by ATC to maintain present level and track direct to CH.
13	0853	The Captain reported to ATC that they have a serious problem with the flight control and the aircraft became uncontrollable when landing gears were extended. He also reported that they were short of fuel and requested runway 31.
14	0854	Captain contacted HABCO for engineering advice.
15	0856	Master caution: Fuel in right wing tank - LOW LEVEL.
16	0900	Landing gears extended, flap selector at CONFIG 1.
17	0901	Roll oscillations began.
18	0903	GPWS: 'SINK RATE SINK RATE'.
19	0903	Significant oscillations in roll and pitch, Captain initiated the MAP at about 0.5 nm from touch down.

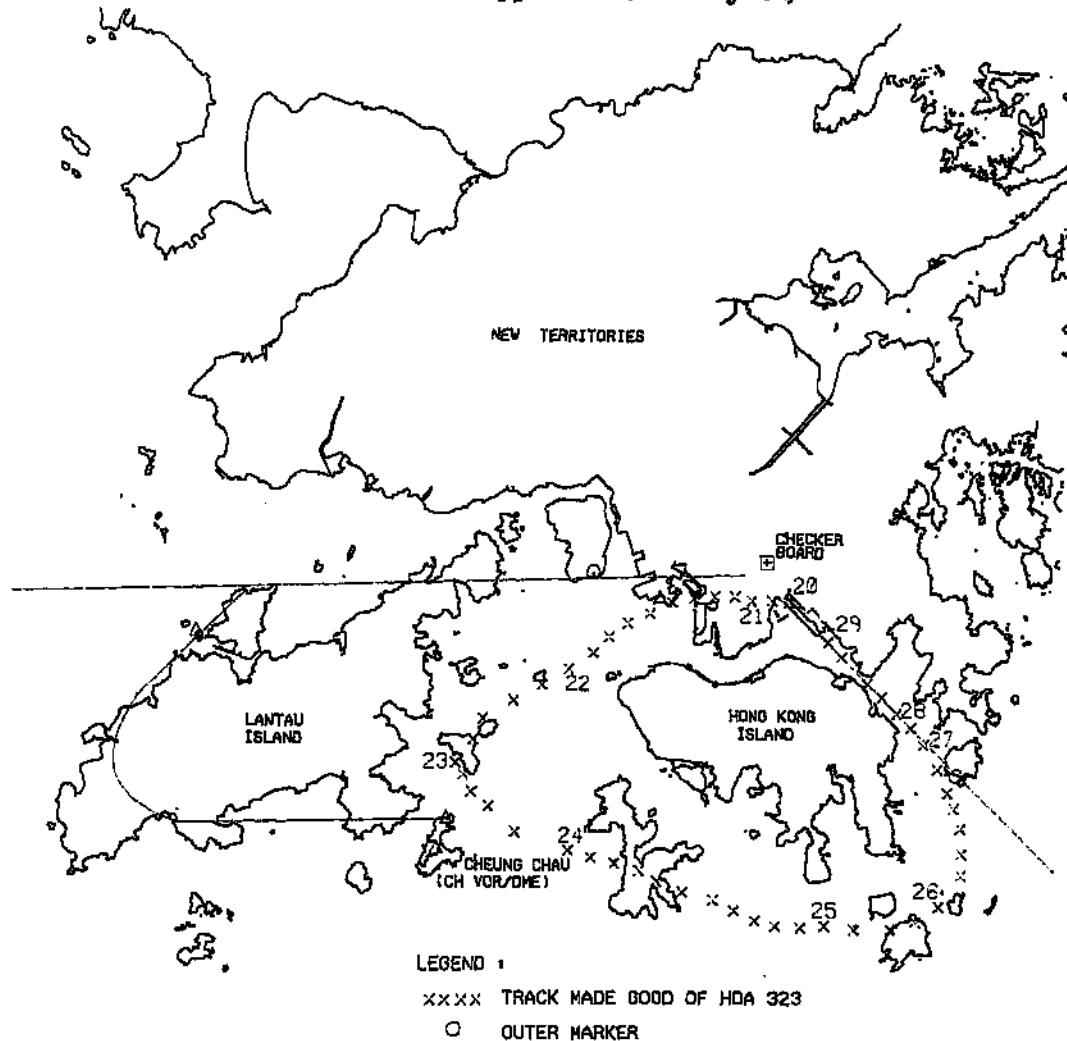
## HDA 323 4th Approach (Runway 31)

<u>Event No</u>	<u>Time (UTC)</u>	<u>Event</u>
20	0903	HDA 323 reported to ATC that they were short of fuel and could not divert to anywhere. ATC up-graded the 'LOCAL' stand-by to a 'FULL EMERGENCY' stand-by.
21	0904	A fuel check was made, fuel remaining was 1120 kg.
22	0906	Captain declared emergency, transmission was crossed and was not heard by ATC.
23	0907	Captain advised the SP to prepare the cabin for a crash landing.
24	0908	Captain made a request to ATC for an immediate landing.
25	0912	Captain reviewed the ditching check list.
26	0913	Aircraft was in VMC.
27	0915	Landing gears was extended.
28	0916	Spoilers were armed.
29	0917	Aircraft touched down and ran off the paved surface.
