FINAL REPORT

96-12/A-5

G-JTCA, Piper PA23 Aztec

Final Report of the investigation into the probable cause of the accident with the Piper PA23 Aztec, G-JTCA at De Kooy Airport, Den Helder, The Netherlands on 11 march 1996.

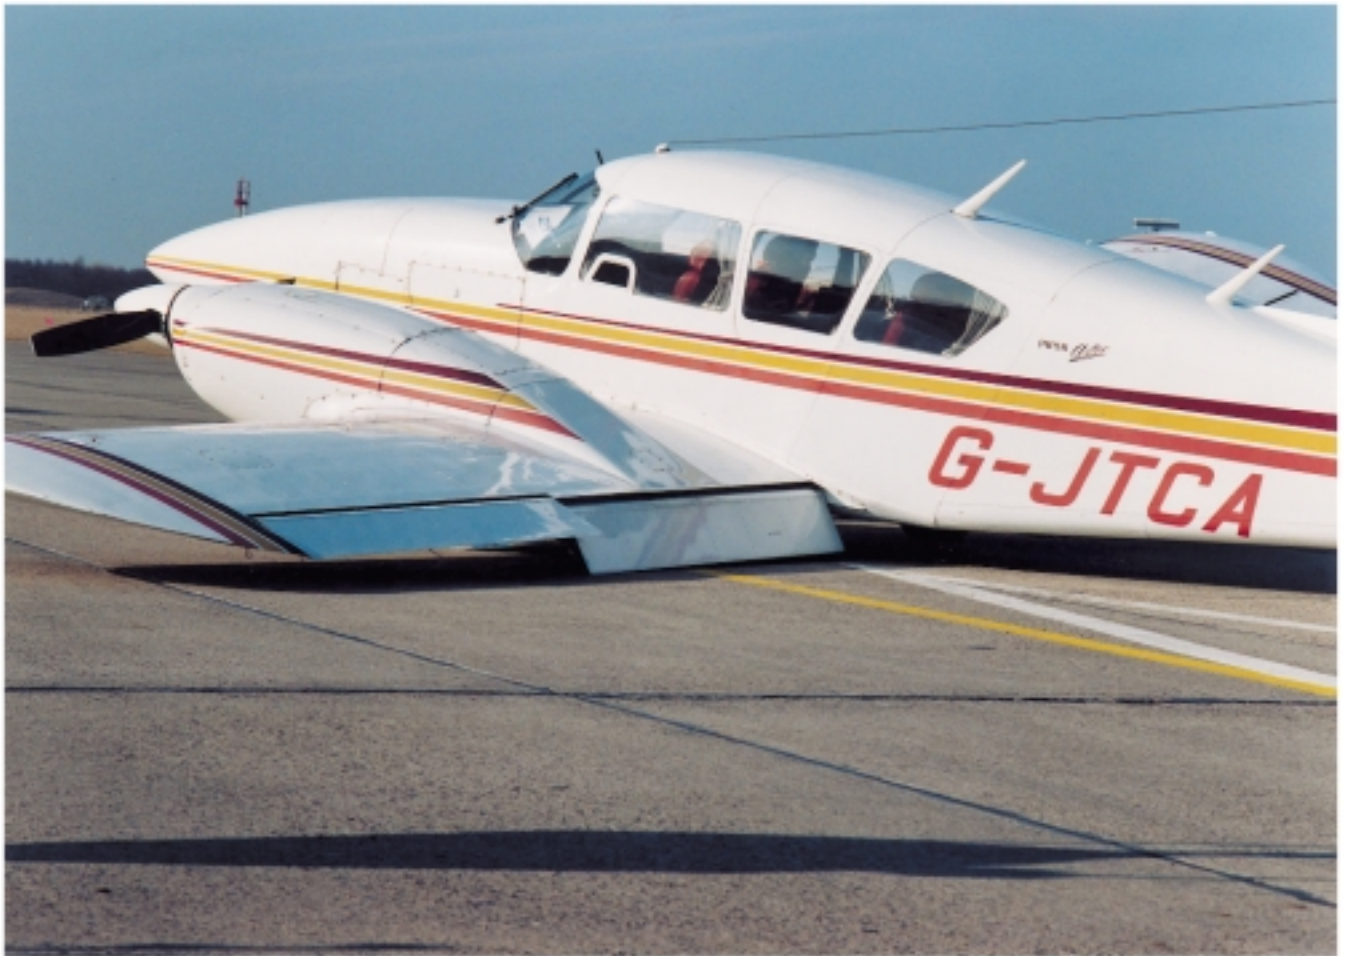
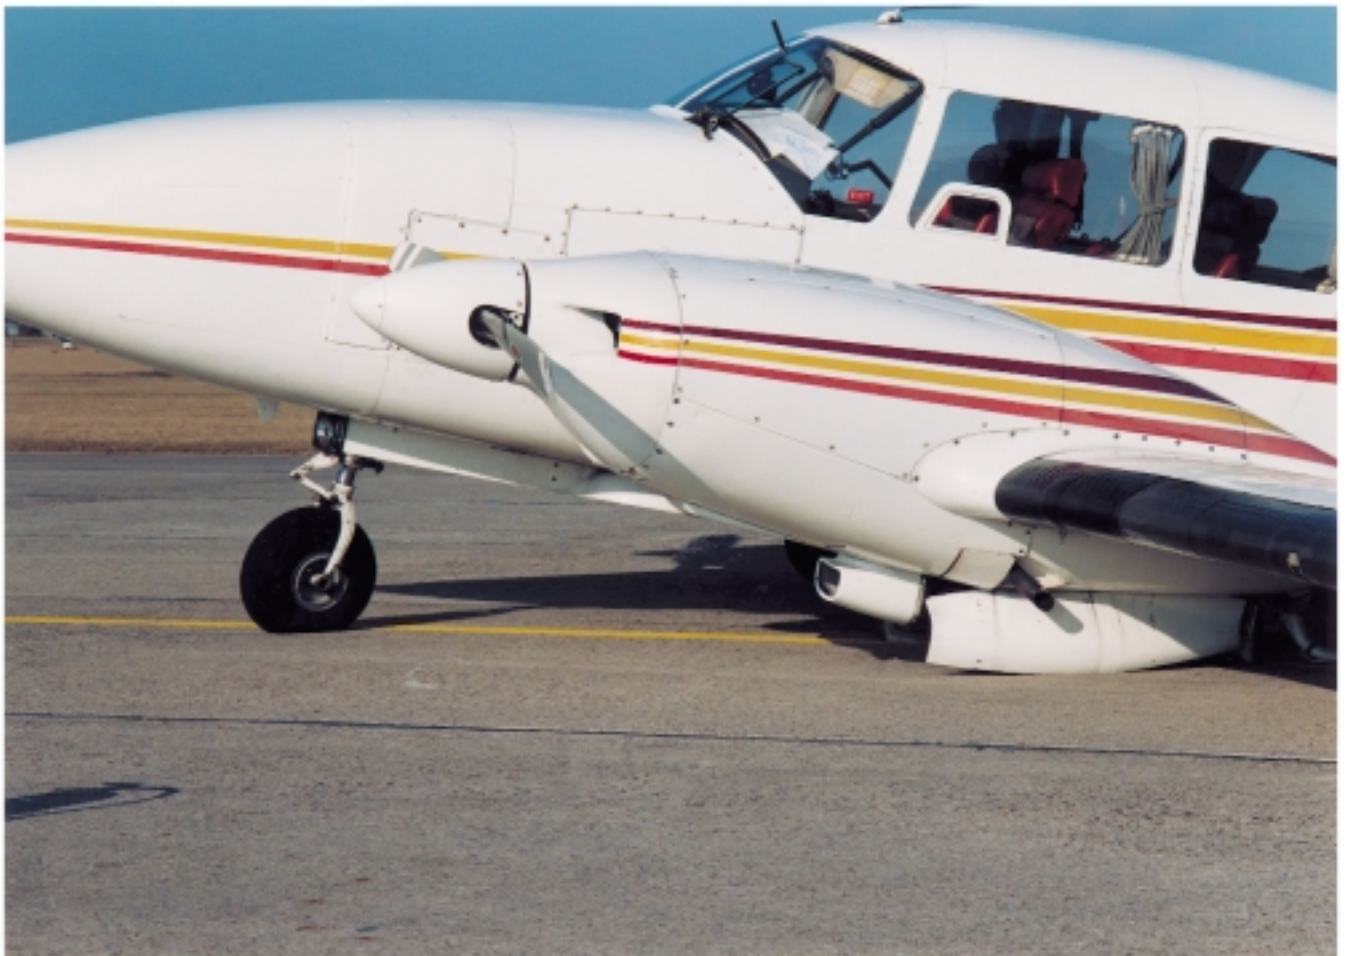
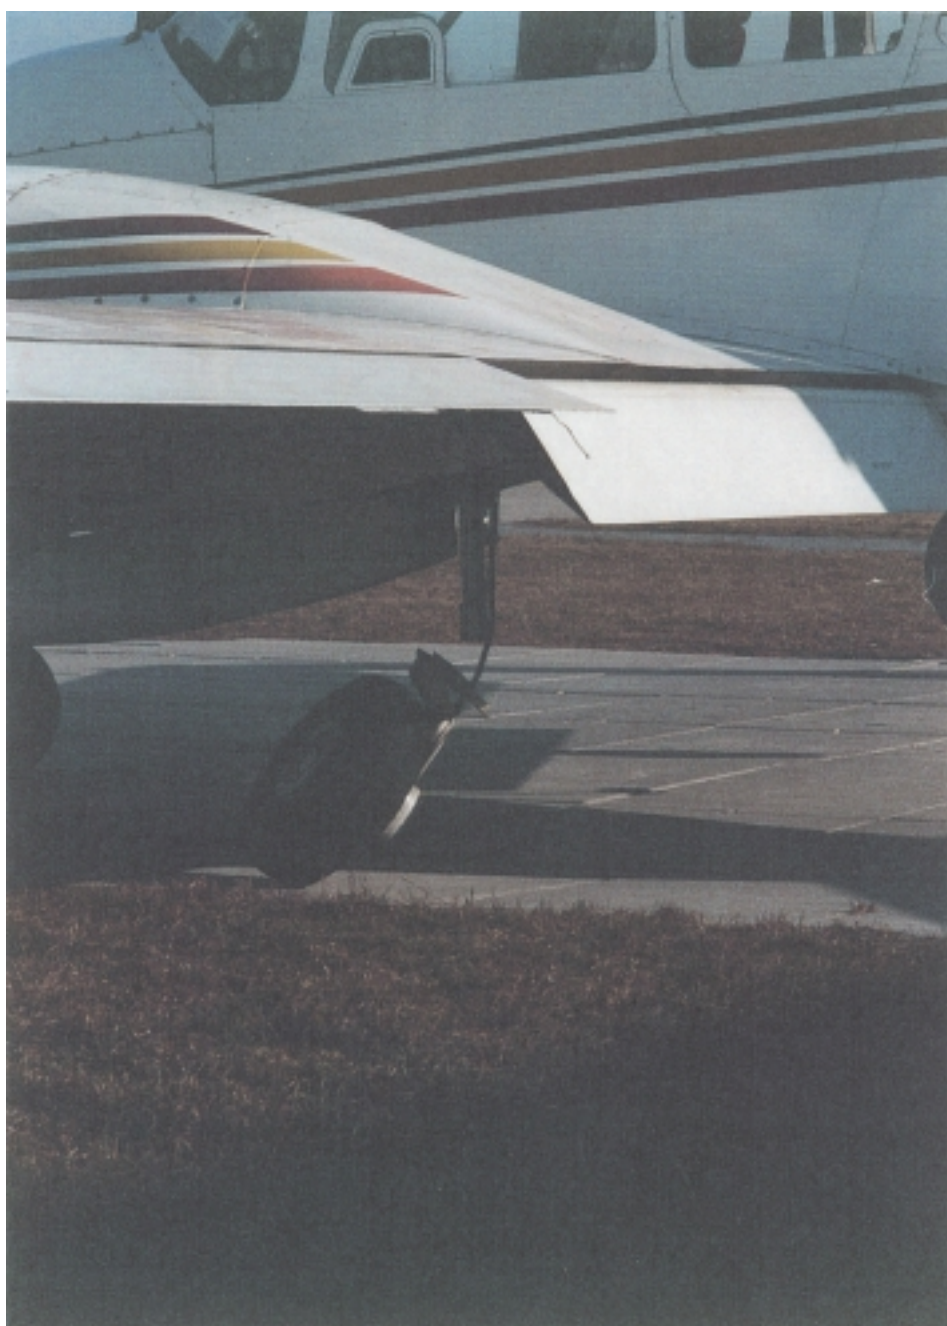
During turning after landing, the left hand main wheel failed. The cause of the failure was corrosion in the collar attached to the oleostrut.

Corrosion cracking, emanating from the bolt holes, caused the failure of the part. It is likely that the corrosion effects were triggered by galvanic corrosion between the steel bolt and the aluminum part. The lack of paint or other corrosion protection in the holes assisted in the corrosion.
