A-040/1999

TECHNICAL REPORT

**Accident of aircraft Agusta A-109-E,
registration EC-GQX, in the municipal area
of Villarejo de Salvanes (Madrid), on 26th
July 1999**

AIR ACCIDENTS AND INCIDENTS INVESTIGATION COMMISSION

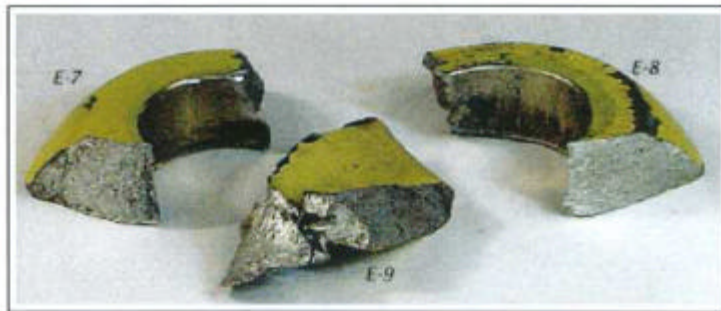
Fig. 13.- Fragmentos, dos procedentes de las orejetas de los tornapuntas (Fig. 9) y el tercero, no identificado

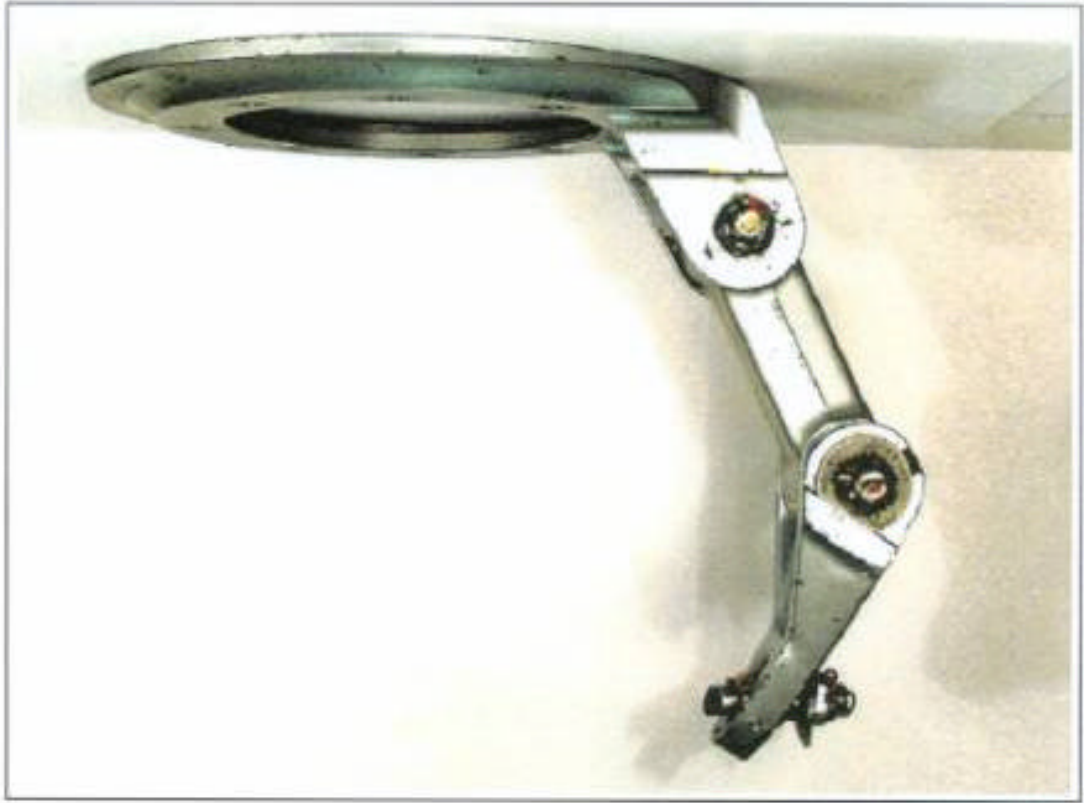
Fig. 1.1.- Tijera completa recibida

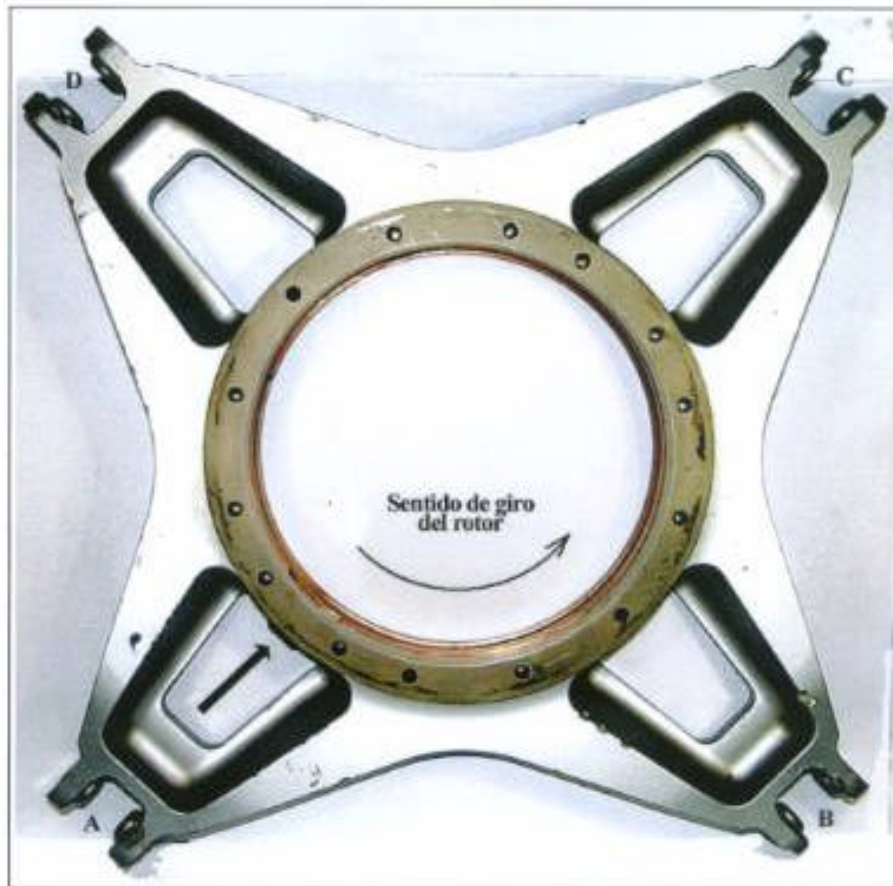
Fig. 1.2.- Vista del plato giratorio desde la cabeza del rotor principal

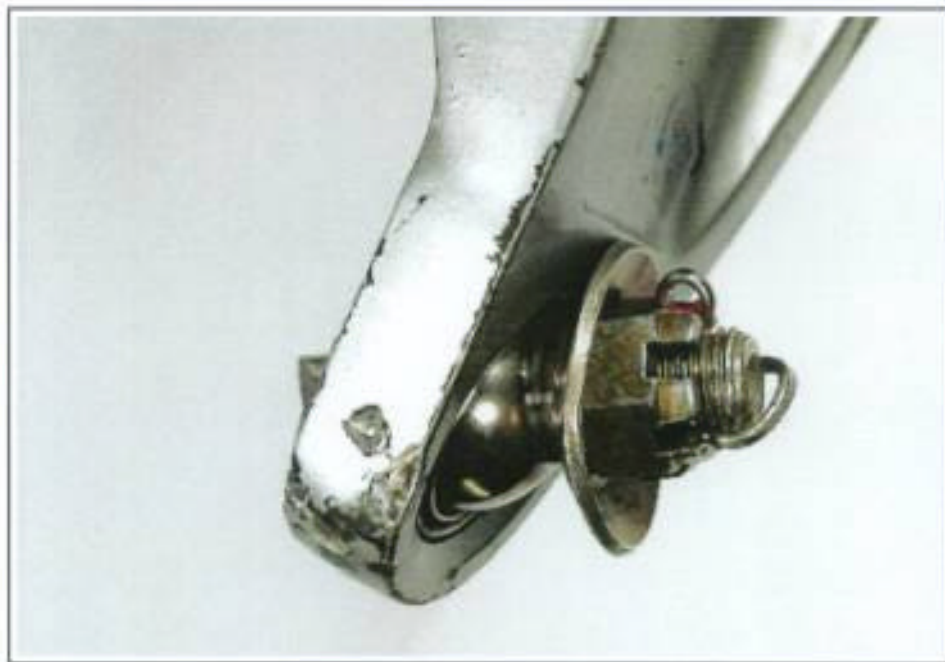
Fig. III.12.- Conjunto hueco-bulón en el brazo de la tijera

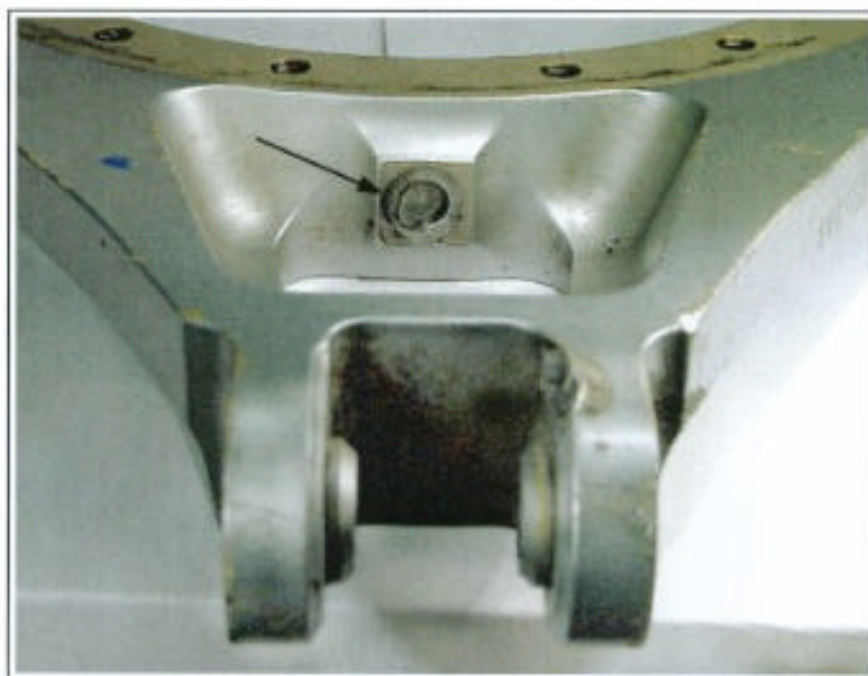
Fig. III.36.- Zona de empotramiento del bulón en el plato

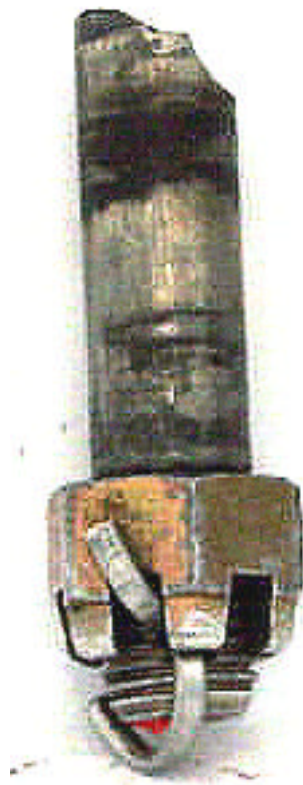
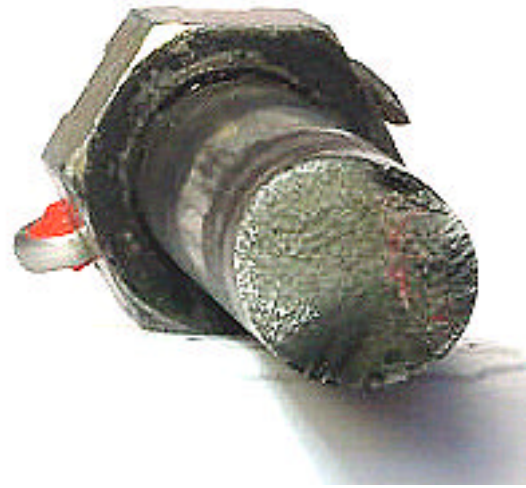
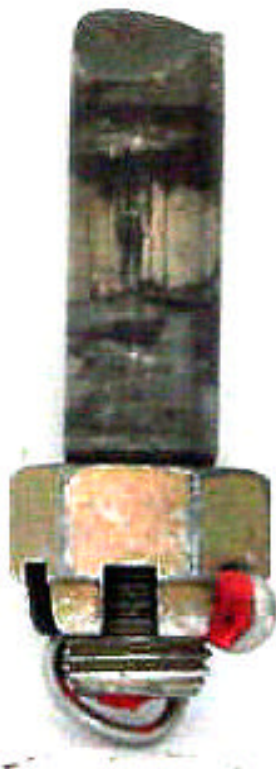
This incorrect assembly of the half-scissors assy. caused bending moments, not considered during the design, on the mounting bolt of the half-scissors assy., "Bolt, close tolerance" P/N NAS6606D28, which finally broke due to fatigue after approximately two hours of flying time.

Fig. III.16.- Detalle de la zona A de la superficie de fractura

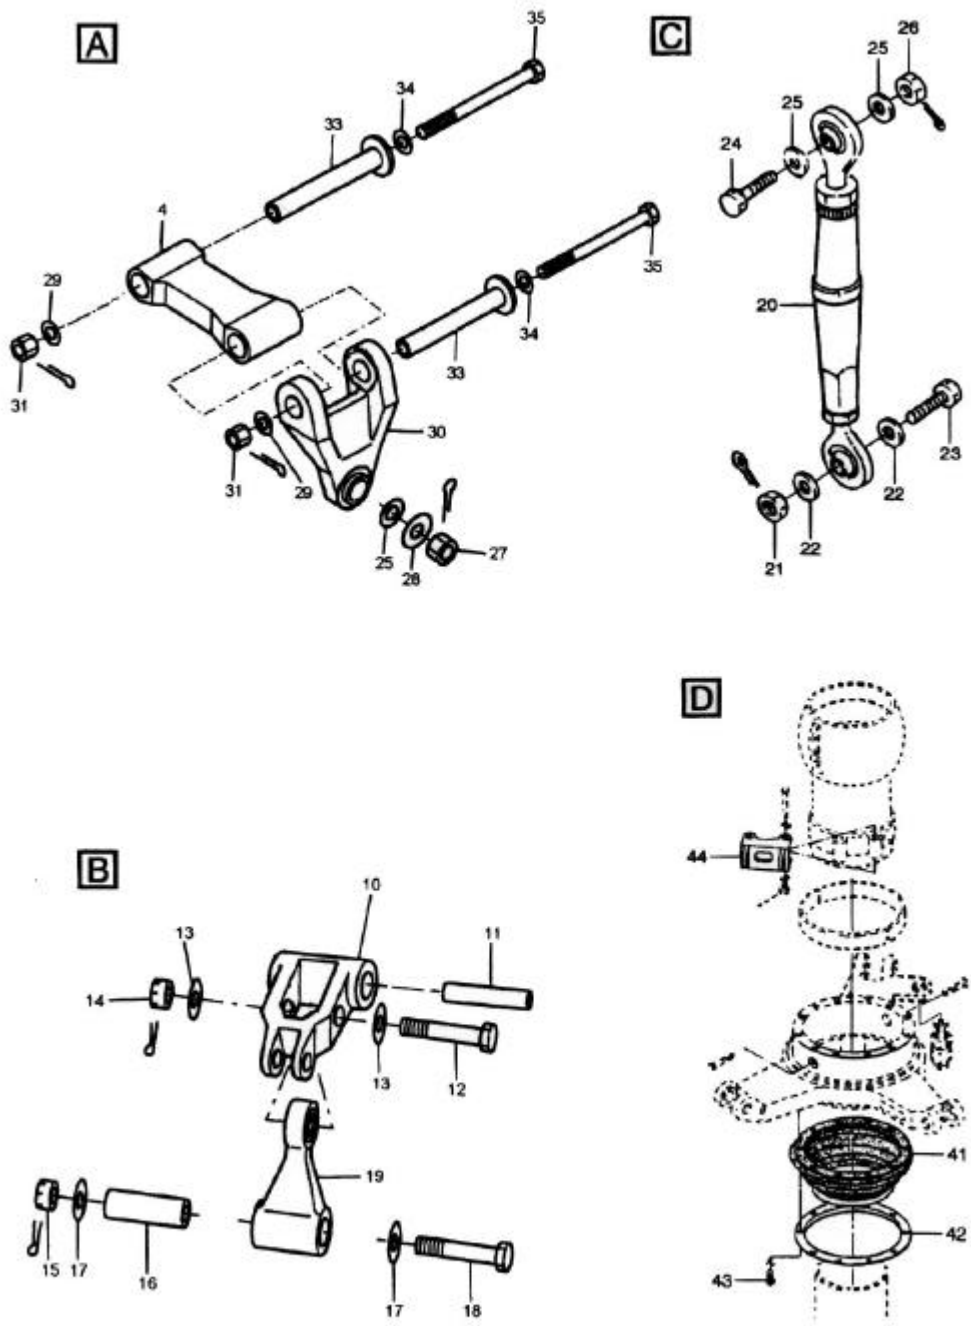
Figure 62-34. (Sheet 2 of 3) Rotating Controls

The reference to item 29 seems to be wrong, since the bevelled washer should be item 25 of the diagram (see figure 62-34 sheet 2 of 3 “Rotating Controls” in Appendix E).

As stated in Section 1.17, the maintenance documentation which provided by figure 62-34 of the A109E-MM Maintenance Manual, including Revision 2 on 4-2-2000 (after the accident occurred), was ambiguous regarding the assembly instructions of the half-scissors assy, since the diagram's perspective did not clearly show towards which side it had to be assembled. Being a spherical bearing, physically it could have been assembled in both positions, as happened with the equivalent part of the A109A helicopters previously maintained by the operator. Neither were there written instructions on how to carry out this assembly.

Moreover, as it happens, the arrangement of the washers on both sides of the spherical bearing were correctly drawn in figure 62-34, but the bevelled washer was indicated as item 25, while in the text, when the installation procedure of the rotating scissors was described in writhing, it was mentioned as item 29. This could have led the maintenance staff to think that there was an error in the diagram, which, along with the fact that when assembling the lower scissors in the inverted position it was more logical to place the bevelled washer between the bearing and the swashplate, it probably meant that the washers were assembled as in figure INTA III.29B in Appendix D. Nevertheless, neither the bevelled washer nor the thin washer were found amongst the wreckage, and so it can not be definitively concluded whether they were installed or not when the part was assembled.

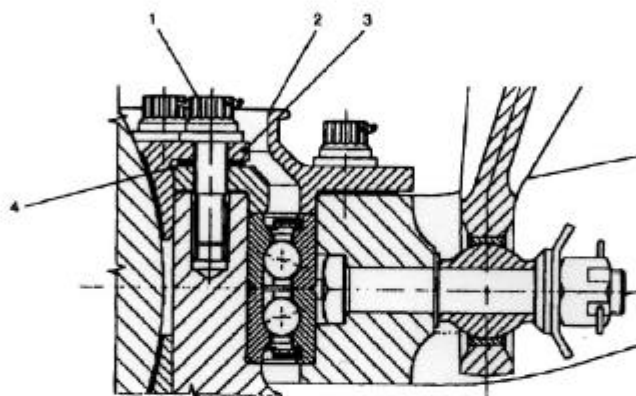
Figure 62-38. Swashplate Friction Adjustment

The Maintenance Manual did include the correct assembly in the diagram of figure 62-38, section 62-31-04 "Swashplate Friction Adjustment" (see Appendix E), but this figure, being part of another maintenance task, was not in the half-scissors assy section.

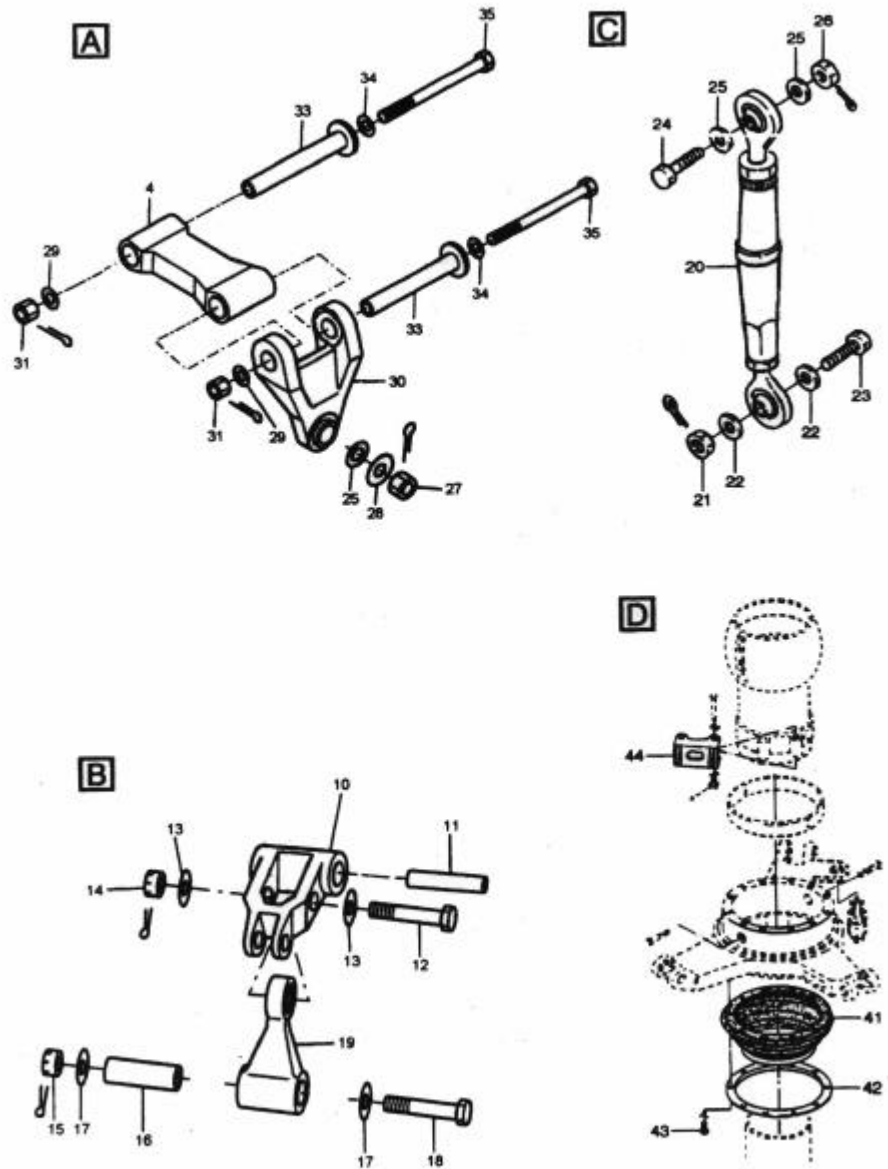
Figure 62-27. (Sheet 2 of 3) Rotating Controls

- The fig. 62-27, detail A, is clear and self explanatory for a correct installation of the parts. It is certainly expected that the maintenance personnel is asked to check the manual and the related figures before to performed the requested maintenance activity.

The washer identification P/N misprint noted in the fig. 62-27 (sheet 2 of 3) "A" is negligible due to installation instructions reported at par. 62-31-14 of the Maintenance Manual.

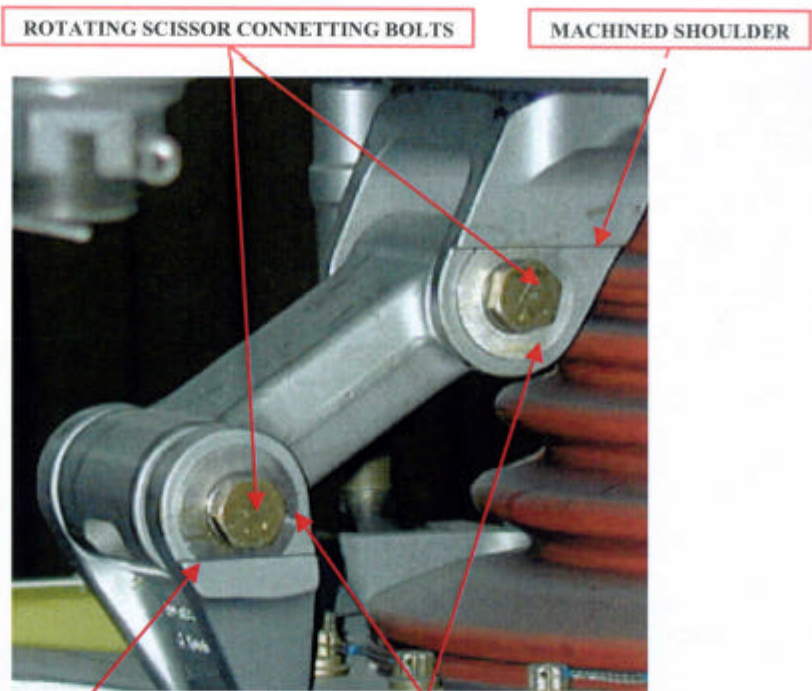
CUT SHAPED FLANGED SLEEVES TO MATCH THE MACHINED SHOULDER. FLANGE SLEEVES POSITIONED AT THE SAME SIDE

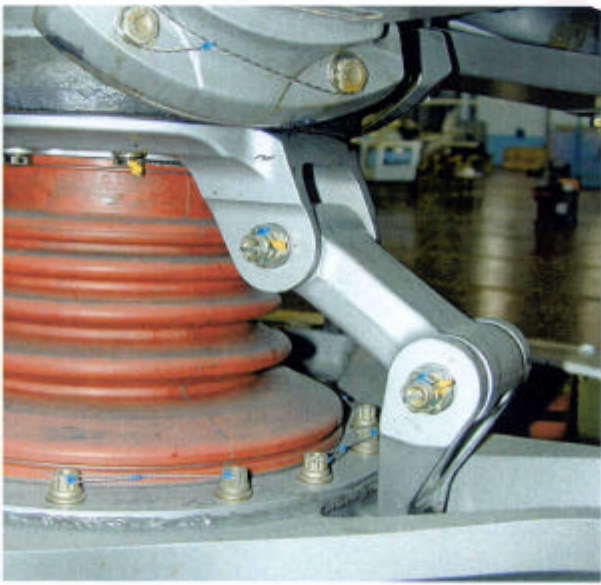
- The reverse installation of the lower scissor link (back to front) needs a consequently wrong positioning of the flanged sleeve. The installation that can be realized is clearly not consistent with the indication of the figure 62-27 A.

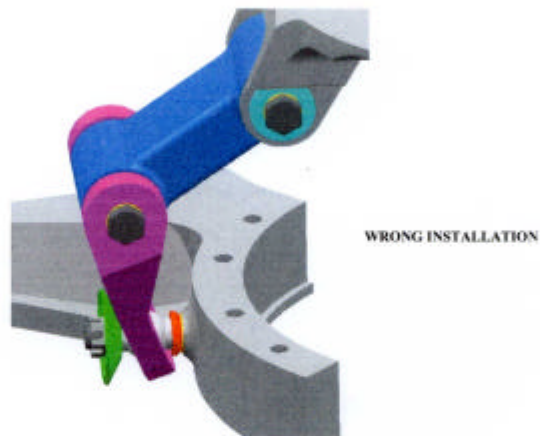
The following three dimension figures clearly show as appear a correct installation in respect to the wrong one. It is evident that a correct positioning of the two flanged sleeves preclude an incorrect installation of the scissors.

The operator installing the lower link in the reverse position (back to front) have consequently assembled also the flanged sleeve in the opposite direction. So doing it was realized an installation clearly not consistent with the indication of the figure 62-27 A.
