Report RL 2000:40e

***Aircraft accident to SE-GDN
8 kilometers northwest of Sundsvall/
Härnösand airport, Y county, Sweden
on the 9th of December 1999***

Case L-107/99

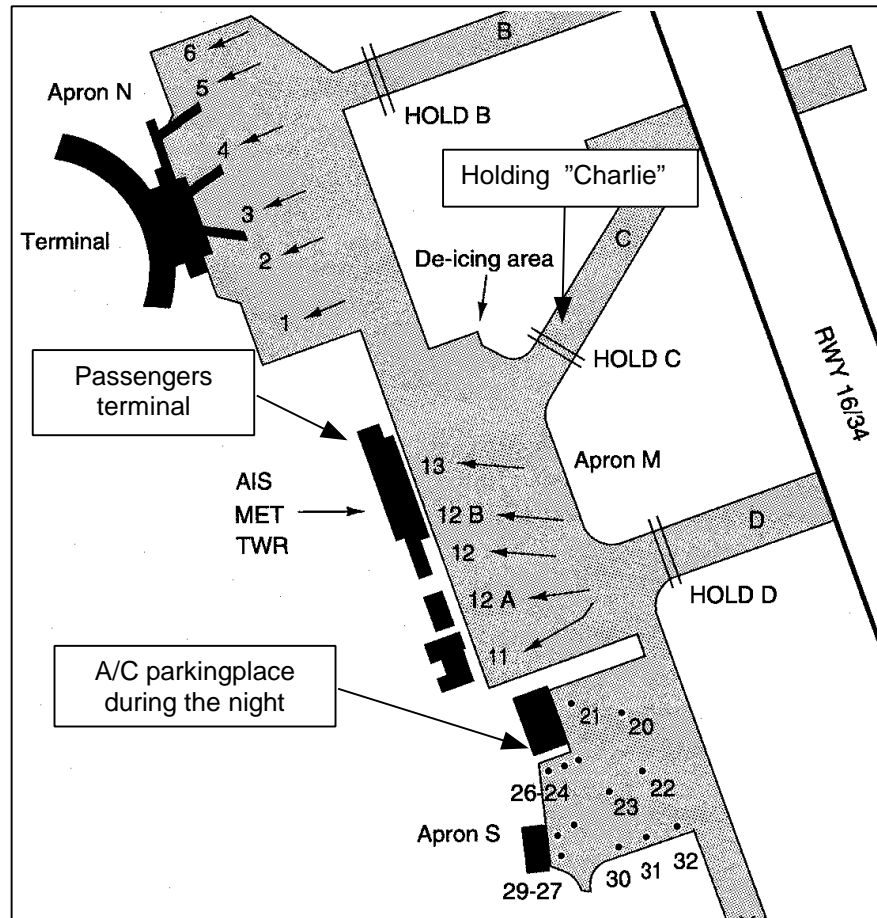
Terminal area at Sundsvall/Härnösand airport

Note. During the investigation it has been stated that magnetic disturbances were found at position #13.

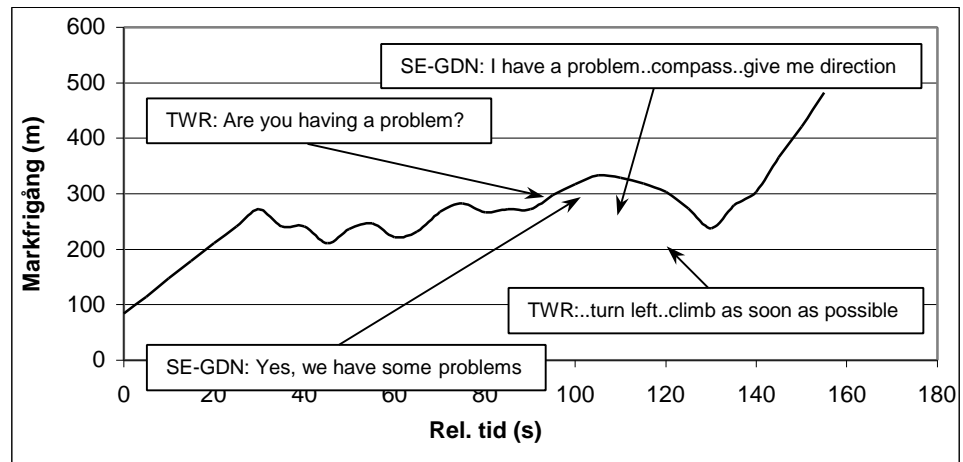
Below, the difference between the corrected flight altitude and the height of the terrain under the flight path, the terrain clearance, is calculated and plotted. Also, at the actual times during the flight, selected radio communication between the pilot (“SE-GDN”) and the air traffic controller (“TWR”) has been included.

Calculated terrain clearance

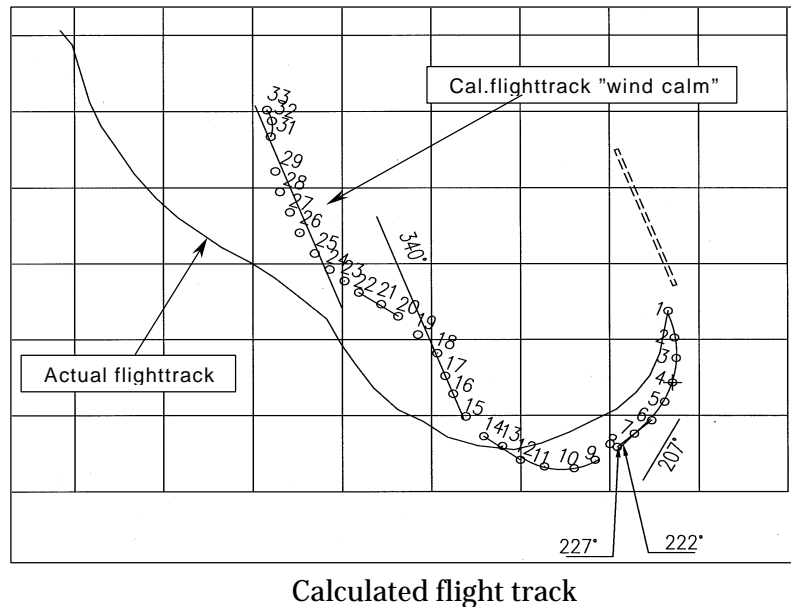
The revised flight path according to the chart below indicates that, among other things, the heading of 207 degrees towards MEGEN was passed about half a minute after the first radar echo, that the last of the right turn took place with a turning speed of about 3 degrees per second and that the approximate heading after the right turn was 340 degrees.
