AIRCRAFT ACCIDENT REPORT AND EXECUTIVE SUMMARY

| | | | | Reference: | CA18/2/3/7609 | |
| Aircraft Registration | ZS-GOS | Date of Accident | 26 December 2002 | Time of Accident | 0845Z | |
| Type of Aircraft | Beech 58 (Aeroplane) | | Type of Operation | Private | | |

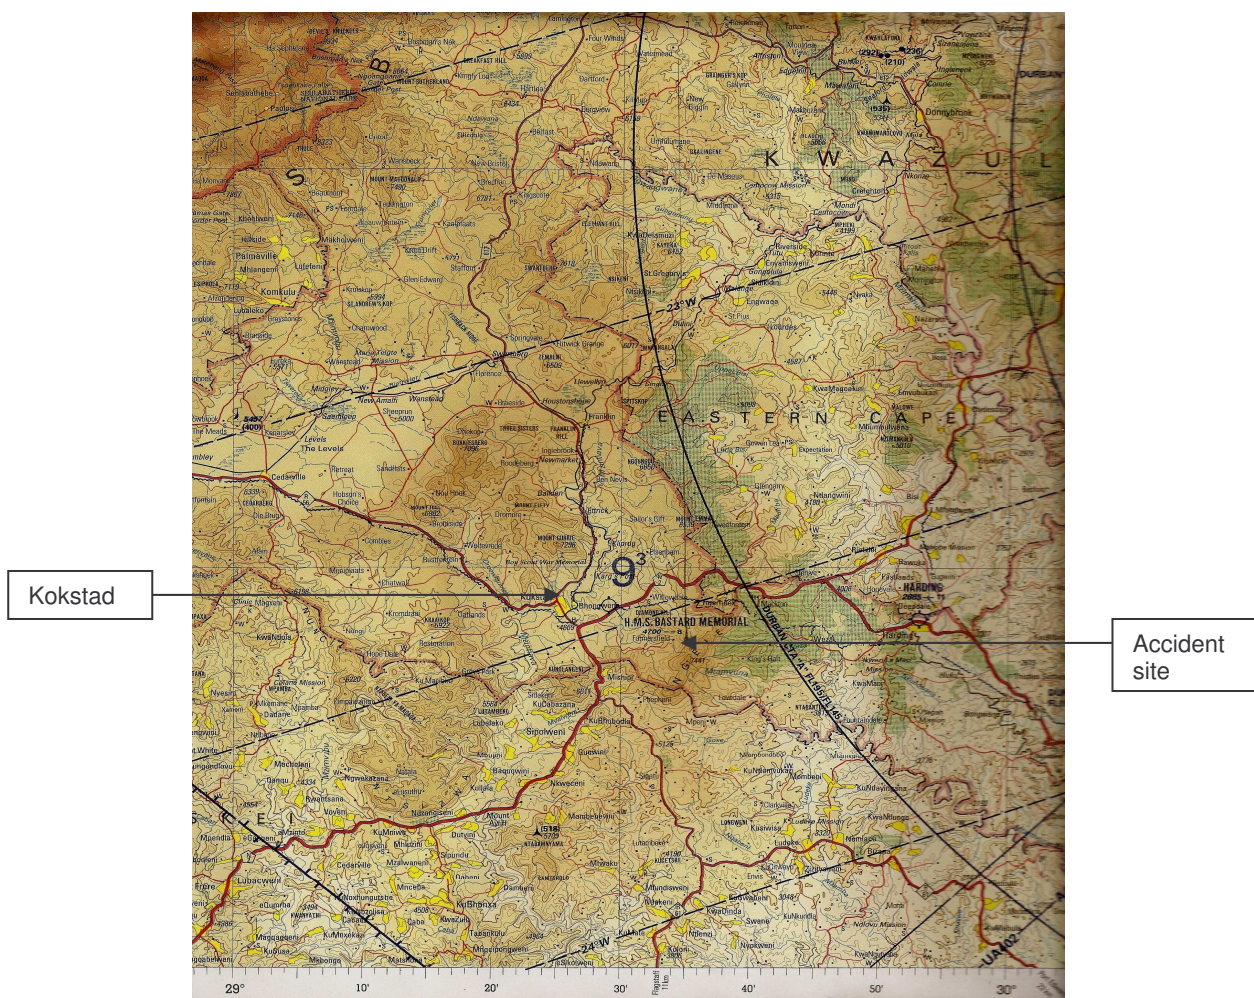
- 1.1.3 Passing abeam Donnybrook, it can be observed from the radar track recording observations that the aircraft started to descend and the airspeed increased marginally. The pilot was instructed by ATC to report passing flight level 70 (FL70), which he acknowledged.
- 1.1.4 The aircraft passed approximately 8 nm to the East of Kokstad on a southerly heading and impacted with the Ingele Mountains at an altitude of approximately 6560 feet Above Mean Sea Level (AMSL) (refer to map below). The minimum off-route altitude (MORA) for the Kokstad area according to the aviation map (inserted below) was 9300 feet AMSL.
- 1.1.5 The accident occurred during daylight conditions at a geographical position determined to be South 30°35'58" East 029°35'122" at an elevation of 6 560 feet above mean sea level (AMSL).

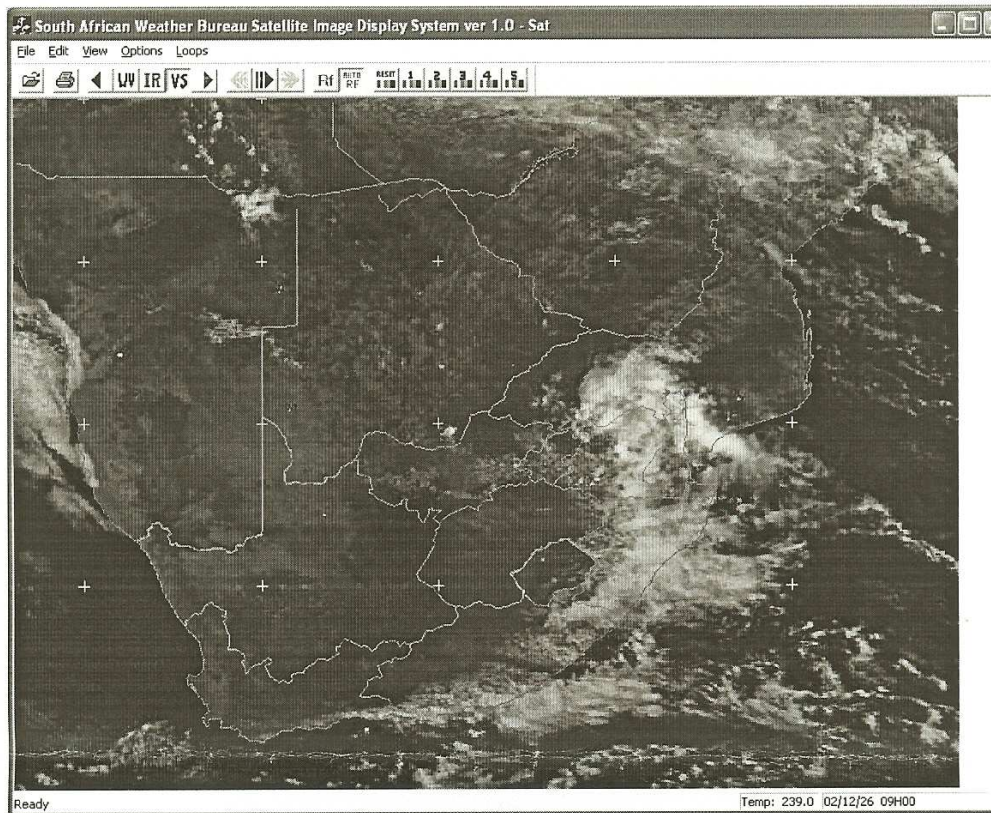
2. Satellite Imagery:

The 0900Z visual image for 26 December 2002 shows cloudy conditions over the eastern parts of the country, including KwaZulu-Natal and the Eastern Cape.
