Statens haverikommission
Swedish Accident Investigation Board

Report RL 2006:12e

**Accident involving aircraft SE-GOP
at Optand airport, Z county, Sweden,
on 6 August 2004**

Case Number L-31/04

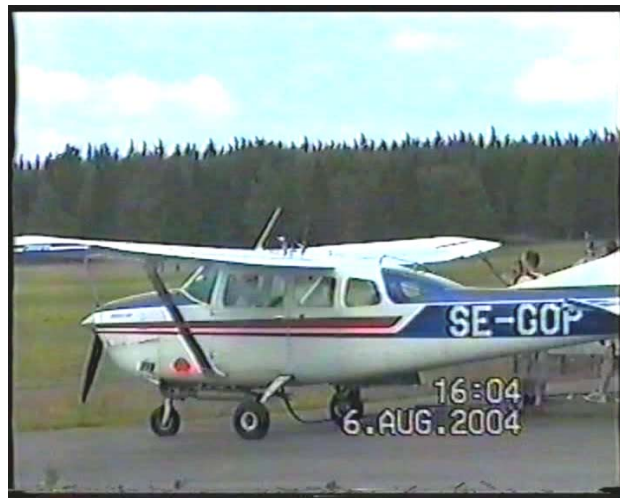
The aircraft's starboard tank being refuelled before the accident flight. Picture from amateur video.

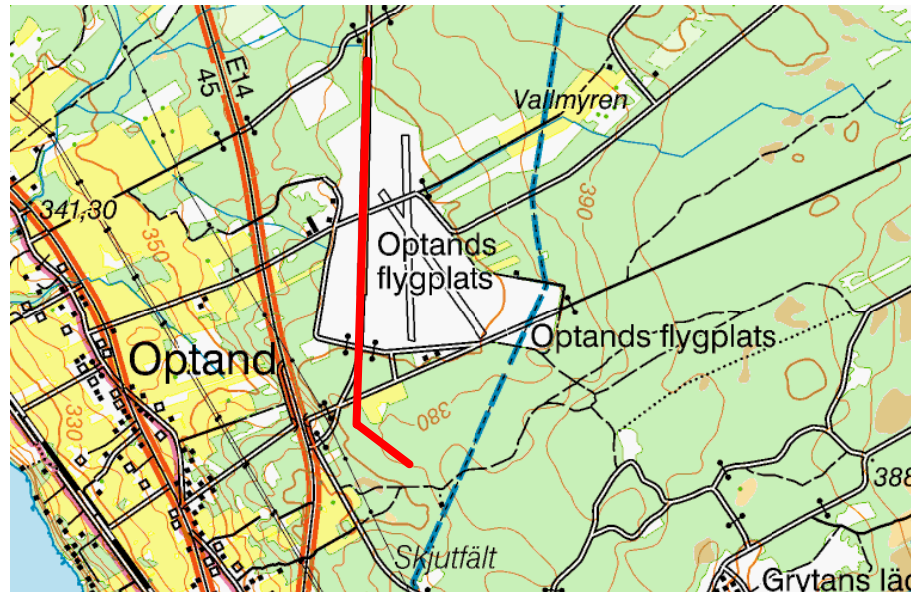
Map of Optand airport. The aircraft's flight path drawn in..

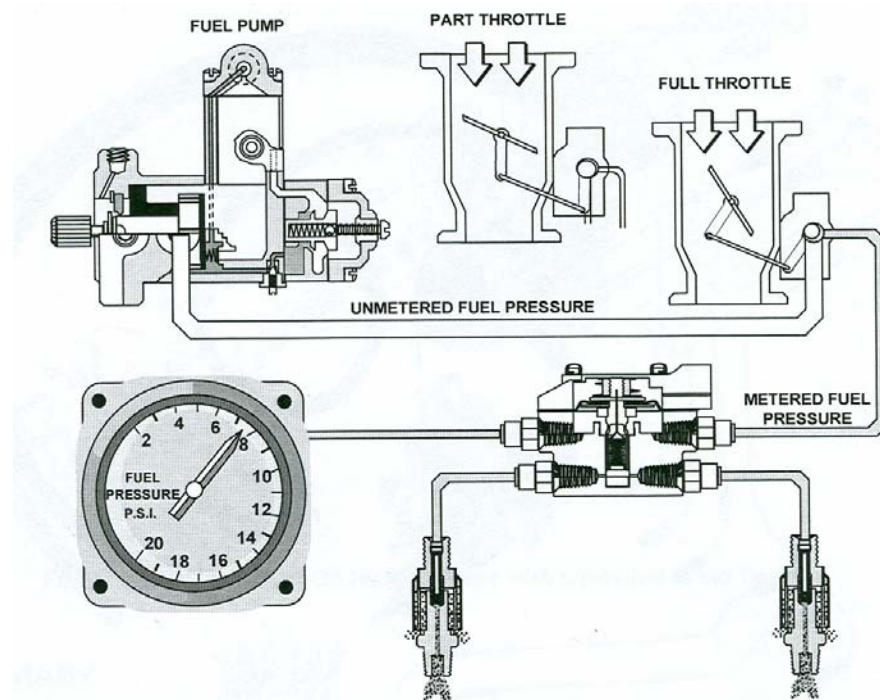
The meter in the illustration shows fuel pressure. In most installations, including SE-GOP, it is marked to show fuel flow instead.

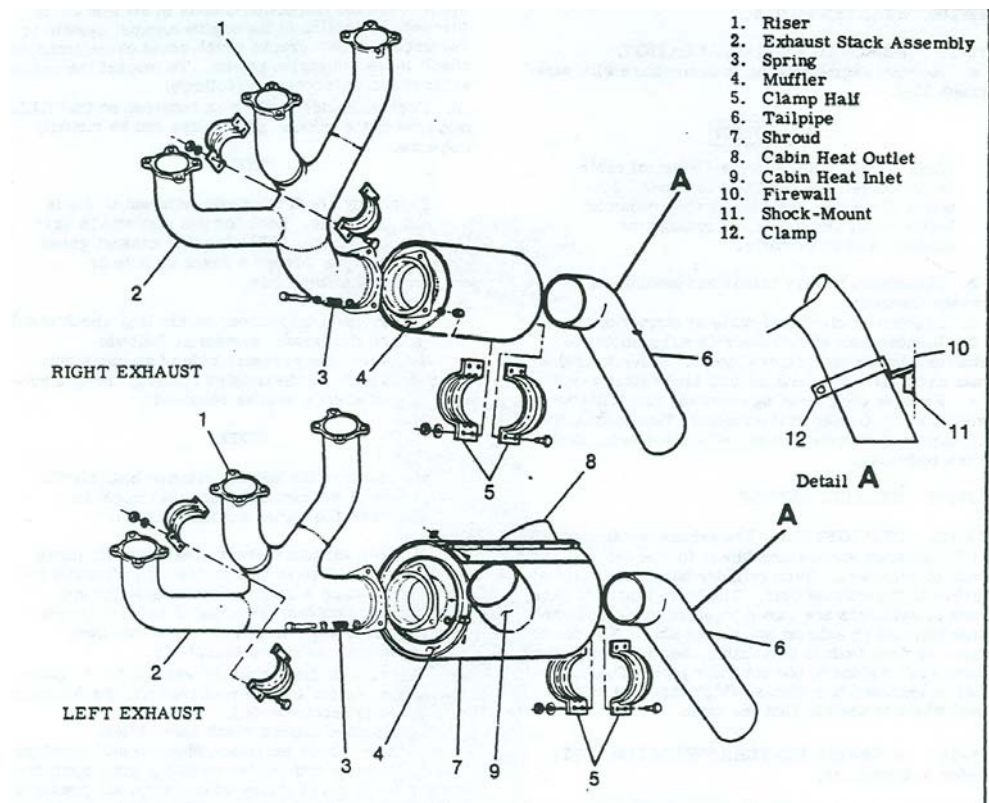
The exhaust system consists of a left half and a right half (see illustration). After each manifold a silencer (muffler) is mounted. The one on the left is designed as a heat exchanger to produce warm air to heat the cabin.
