Report RL 2006:08e

**Aircraft accident to SE-LTF
at Gråbo, O county, Sweden
on 15 February 2005**

Case L-03/05

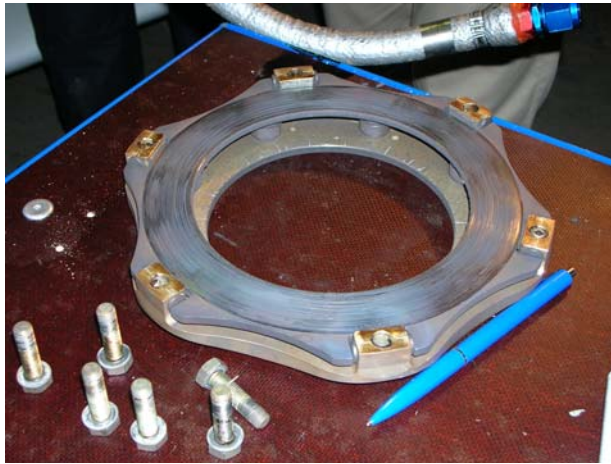
The figure above shows the clutch basket with the pressure plate on top. The spring stacks can be seen between them. Each of these consists of a number of disc springs (Bellville washers) arranged so as to give the clutch a slipping torque of 290 Nm.

The rear side of the pressure plate showed clear marks from the spring stacks, but with an extra set of marks, probably from a previous assembly.

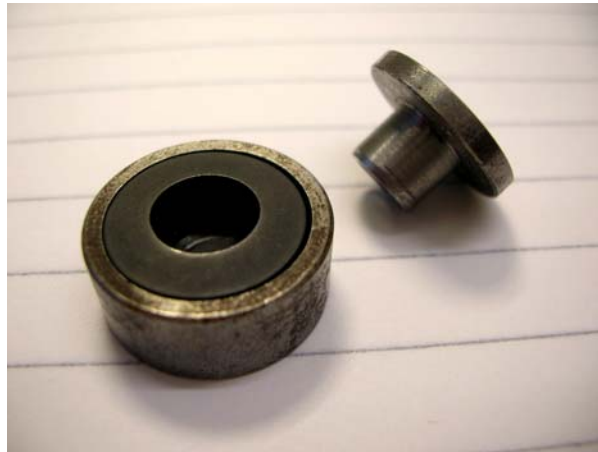
Each spring stack consists of 12-13 disc springs mounted in a two-part holder. See figure on next page.

In the assembly in question the disc springs were assembled in parallel and series alternately. The diagrams below show three parallel disc springs and three assembled in series as well as how the assembly orders 3-3-3-2-1 and 3-3-3-2-2 are arranged. According to a factory documentation, the disc springs should be assembled 3-3-3-2-2. The assembly order 3-3-3-2-1 was also mentioned verbally.

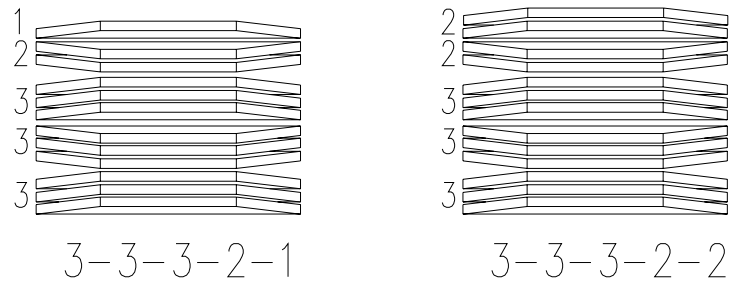
The assembly order chosen resulted in several springs in the spring stack being compressed together completely and flattened, which resulted in the spring force decreasing very rapidly when the compression decreased; in this case, with the wearing of the clutch plate.

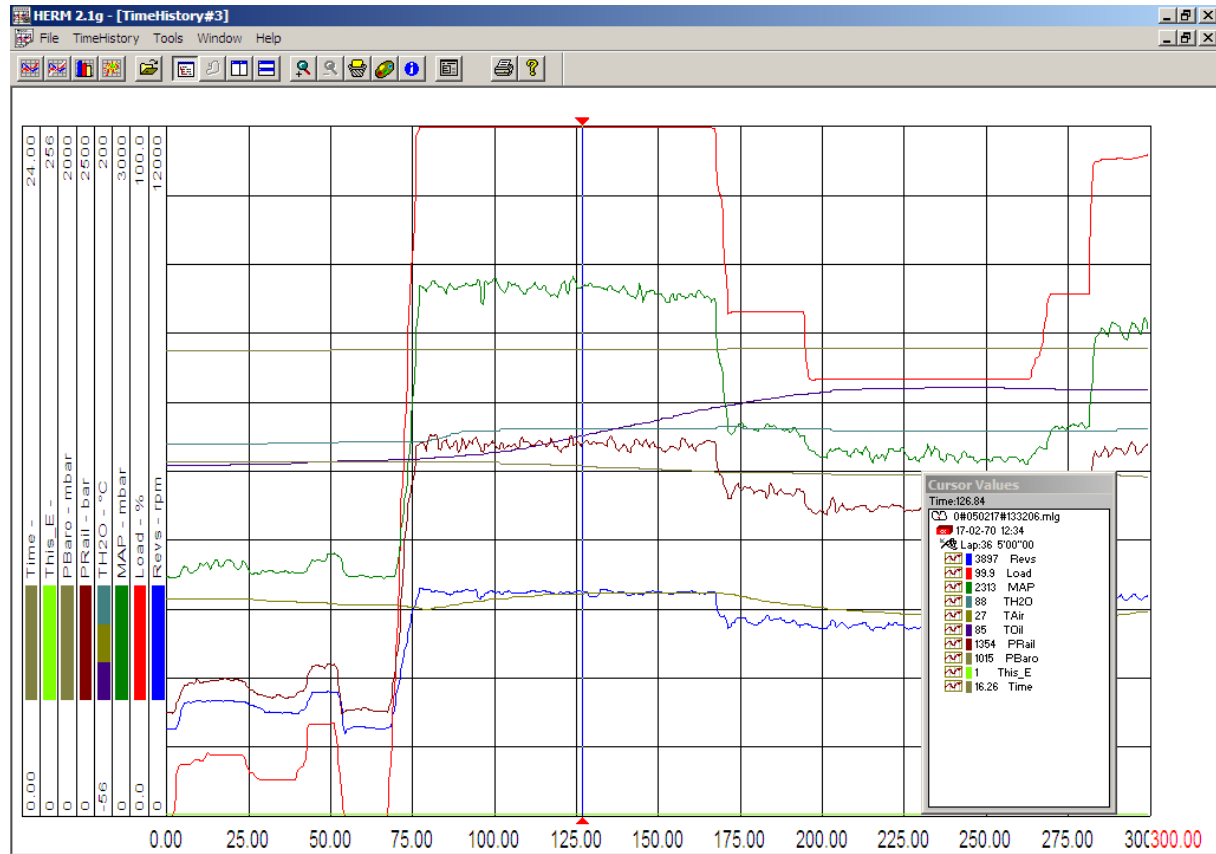
Graph 1: Motor 02-01-0408-SL01-104-0063, Start of the flight, Take Off

The FADEC Logger data were downloaded on the 17th of February 2005. The engine was started at 16:14 hour (local time). The run up check was carried out successfully. Graph 1 shows the take off at 16.25 hour. All parameters were within the limits at that point of time.

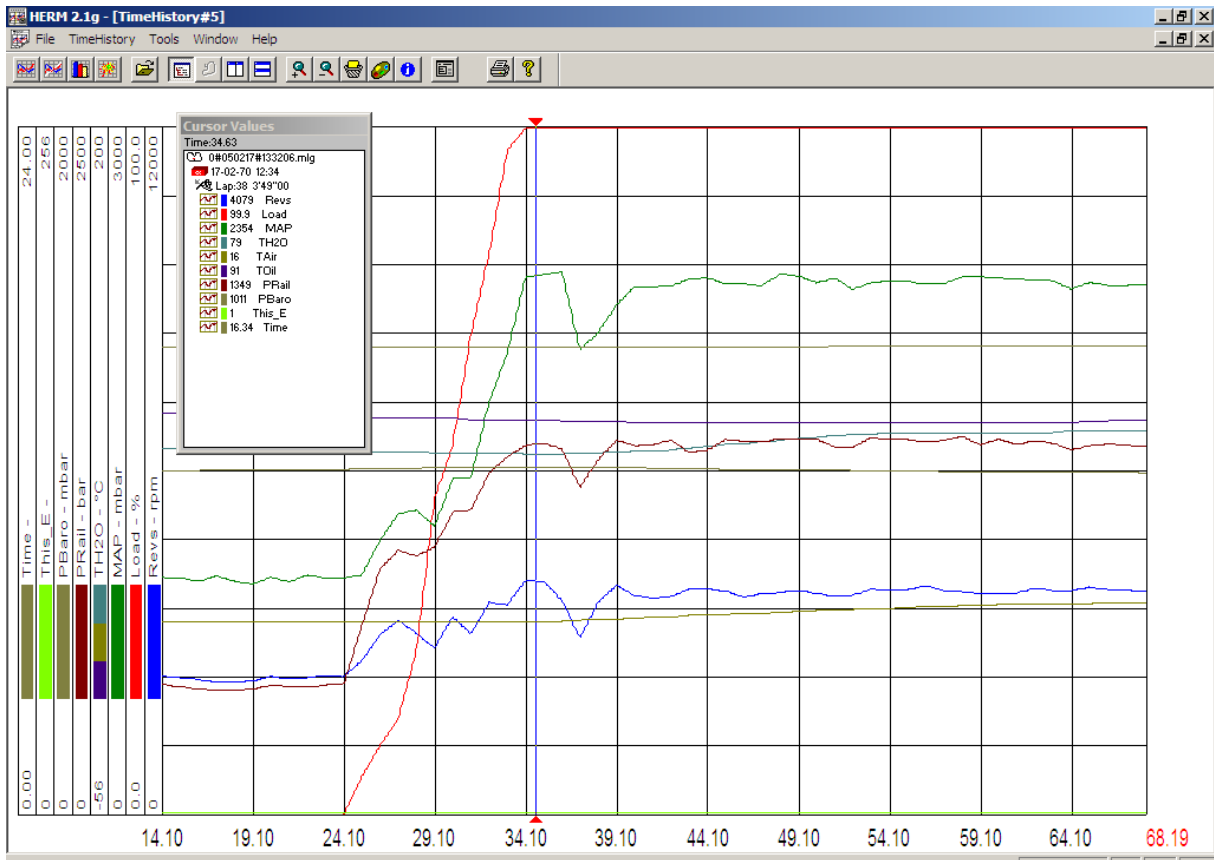
After Take-off, the aircraft climbed and began with idle decent stages. Graph 2 shows the first and the second full power stage. The aircraft descended with idle power setting at second 25 of graph 2. After that stage, the pilot put the throttle lever to 100 %. During this acceleration, the engine was running with an engine speed up to 4077 (2410 Prop RPM). In the next second, the engine speed broke down to 3300 RPM. This breakdown is probably caused by the propeller regulator. As soon as a high engine speed is detected, the propeller control system starts with reducing the propeller speed by changing the pitch angle. Graph 3 shows a zoom-in of the first acceleration.

Graph 3: 02-01-0408-SL01-104-0063, Small high revving of the engine during the acceleration stage
