AIRCRAFT ACCIDENT REPORT AND EXECUTIVE SUMMARY

| | | | | Reference: | CA18/2/3/8179 | |
| Aircraft Registration | ZU-CYI | Date of Accident | 22 September 2006 | | Time of Accident | 1452Z |
| Type of Aircraft | L-29 Delphin (Aeroplane) | | Type of Operation | | Private | |

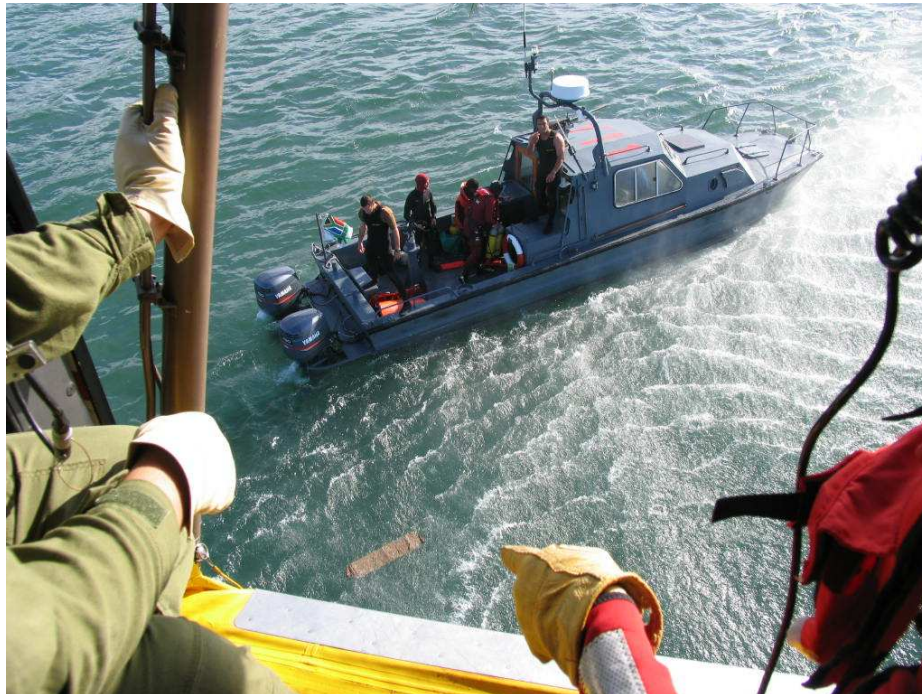
Following notification of the accident, a military rescue helicopter that was on standby at AFB Ysterplaat was dispatched within minutes (5 – 10 minutes) to the scene. Police and navy patrol boats that were at sea at the time of the accident responded quickly to where the aircraft impacted with the sea. The helicopter orbited the area while the patrol boats moved into position and started searching the area for the missing pilot, who was found to be fatally injured.

Figure 9: View from the rescue helicopter with a navy patrol boat visible, searching the area.
