AIRCRAFT ACCIDENT REPORT AND EXECUTIVE SUMMARY

Reference:	CA18/2/3/8427	
Aircraft Registration	ZS-NWO	Date of Accident	30 January 2008		Time of Accident	0945Z
Type of Aircraft	Piper PA23-250		Type of Operation	Training		
Pilot-in-command Licence Type		Commercial	Age	33	Licence Valid	Yes
Pilot-in-command Flying Experience		Total Flying Hours	1 313.4		Hours on Type	67.0
Last point of departure		Benoni/Brakpan Aerodrome (FABB)				
Next point of intended landing		Benoni/Brakpan Aerodrome (FABB)				
Location of the accident site with reference to easily defined geographical points (GPS readings if possible)						
On the apron at Benoni/Brakpan Aerodrome (FABB)						
Meteorological Information		Wind 090° at 5 kts, temperature 24°C, visibility CAVOK				
Number of people on board	1 + 1	No. of people injured	0	No. of people killed	0	
Synopsis						
<p>The flight instructor and a pilot under training returned from the East Rand general flying area where they were conducting conversion training for the pilot onto the Piper PA23-250 aircraft type.</p> <p>After landing on runway 18, they turned off the runway onto the taxiway at the end of the runway. The flight instructor stated that they pro

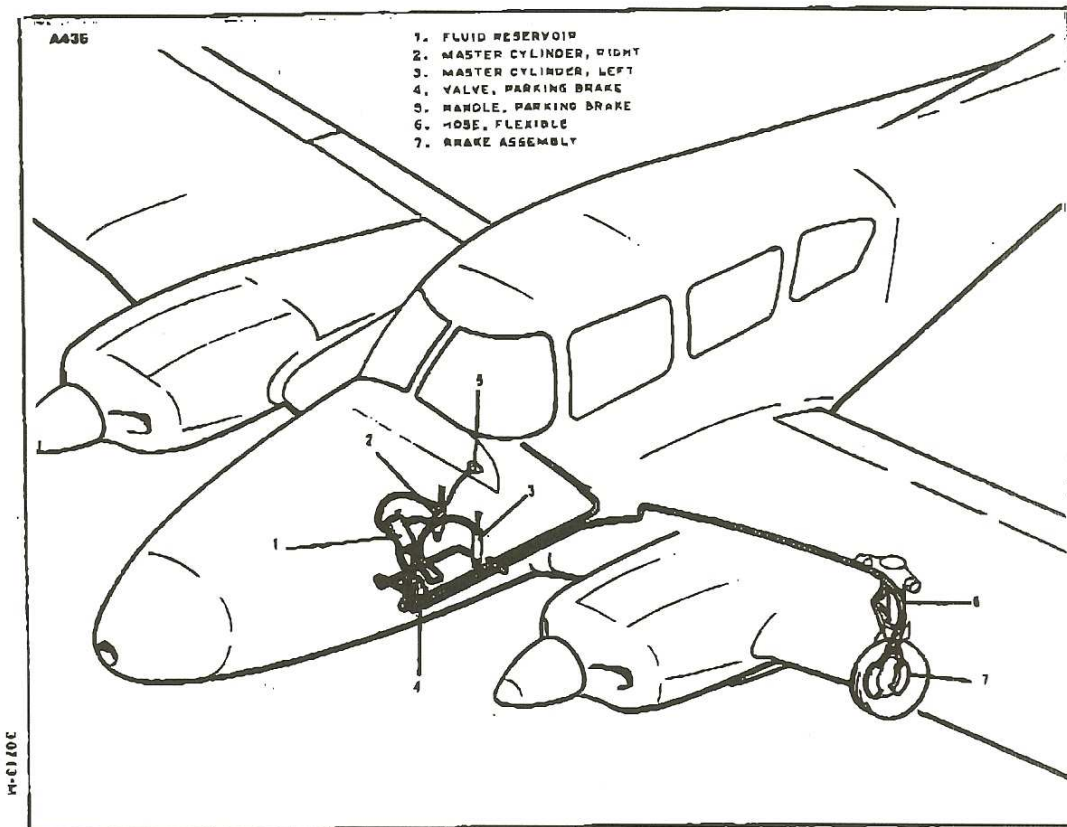
Figure 8: The brake system installation on the Piper Aztec type aircraft

1.18.3 The brakes was examined and tested by an approved AMO approximately one hour after the accident and the brakes were found fully functional and serviceable.

No hydraulic system leaks were observed in the brake system and brake assemblies at the main wheels.

2.4 The brakes and brake system was inspected by an approved maintenance facility an hour after the accident and found fully serviceable and operational.
