## AIRCRAFT ACCIDENT REPORT AND EXECUTIVE SUMMARY

Reference:	CA18/2/3/8460	
<b>Aircraft Registration</b>	ZS-RTV	<b>Date of Accident</b>	20 March 2008		<b>Time of Accident</b>	1145Z
<b>Type of Aircraft</b>	Robinson R22 Beta II (Helicopter)		<b>Type of Operation</b>	Private		
<b>Pilot-in-command Licence Type</b>		Private	<b>Age</b>	37	<b>Licence Valid</b>	Yes
<b>Pilot-in-command Flying Experience</b>		Total Flying Hours	361.6		Hours on Type	361.6
<b>Last point of departure</b>		Brits aerodrome (FABS), North West Province				
<b>Next point of intended landing</b>		Rustenburg aerodrome (FARG), North West Province				
<b>Location of the accident site with reference to easily defined geographical points (GPS readings if possible)</b>						
Open, grassy area near the town of Rustenburg; GPS position S25° 38.765' E027° 15.040'; elevation 3 588 ft						
<b>Meteorological Information</b>		Temperature: 23°C; Wind: 135°/10 kts; Visibility: 10 km				
<b>Number of people on board</b>	1 + 0	<b>No. of people injured</b>	0	<b>No. of people killed</b>	0

**Name of Owner/Operator** : Louis Fourie Game Capture (PTY) LTD  
**Manufacturer** : Robinson Helicopter Company  
**Model** : R22 Beta II (helic

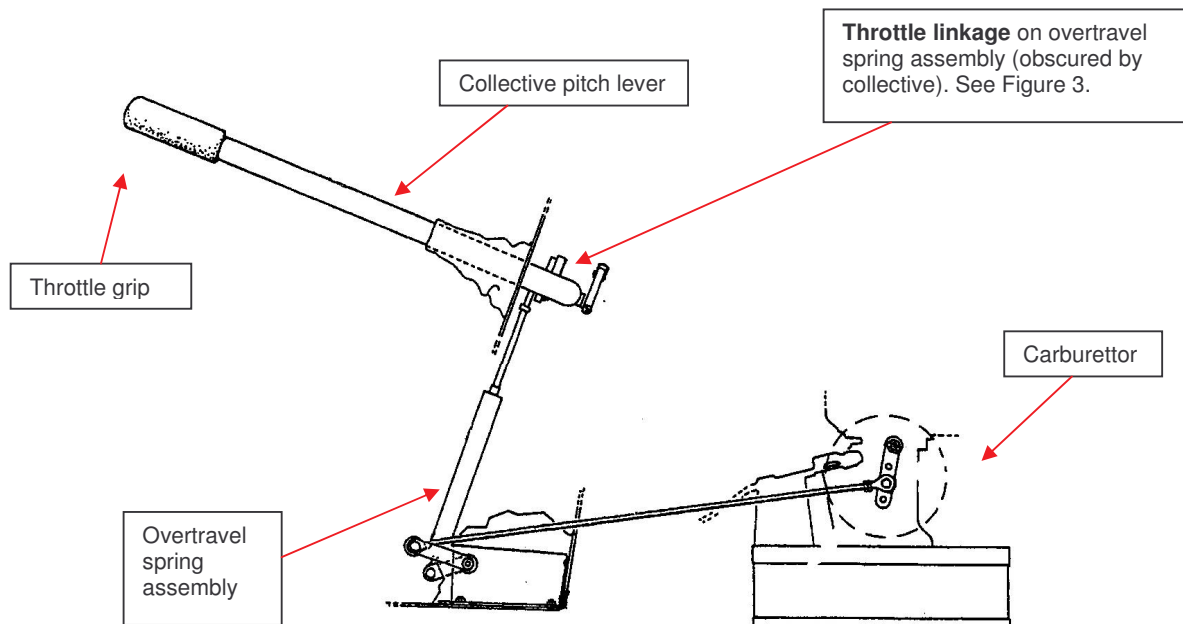
**Figure 4 .** Collective, overtravel spring assembly and carburettor link.

- (a) The throttle can be controlled as follows:
  - by rotating the throttle twist-grip on the collective
  - the upwards or downwards movement of the collective
  - automatically with the governor
- (b) A failure of a linkage at the collective, throttle twist-grip or carburettor will render the governor inoperative. The throttle and engine speed will then stay in the last selected position regardless of throttle, collective or governor inputs as there is no “spring-loaded” position on the carburettor throttle.
- (c) The overtravel spring assembly has a spring-loaded dampening function that protects the control system when the collective pitch lever movement limit is exceeded.

- 1.18.2 The throttle linkage, as shown above, is screwed onto the end of the overtravel spring rod.
- 1.18.3 Further investigation established that, during throttle movement, a small amount of longitudinal force is exerted on the throttle linkage and overtravel spring assembly. The diameter of the threaded part of the throttle linkage is very small (approximately 10/32 inches) and during operation no bending force is exerted on it as the overtravel spring protects it through dampening when the collective pitch lever movement limits are exceeded.
- 1.18.4 No evidence was found to suggest that the throttle linkage, part no. A759-1, fitted to the helicopter had been damaged prior to this accident or replaced from the time the helicopter came into service until this accident occurred.
