AIRCRAFT ACCIDENT REPORT AND EXECUTIVE SUMMARY

Reference:	CA18/2/3/8524	
Aircraft Registration	ZU-BEG	Date of Accident	27 July 2008		Time of Accident	1145Z
Type of Aircraft	Piper PA-22 (Fixed Wing)		Type of Operation		Private	
Pilot-in-command Licence Type		Private Pilot	Age	44	Licence Valid	Yes
Pilot-in-command Flying Experience		Total Flying Hours	122.32		Hours on Type	14.0
Last point of departure		Port Elizabeth International Airport (FAPE).				
Next point of intended landing		Port Elizabeth International Airport (FAPE).				
Location of the accident site with reference to easily defined geographical points (GPS readings if possible)						
At approximately 5 metres on the right-hand side of Runway 26 at Port Elizabeth International Airport.						
Meteorological Information		Wind Direction: 270°/ 25 Gusting 32kts, Visibility: Good.				
Number of people on board	1 + 1	No. of people injured	0	No. of people killed	0	
Synopsis						
<p>The pilot and passenger were engaged on a private, visual flight rules (VFR) flight by day. They took off at approximately 1040Z, from Port Elizabeth International Airport (FAPE) for a flight to Jeffery's Bay – Paradise Beach area. When the aircraft re

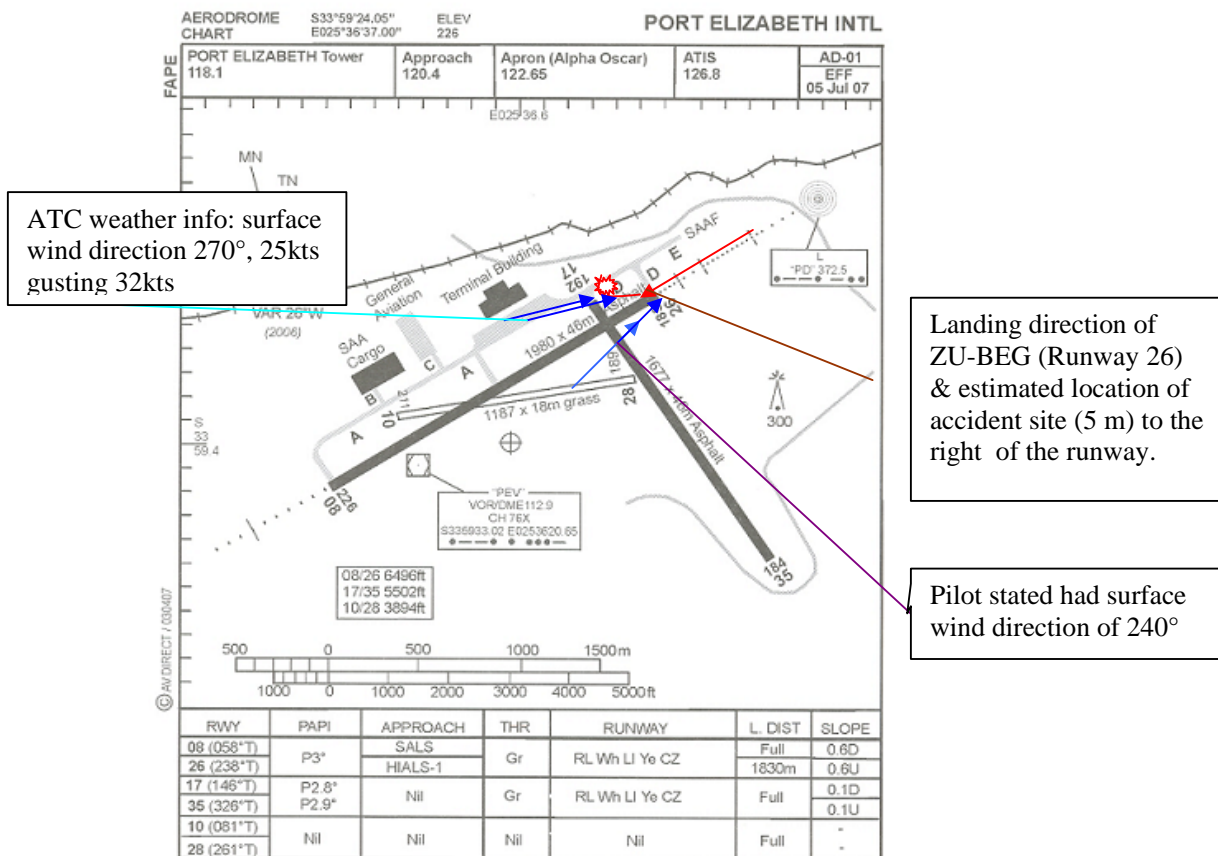
1.10.2 The aircraft heading and wind direction information shown on the sketch above is per the Pilot and ATC statements.
