AIRCRAFT ACCIDENT REPORT AND EXECUTIVE SUMMARY

Reference:	CA18/2/3/8541	
Aircraft Registration	ZS-OZM	Date of Accident	30 August 2008	Time of Accident	1407Z	
Type of Aircraft	Ayres S2R-T34 Fixed Wing Aircraft		Type of Operation	Aerial Fire Fighting		
Pilot-in-command Licence Type		Commercial Pilot	Age	68	Licence Valid	Yes
Pilot-in-command Flying Experience		Total Flying Hours	23163		Hours on Type	Unknown
Last point of departure		Kataza Aerodrome, Melmoth, Kwazulu-Natal				
Next point of intended landing		Kataza Aerodrome, Melmoth, Kwazulu-Natal				
Location of the accident site with reference to easily defined geographical points (GPS readings if possible)						
In a tree plantation in Havemanshoogte area, Melmoth, Kwazulu-Natal GPS S28°30.349 E031°15.611 at 3589 feet elevation.						
Meteorological Information		Temperature: 25.4°C; Dew point: -15°C; Wind: 300°1 5-35knots; Cloud cover: None; Visibility: 3km				
Number of people on board	1	No. of people injured	0	No. of people killed	1

Name of Owner/Operator : Osmond Aerial Spray (PTY) LTD
Manufacturer : Ayres
Model : S2R-T34
Nationality : South African
Registration Marks : ZS-OZM
Place : Havemanshoogte area, Melmoth, Kwazulu-Nata

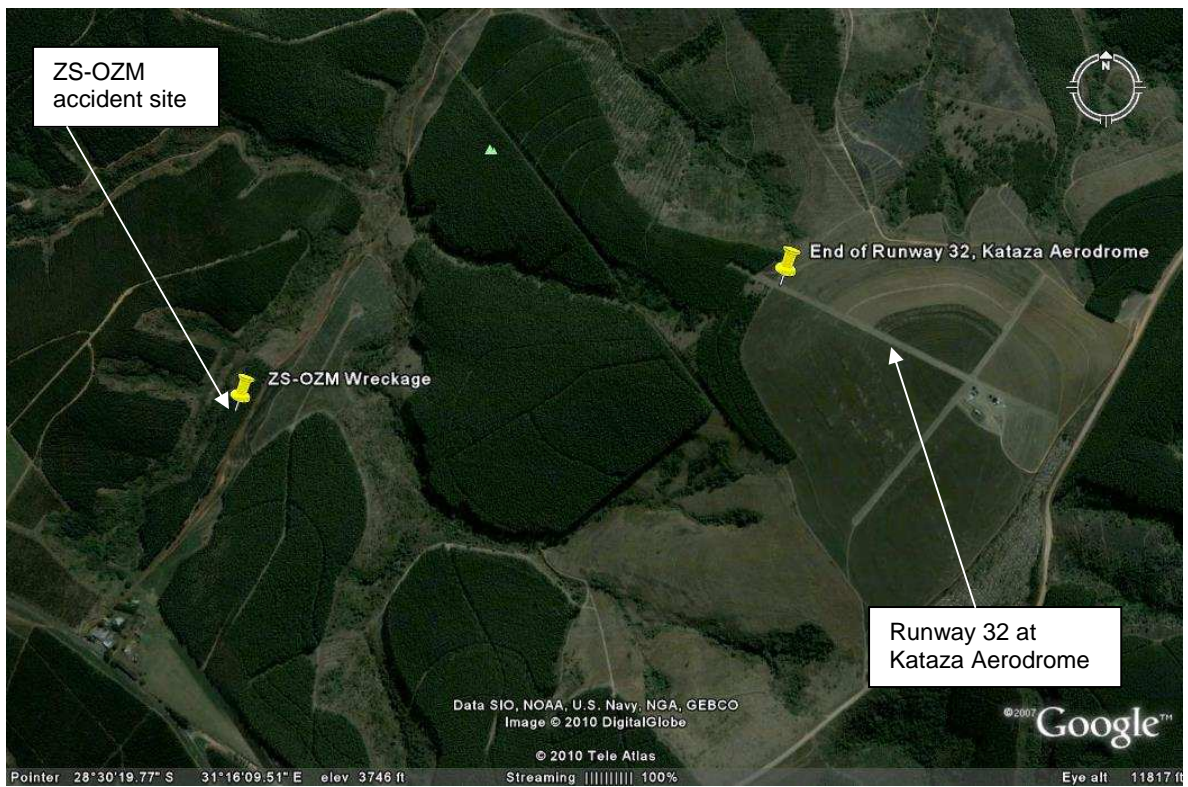
- 1.1.7 Approximately 1356 meters from Kataza Aerodrome fire fighting ground teams located the accident site of ZS-OZM. Emergency services as well as the local police were notified of the accident.

Photo 1: Google Earth photo of the accident site and Kataza Aerodrome.

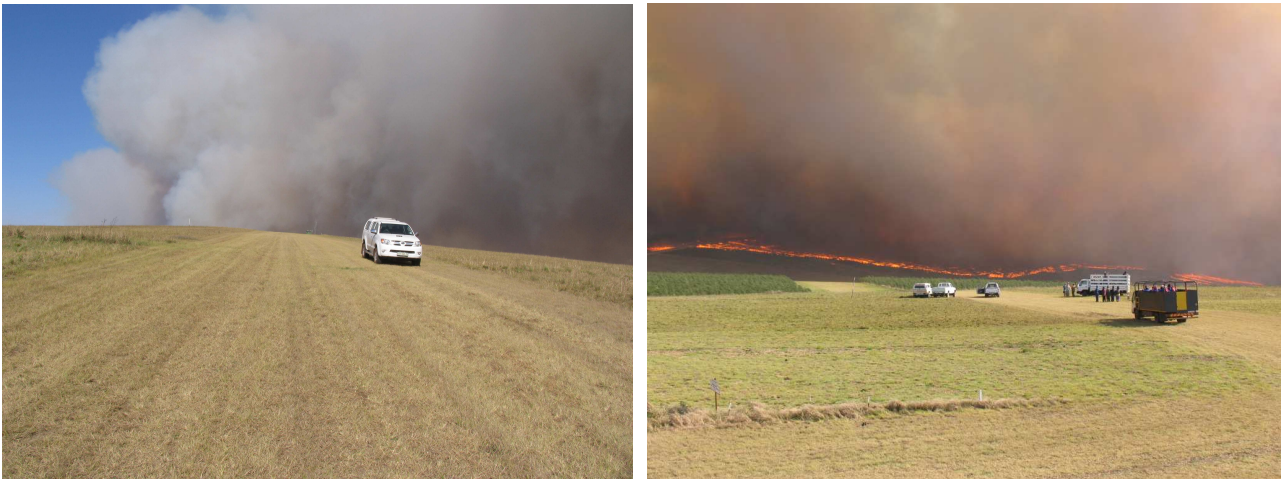
Photo 4 & 5: View of Runway 32 at Kataza Aerodrome.
The photos was taken a day after the accident occurred.

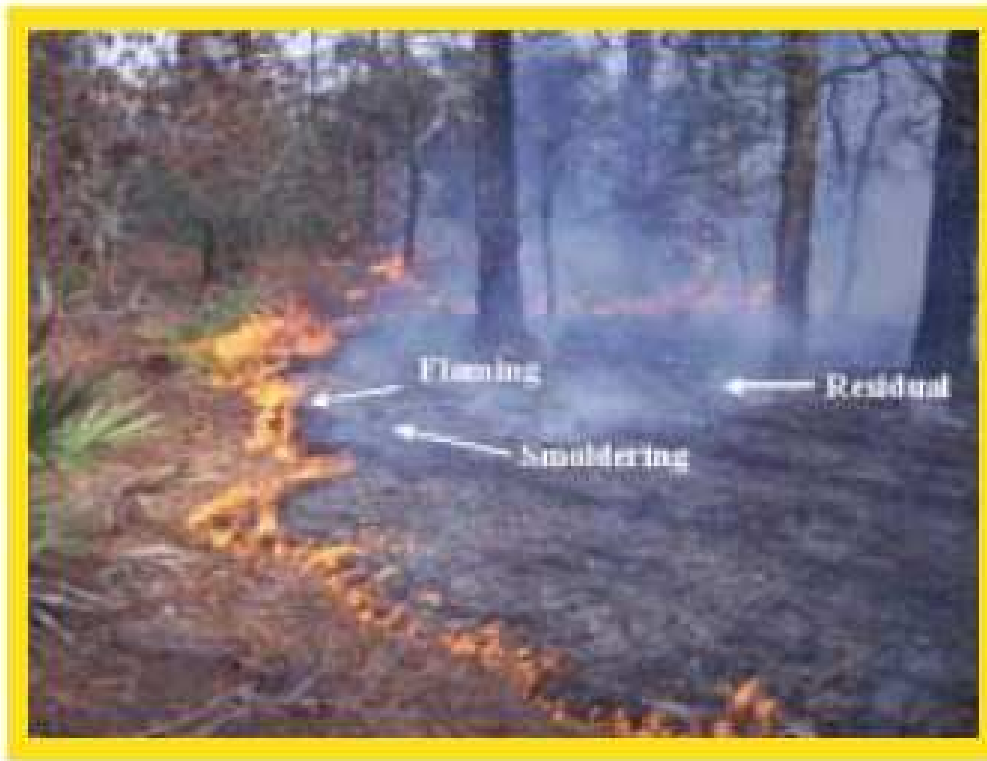
At least three important stages of combustion exist when fuel particles are consumed (Mobley 1976; NWCG 1985): **flaming**, **smoldering**, and **residual** (also known as "glowing," "residual smoldering," or "residual combustion") (fig. 2). The efficiency of combustion is distinct for each stage, resulting in a different set of chemical compounds and thermal energy being released at different rates into the atmosphere.

Figure 2: Flaming, smoldering and residual combustion stages during a fire
