**CIVIL AVIATION
DIRECTORATE
OF THE REPUBLIC OF SERBIA**

**AIR ACCIDENT AND INCIDENT
INVESTIGATION COMMISSION**

SERIOUS INCIDENT FINAL REPORT

Aircraft:	BOEING 737/800
Aircraft registration marks:	D-AXLF
Operator:	XL Airways Germany
Place of incident:	Airspace under the jurisdiction of ACC Belgrade
Date of incident:	18 October 2008.
Time of incident:	05.19 (UTC)

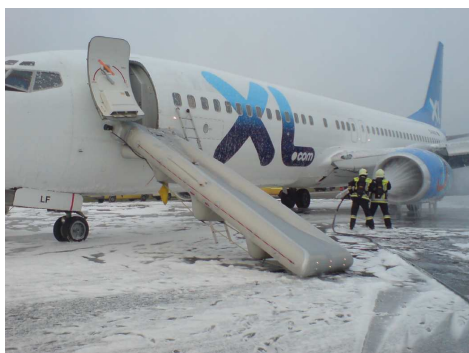
Figure 1.6

The fire on the engine was extinguished in 30 seconds after the aircraft had stopped. After that, the cooling of the aircraft's engine and landing gear began. Cooling time with interruptions was about 60 minutes. The details of the operation of cooling the aircraft structure are depicted in Figures 1.6 and 1.7.

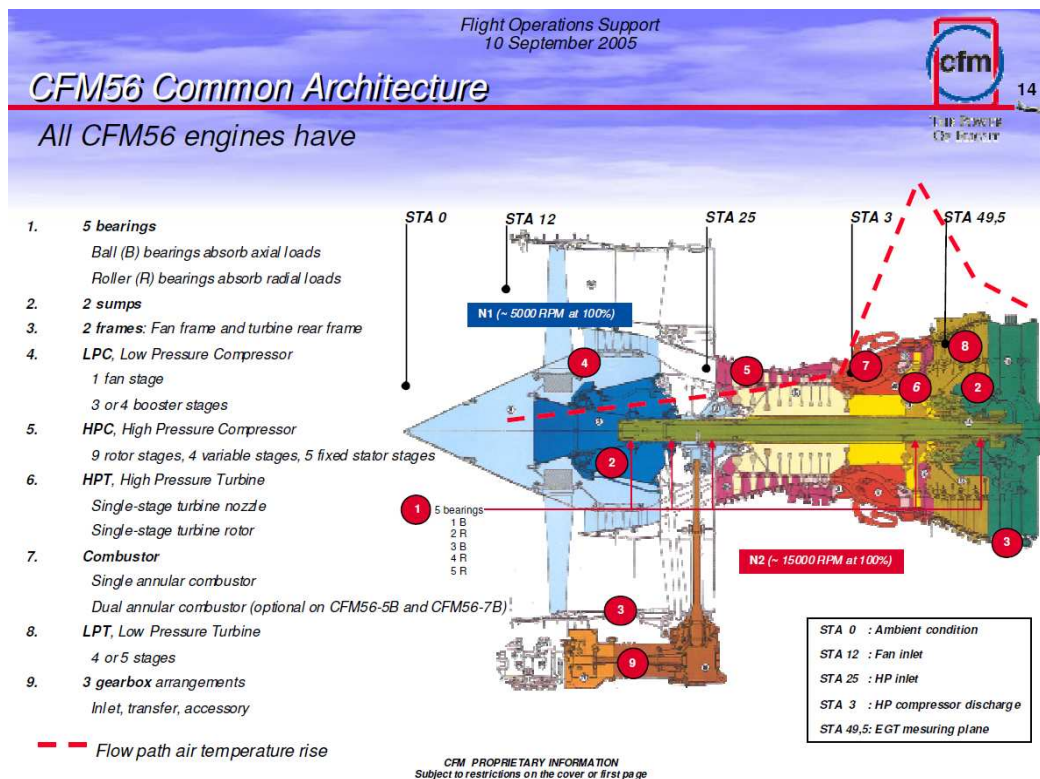
Figure 2.1 shows a cross-section of CFM56 engine with the basic components that are common for all variants of this engine.

The No 4 bearing is the inter-shaft roller bearing between the High Pressure and Low Pressure rotors and lies within the LPT module at the rear of the engine (Figure 2.1). The inner race, with the rollers and cage, are mounted on the LP shaft and the outer race is mounted in the rear of the HP spool.

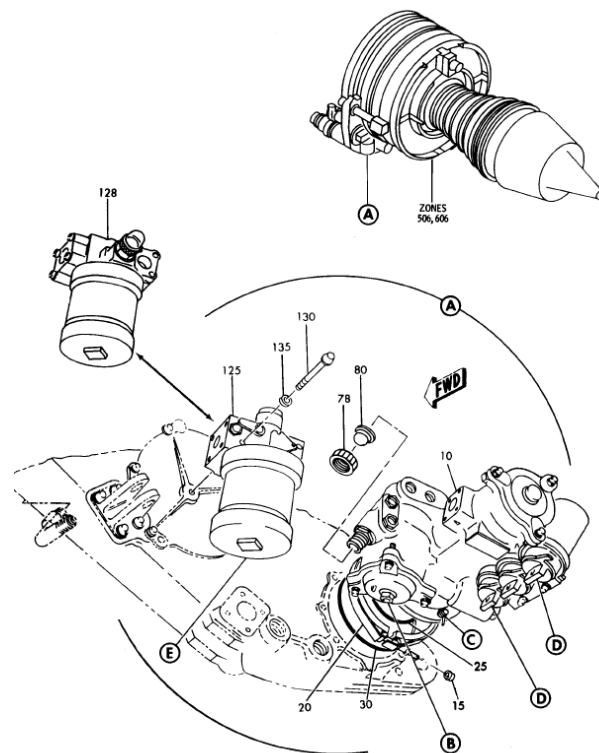
Figure 2.7

- Lubrication unit and its location on the engine are shown in Figure 2.7.

- The Lubrication Unit was running during the event flight (Shaft shear section not broken)
- Pump performances within CMM limits
- Dark oil deposit most likely occurred post bearing failure and during the low / no oil operation
- The analysis of the oil filter showed the presence of particles of various metals and non-metals: tungsten, chromium, nickel, vanadium, manganese, aluminum, molybdenum, iron, titanium, etc. Also, the traces of metal that match the composition of M50 steel (from which the outer race engine bearing No. 4 is made) were found.
- The exploded view of the CMD (detail D in the Figure 2.7) is shown in the Figure 2.8.

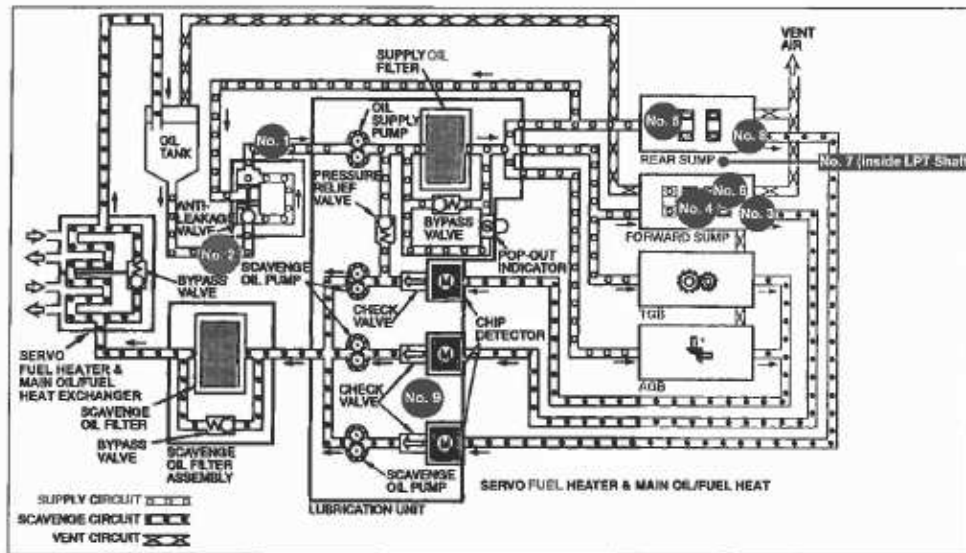
Figure 2.9 schematically shows the oil circuit with marked locations on which oil samples were taken for the analyses during engine disassembling.

The samples were visually examined before the more sophisticated analyses. Several samples were light orange, several were dark orange-brown and one sample was a mixture of dark gray oil over colorless, transparent water.

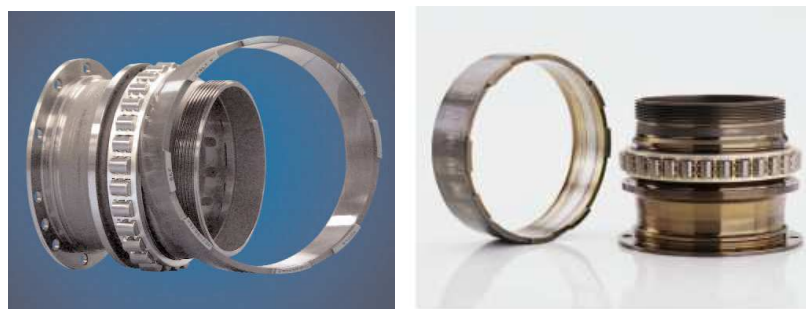
Figure 2.10 shows the appearance of this bearing assembly. On the left side, there is assembly of the bearing with part number 305-355-717-0 or 305-355-720-0 (depending on material of the outer race) manufactured by SKF Avio. On the right side, there is assembly of the bearing with part number 335-352-301-0 to 335-352-305-0 (depending on material of the outer race) which is repaired by FAG Aerospace.
