AIRCRAFT ACCIDENT REPORT AND EXECUTIVE SUMMARY

Reference:	CA18/2/3/8567	
Aircraft Registration	ZS-JZF	Date of Accident	21 October 2008		Time of Accident	0609Z
Type of Aircraft	Piper PA32R-300		Type of Operation		Private	
Pilot-in-command Licence Type		Private	Age	55	Licence Valid	Yes
Pilot-in-command Flying Experience		Total Flying Hours	297.29		Hours on Type	176.29
Last point of departure		Rand Aerodrome (FAGM) Gauteng.				
Next point of intended landing		Ficksburg Aerodrome (FAFB) Free State Province.				
Location of the accident site with reference to easily defined geographical points (GPS readings if possible)						
Wesbank Raceway, approximately 2km north of Rand Aerodrome near Germiston (GPS Positions: S25° 13.957 E028° 07.960)						
Meteorological Information		Fine weather conditions; No clouds; Temperature; 18°C; Wind: 360°/10kt.				
Number of people on board	1 + 5	No. of people injured	0	No. of people killed	1+5	
Synopsis						
<p>On 21 October 2008, the pilot accompanied by 5 passengers took off from Runway 35 at Rand Aerodrome at approximately 0609Z for the intended flight to Ficksburg Aerodrome (FAFB). The aircraft was fuelled to full capacity of 94 US gallons the pre

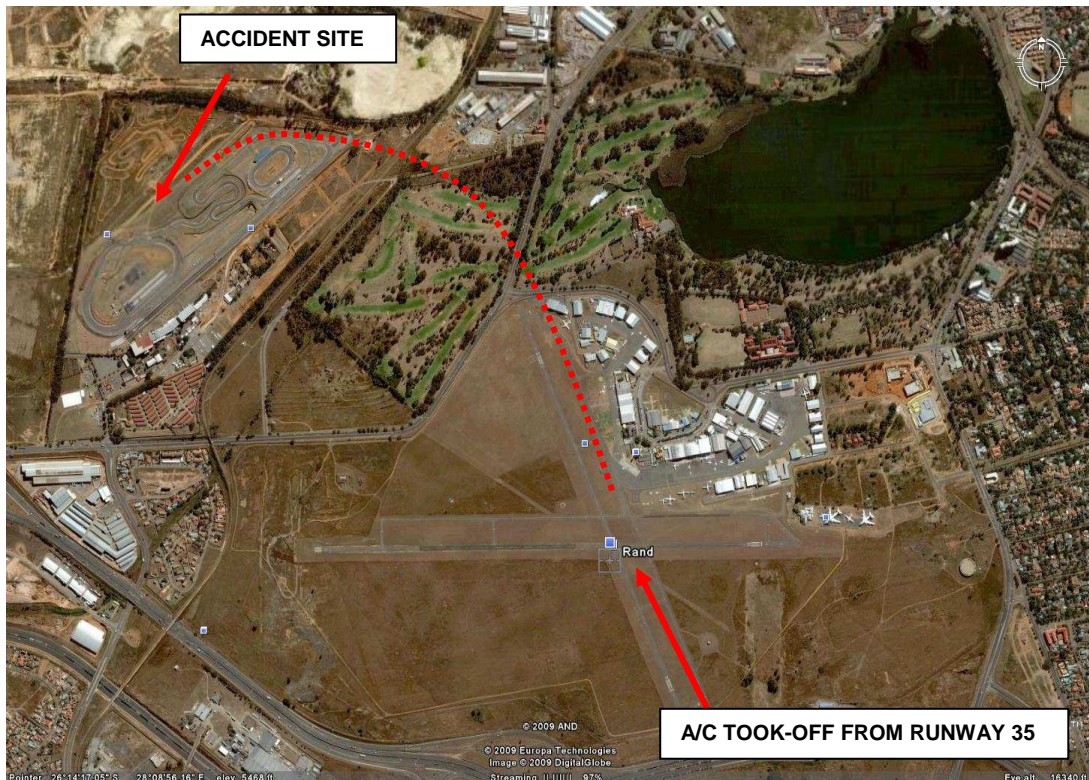
VIEW OF RAND AERODROME RWY 35 FROM WHERE A/C TOOK OFF & WHERE ACCIDENT OCCURRED.

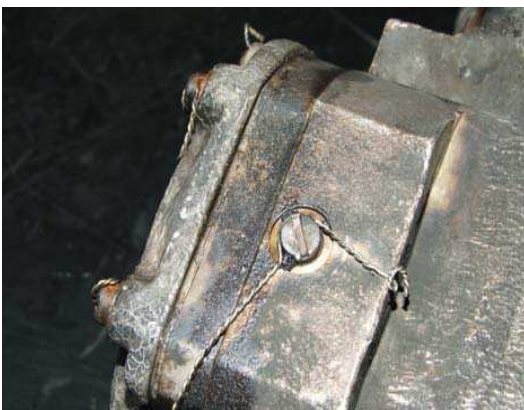
PHOTOS: The AC type fuel pump was excessively damaged due to fire, so no further test or inspections were carried out. (see attached photo)
