AIRCRAFT ACCIDENT REPORT AND EXECUTIVE SUMMARY

| | | | | Reference: | CA18/2/3/8568 | |
| Aircraft Registration | ZS-NAB | Date of Accident | 23 October 2008 | | Time of Accident | 1647Z |
| Type of Aircraft | Beechcraft Baron 58 | | Type of Operation | Unknown | | |

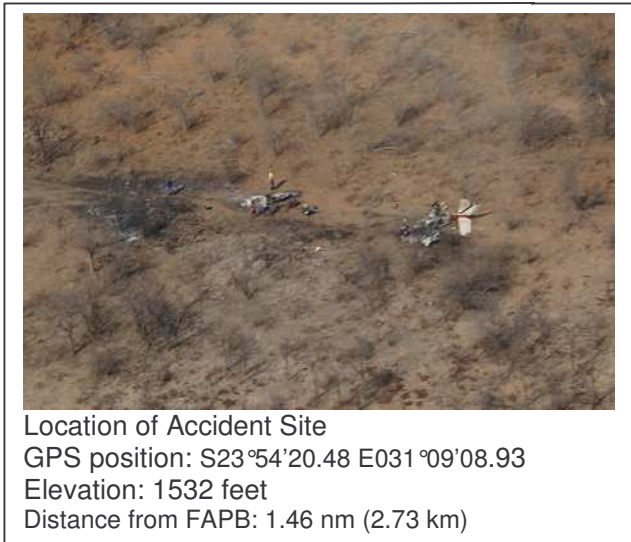
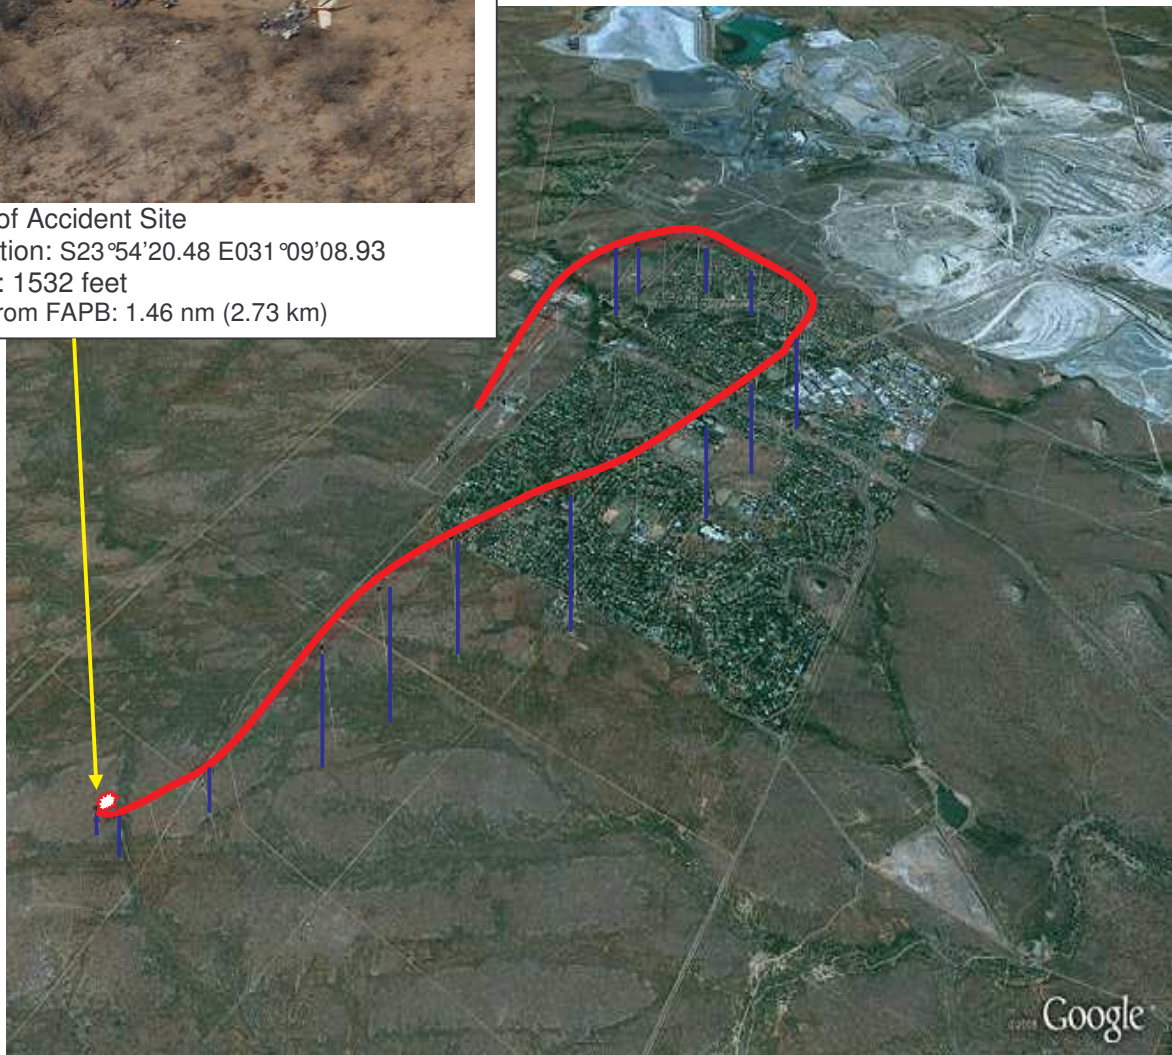
Figure 2 showing Flight Path Diagram.

- 1.1.6 According to an eyewitness, during the downwind sector of the flight, the aircraft was positioned on the western side of the aerodrome, which was over the Central Business District (CBD) of Phalaborwa. A strange noise, which sounded like a “rough running engine” was heard coming from the aircraft. Whilst the aircraft was turning onto a right base leg, approximately 3 nautical miles (NM) from Runway 19, the aircraft entered into a right-hand turn which was in a slightly nose-down attitude. The aircraft then impacted with a tree, prior to impacting with the ground.

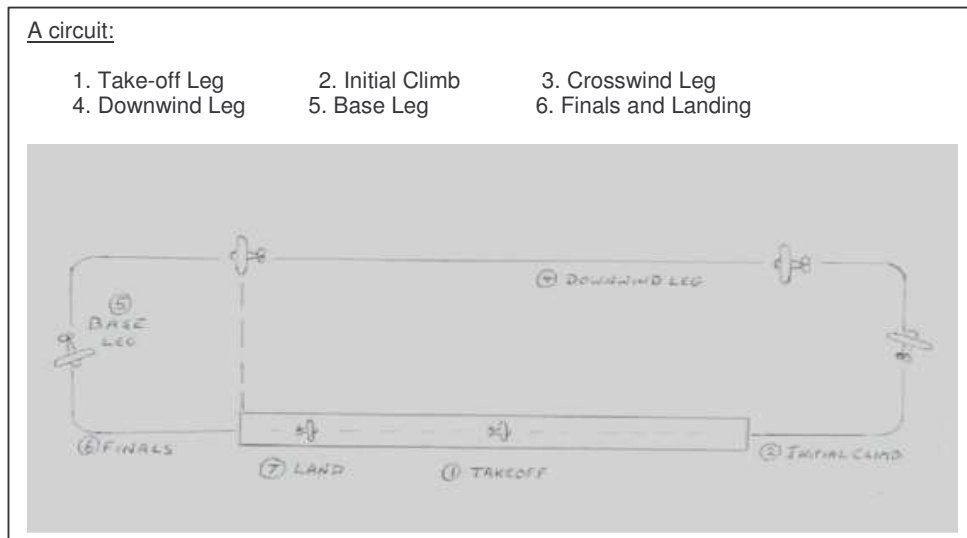
Fig 6. A normal circuit pattern.

- 1.8.5 The circuit flown by the pilot deviated significantly from that of a normally flown circuit, which is within a specific pattern around an aerodrome. A circuit normally consists of the following flight phases: Take-off, climbing turn, crosswind leg, downwind leg, base leg and final approach to the RWY for landing. During the take-off phase, the aircraft maintains the projected departure centreline heading and climbs up to the point when it starts turning into the crosswind leg. The crosswind shall be so that a 90 degree track is maintained with the runway until the turn into the downwind leg. The downwind leg is normally parallel to the runway but in the opposite direction to the take-off. At the end of the downwind leg, the aircraft turns into the base leg and final approach to the RWY.

The actual circuit flown by the pilot, indicating that the aircraft was flying in the downwind leg not parallel to the RWY, but cutting into the circuit towards the RWY centreline.
