Statens haverikommission
Swedish Accident Investigation Board

Finalreport RL 2011:14

**Aircraft accident to helicopter SE-JKF
at Stockholm/Arlanda airport,
Uppsala county, Sweden on 9 January 2009**

Case L-01/09
2011-10-21

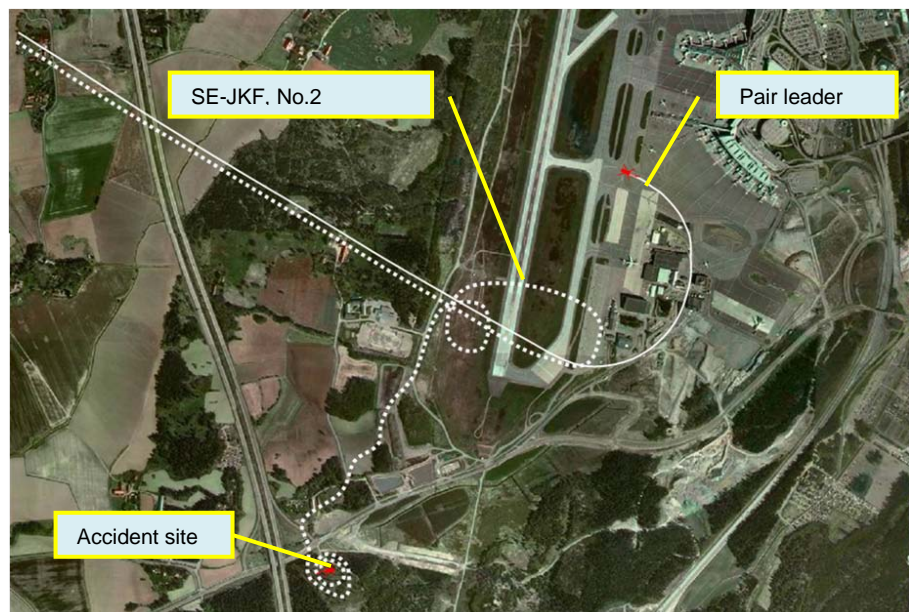
Figure 2. The approximate flight tracks of the helicopters.

It has been possible to reconstruct the approximate flight track of both the helicopters, using information from witnesses on the ground, testimony from the pilots of both helicopters, recorded radio communications and radar tracking. The flight tracks and accident site have been drawn on the satellite image below of the south-western part of the airport.

The malfunction of the tail rotor system occurred just before the helicopter reached the western boundary of Stockholm/Arlanda airport. It then flew in an increasingly uncontrolled manner across the southern part of runway 01L and a little south-west of the runway threshold for over two minutes before it impacted with the ground.

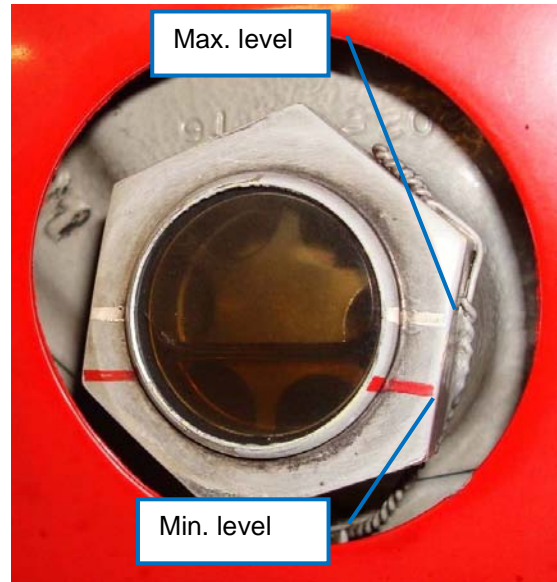
Figure 7. Oil level indication

The sight glass on the gearbox is visible through a hole in the left side of the gearbox cover. There are markings on the sight glass that show the lowest and highest permitted oil levels for flight. The normal oil level indication when the helicopter is standing on a flat surface is shown in the following illustration.

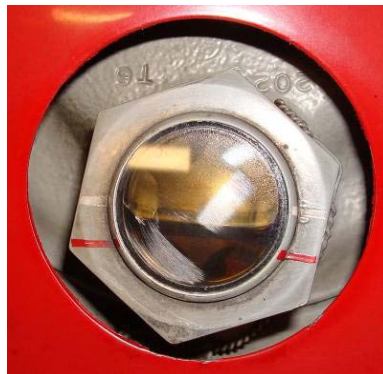
Figure 8. Nose down approx. 5°

The following illustrations show the sight glass with the same oil amount in the gearbox and the helicopter tilted in different ways.
