AIRCRAFT ACCIDENT REPORT AND EXECUTIVE SUMMARY

Reference:	CA18/3/2/8610	
Aircraft Registration	ZS-CPC	Date of Accident	22 January 2009		Time of Accident	1500Z
Type of Aircraft	Extra 300 L		Type of Operation		Private Flight	
Pilot-in-command Licence Type		Airline Pilot	Age	46	License Valid	Yes
Pilot-in-command Flying Experience		Total Flying Hours	25 000.00		Hours on Type	254.3
Last point of departure		Kitty Hawk Aerodrome (Boschkop)Gauteng Province				
Next point of intended landing		Kitty Hawk Aerodrome (Boschkop)Gauteng Province				
Location of the accident site with reference to easily defined geographical points (GPS readings if possible)						
Gravel road next to Kitty Hawk GPS co-ordinates: S25°52.190E028°26.380 Elevation 4586' AMSL						
Meteorological Information		Temperature:23°C Visibility: 10 km, Surface wind 360°/5 kt.				
Number of people on board	1 + 1	No. of people injured	0	No. of people killed	0	
Synopsis						
<p>The pilot accompanied by a passenger was engaged on a private flight from Kitty Hawk aerodrome to the general flying area (GFA). The pilot stated that after a flight of approximately 10 minutes, he decided to return to Kitty Hawk. During the downwind leg

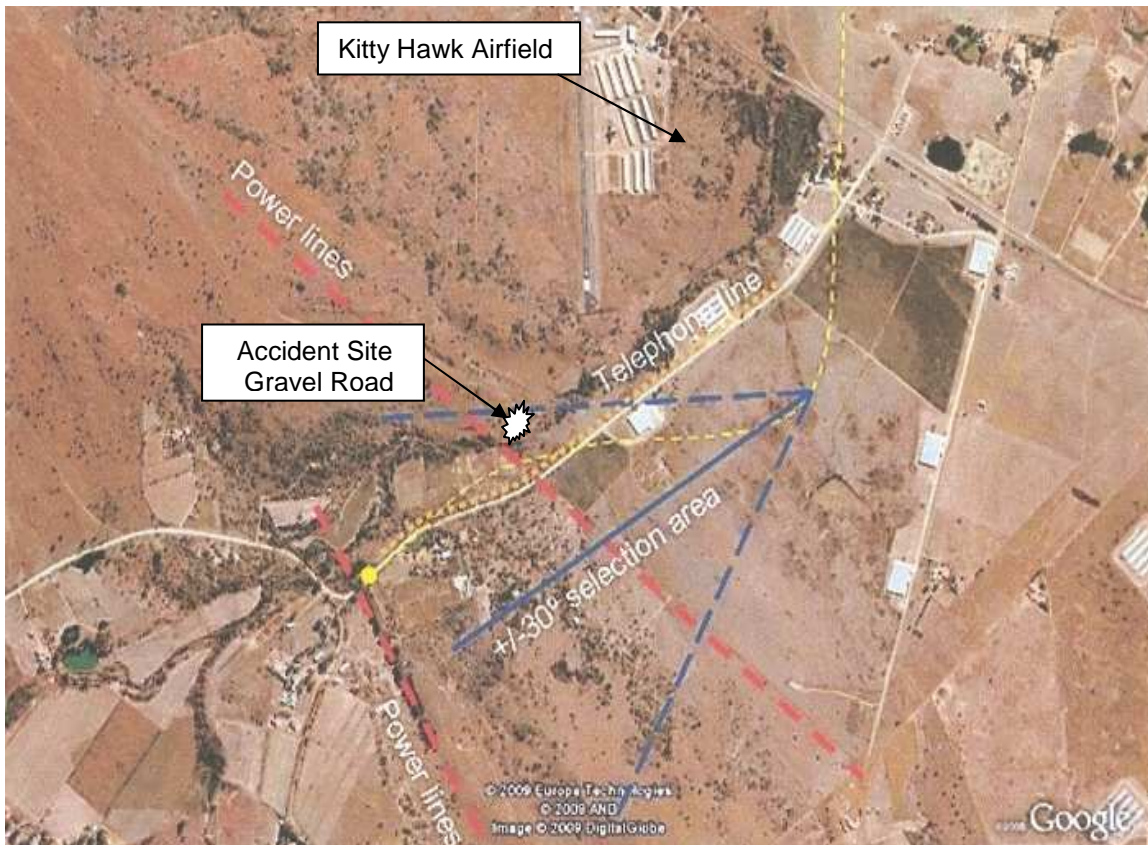
1.12.1 The aircraft approached Kitty Hawk aerodrome in a northerly direction with the intention to land on RWY 01 when the engine failed to produce power after he reduced the power. He was then committed to execute a forced landing on a gravel road after he cleared obstacles such as power lines and telephone lines in his flight path on a heading of 37.18 degrees on the north-westerly side of Kitty Hawk aerodrome. The location of the accident site was approximately 0.53 nautical miles away from the threshold of RWY 01.

Figure 5, shows location of accident site, airfield and obstacles.
