# AIRCRAFT ACCIDENT REPORT AND EXECUTIVE SUMMARY

Reference:	CA/18/2/3/8675	
<b>Aircraft Registration</b>	ZS-MPB	<b>Date of Accident</b>	18/07/2009		<b>Time of Accident</b>	1330Z
<b>Type of Aircraft</b>	Beech 36		<b>Type of Operation</b>	Private		
<b>Pilot-in-command Licence Type</b>		Private	<b>Age</b>	42	<b>Licence Valid</b>	Yes
<b>Pilot-in-command Flying Experience</b>		Total Flying Hours	1898,22		Hours on Type	177,2
<b>Last point of departure</b>		Stellenbosch aerodrome (FASH) in the Western Cape Province				
<b>Next point of intended landing</b>		Upington International Airport (FAUP) in the Northern Cape Province				
<b>Location of the accident site with reference to easily defined geographical points (GPS readings if possible)</b>						
Gravel road approximately 25 km west of Kenhardt in the Northern Cape						
<b>Meteorological Information</b>		Temperature 22°C. CAVOK.				
<b>Number of people on board</b>	1+0	<b>No. of people injured</b>	0	<b>No. of people killed</b>	0

**Name of Owner/Operator** : JF Holdings (PTY) LTD  
**Manufacturer** : Beech Aircraft Corporation  
**Model** : B 36 TC  
**Nationality** : South African  
**Registration Marks** : ZS-MPB  
**Place** : Appro

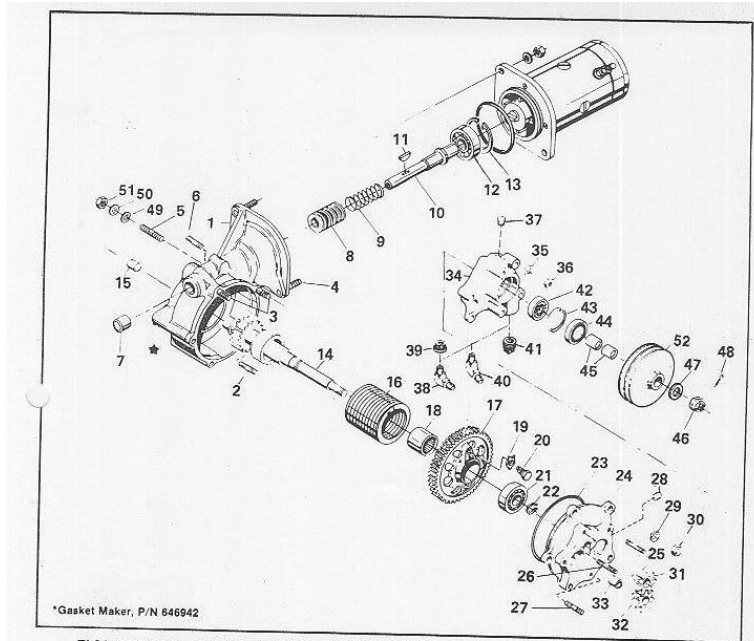
FIGURE 09-01. STARTER AND STARTER ADAPTER ASSEMBLY, TSIO-520-E, J, K.  
(OPTIONAL FOR AIR CONDITIONING DRIVE)

3.1.5 The dislodged seal caused the engine oil to leak out of the engine. The absence of adequate lubrication resulted in the engine suffering an uncontained engine failure in flight.

- (1) The pilot's actions during the uncontained engine failure indicated that his knowledge and understanding of the aircraft's emergency systems and procedures were inadequate.
- (2) A clip seal retainer had been omitted during installation of the starter clutch to the engine, resulting in the seal becoming dislodged during flight.
