FINAL INCIDENT REPORT

HCLJ510-000696	Incident		
Aircraft:	Bombardier CL-600-2D24 (CRJ 900)	Registration:	OY-KFF
Engines:	2 General Electric CF34-8C5	Flight:	Scheduled flight, IFR
Crew:	4 – no injuries	Passengers:	55 – no injuries
Location:	Copenhagen Airport Kastrup (EKCH) RWY 04R	Date and time:	09.10.2009 at 21.03 UTC

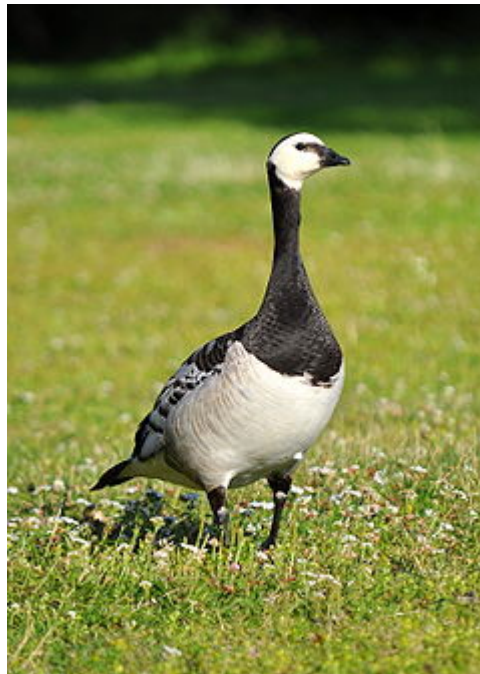
Bird species:	Barnacle goose (<i>Branta leucopsis</i>)
Weight:	1500 – 2000 grams
Length:	60 - 70 cm
Wing span:	132 - 145 cm

The Barnacle goose is recognisable from its white face, black neck and breast, grey back and light-coloured abdomen. From a distance, the species can be mistaken for the Brant goose, but that has a darker plumage and does not have the white facial 'mask'. The Canada goose (*Branta canadensis*) also has a highly-contrasting black and white plumage but is considerably larger, has less white on its face and has a light-coloured breast under its dark neck. Its voice is similar to a loud bark.

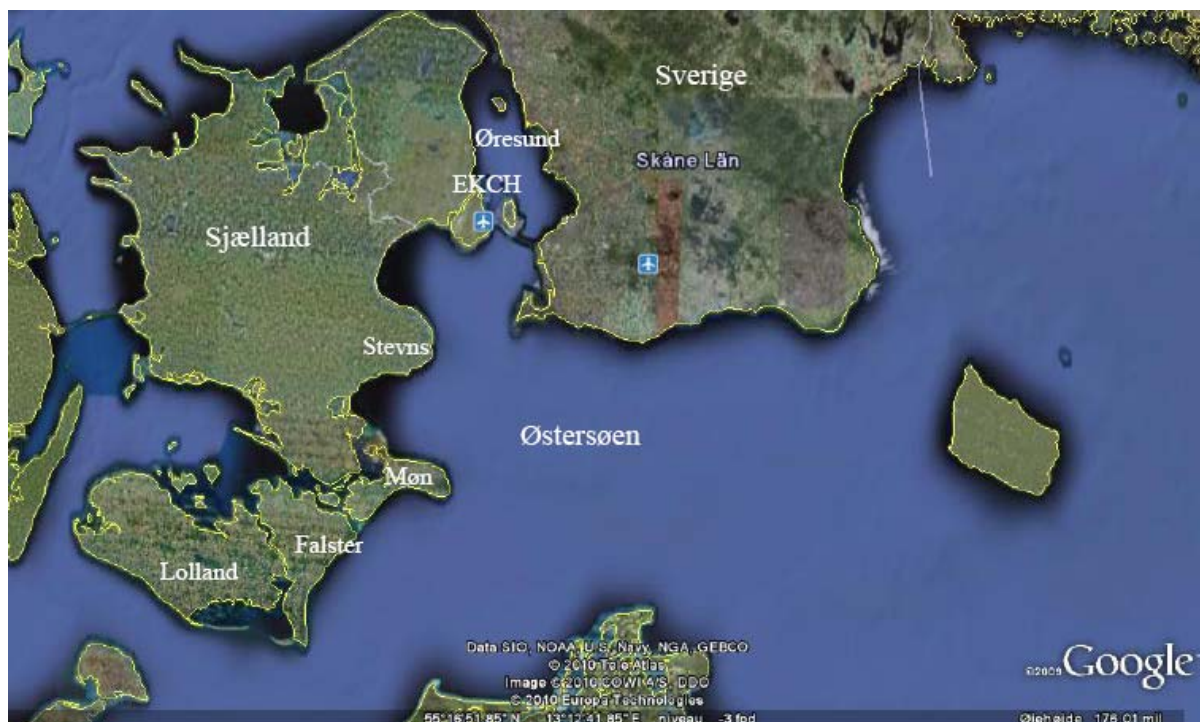
The Danish Ornithological Society (DOF) database of bird observations (www.dofbasen.dk) has registered observations of Barnacle geese as they migrate through Denmark in the period 9th and 10th October 2009. At the end of the day on 9th October 2009, large flocks of Barnacle geese were observed migrating over Stevns, Møn, South Zealand and Lolland-Falster (for example, 811 geese were observed at Højerup on Stevns, 1400 at Stevns lighthouse, and 6125 at Hyllekrog on Lolland).

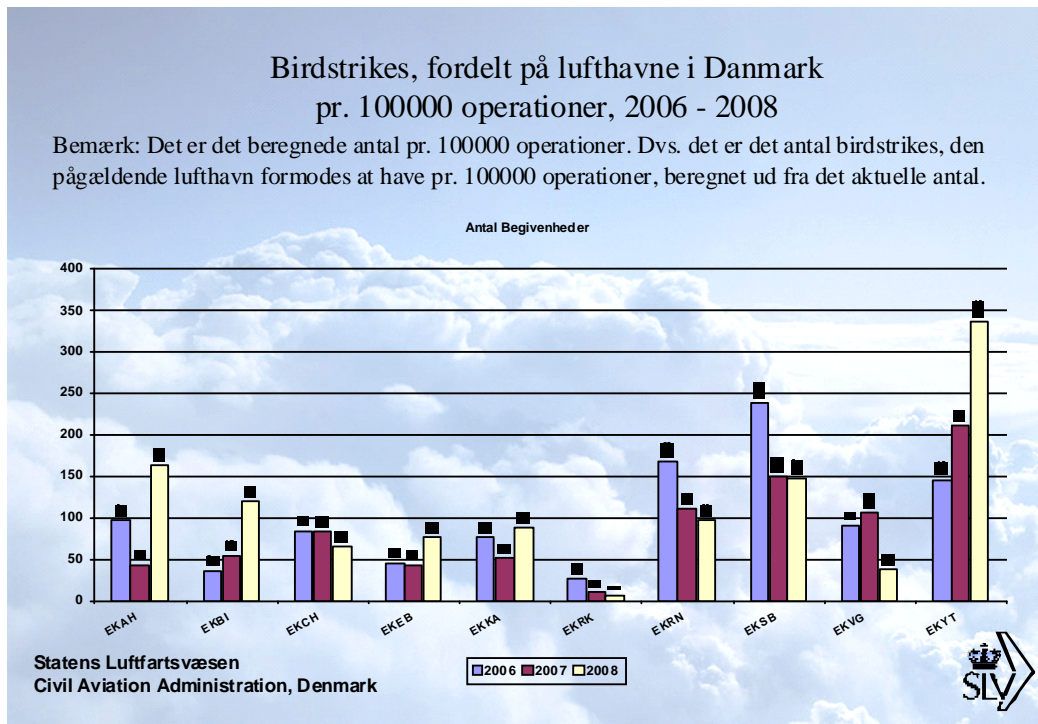
Below, you can see the number of “bird strikes” distributed between airports in Denmark in the years 2006, 2007 and 2008.

Note: The graph shows the estimated number of incidents per 100,000 operations, i.e. the number of bird strikes the airport in question is assumed to have had per 100,000 operations, calculated on the basis of the actual number.

The Danish Accident Investigation Board analysed the "bird strike" statistics and found that EKCH was not particularly vulnerable to "bird strikes" compared to the other airports in Denmark.
