AIRCRAFT ACCIDENT REPORT AND EXECUTIVE SUMMARY

Reference:	CA18/2/3/8706	
Aircraft Registration	ZU-BEX	Date of Accident	14 November 2009		Time of Accident	1022Z
Type of Aircraft	English Electric Lightning MK T5		Type of Operation		Commercial – Air Show	
Pilot-in-command Licence Type		Airline Transport	Age	46	Licence Valid	Yes
Pilot-in-command Flying Experience		Total Flying Hours	10993.0		Hours on Type	unknown
Last point of departure		Overberg – Test Flying and Development Aerodrome (FAOB)				
Next point of intended landing		Overberg – Test Flying and Development Aerodrome (FAOB)				
Location of the accident site with reference to easily defined geographical points (GPS readings if possible)						
Overberg – Test Flying and Development Aerodrome (FAOB) at GPS co-ordinates: S 34°31.232 E020°22.618						
Meteorological Information		Wind direction: 250° , Wind speed: 10 kts , Temperature: 20°C, Visibility: Good, Cloud cover: 5/8, Cloud base: 2500 ft.

Probable Cause						
Uncontrolled flight due to double hydraulic failure.						
Contributory Factors						
<p>There was evidence found indicating that the aircraft was exposed to a pre impact fire in flight and the heat from the fire pro

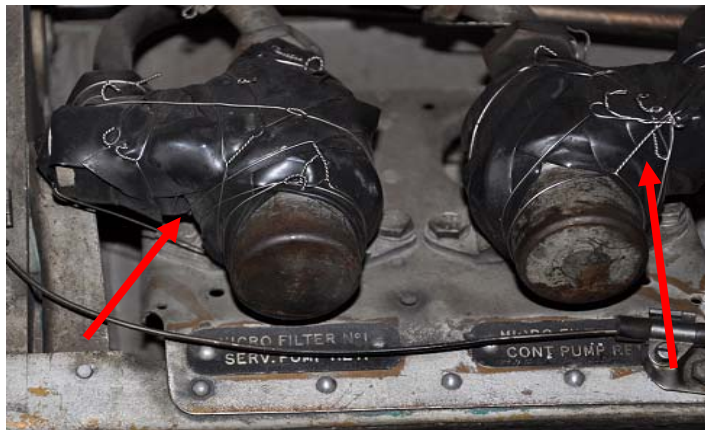
Figure 9, shows components from ZU-BBD.

Note: ***“The viton tape was wrapped around incorrectly and wire locking is not restraining the tape correctly.”***

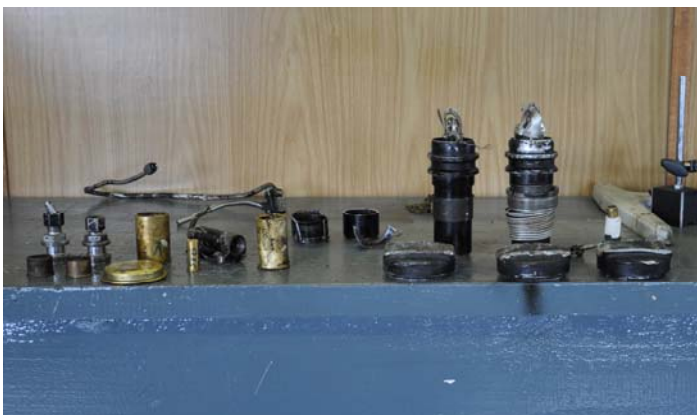
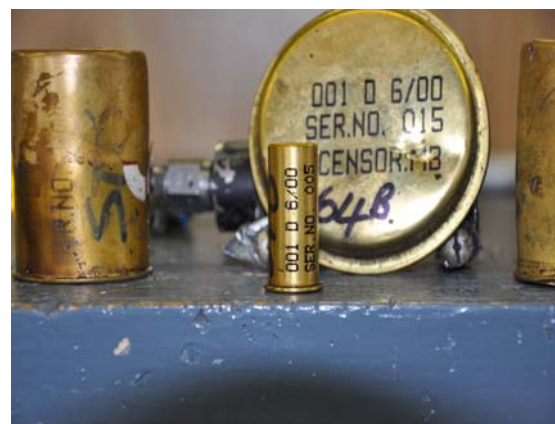
Note: According to the manufacturer, the install life cycle of the cartridges was 24 months (2 years) and 60 months (5 years) total life for uninstalled cartridges. The cartridges installed on the Lightning exceeded the identified required calendar time intervals, as such the cartridges in service life were considered to be expired.

Figure 12 & 13, showing cartridges recovered from accident site.

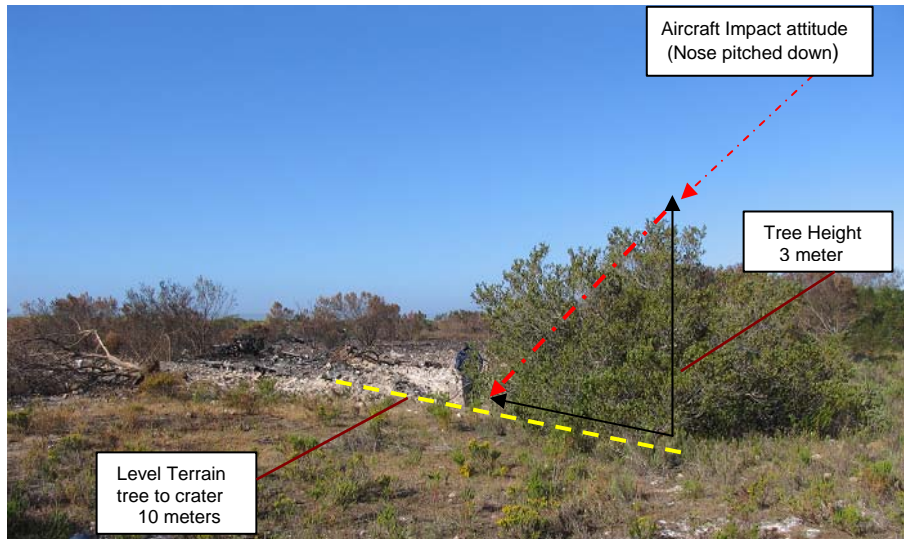
Figure 16, shows the measurements used to determine impact angle.

- (ii) *Impact Angle:* The impact angle was determined by using the aircraft pitch attitude with respect to the flight path. The terrain and elements (trees) close to the crater was used in a calculation to determine impact angle. The information of tree height and distance from the crater was measured and used in a mathematical formula. The impact angle was then determined to be approximately 17° (degrees).

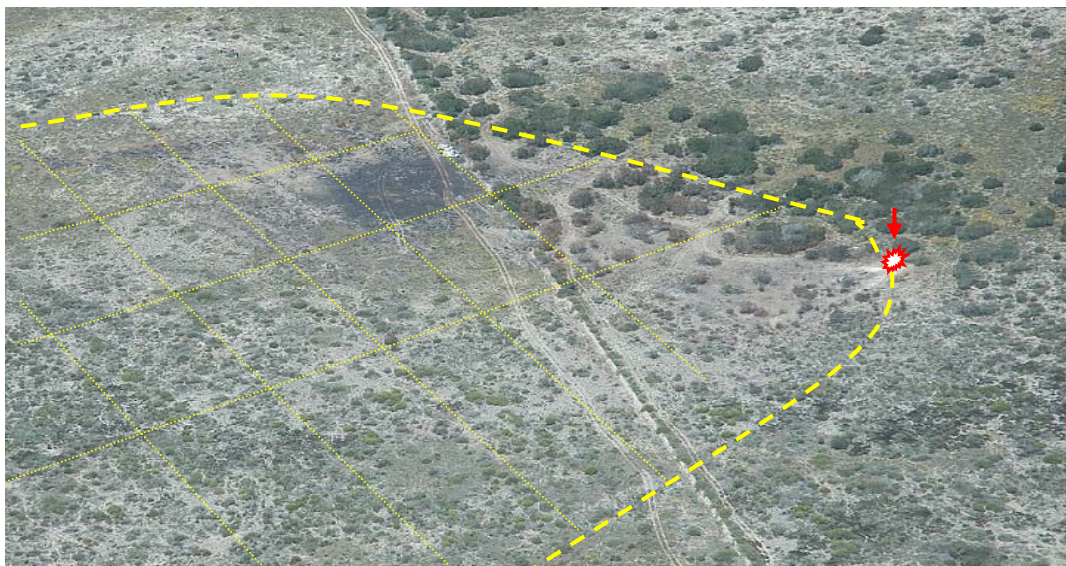
1.12.6 The aircraft entered into a right turn prior to it impacting the ground. The outer wing (right side) was raised slightly higher than the inner wing (left side). The nose impacted the ground which resulted in the fuselage to disintegrate. The debris were found scattered over a large area (approximately 36 700 square meters - m²).

Figure 17, shows the aerial photo of accident site, wreckage distribution area (Approximately 36700 square meters (m²)).

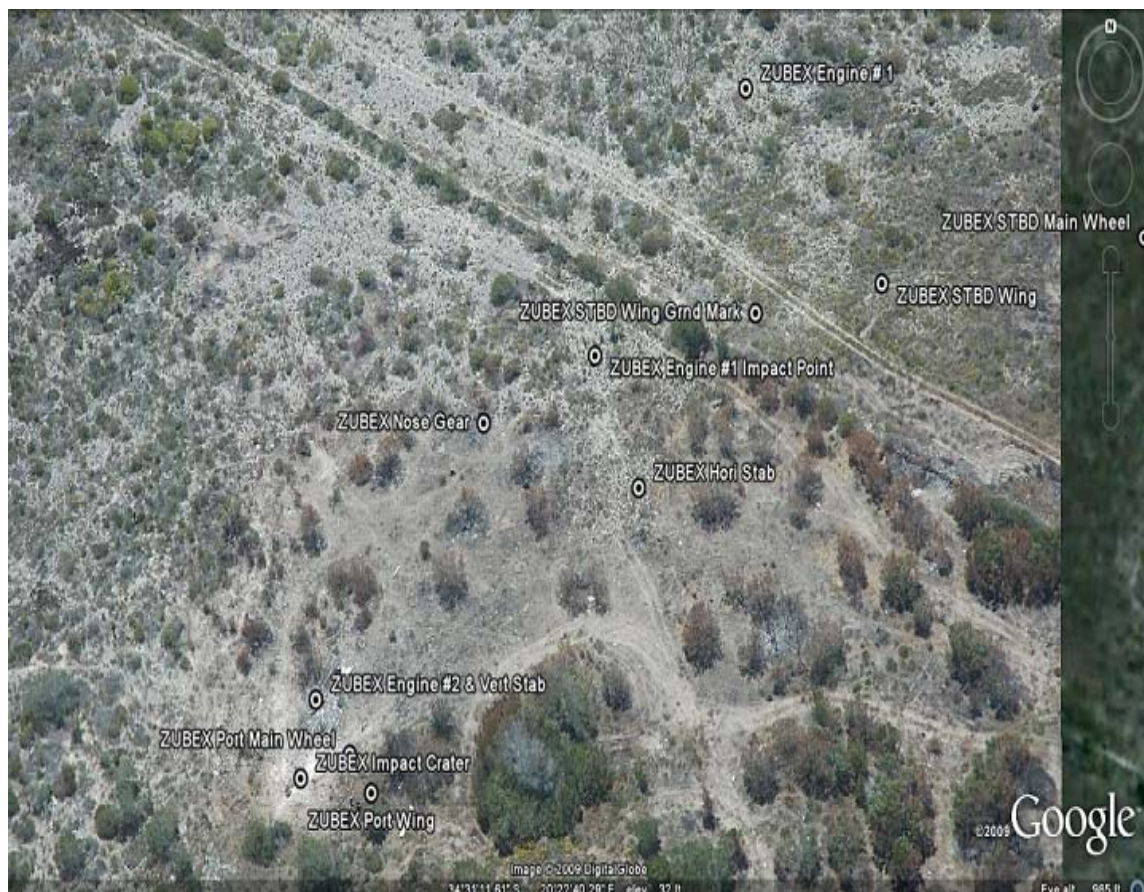
Figure 18, a Google earth picture showing the wreckage distribution

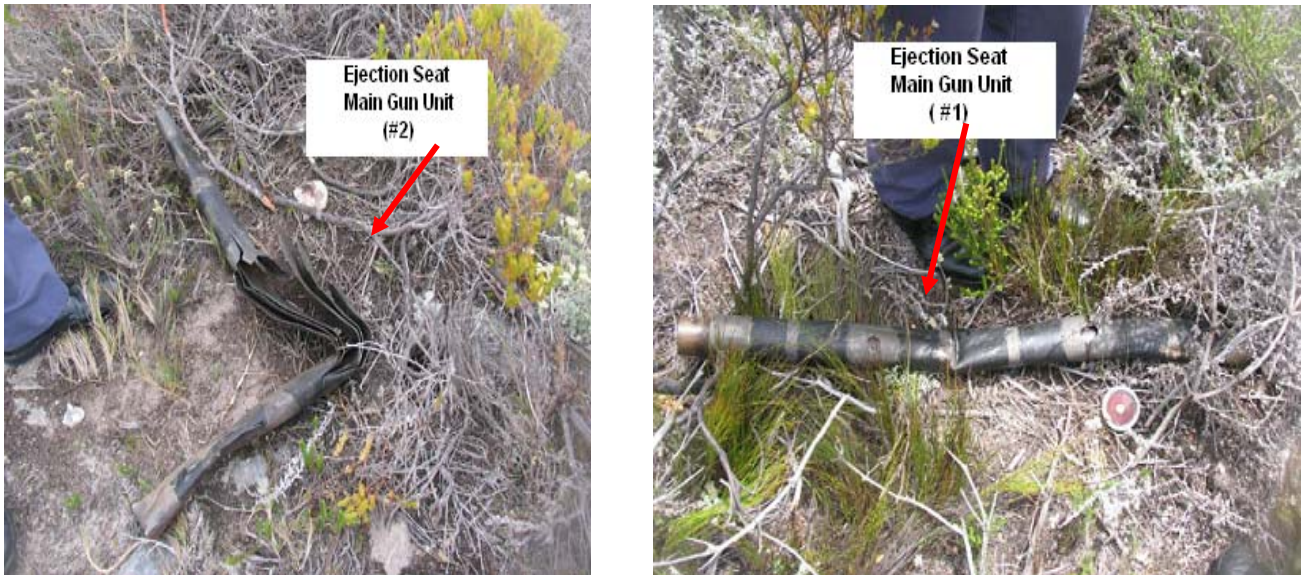
1.12.13 *Main Guns*: The main gun units separated from the ejection seats. The evidence of the main gun units showed that they did not extend, which also indicated that the ejection seat failed to eject. The first (#1) main gun display bending damage in the middle and the second (#2) main gun was flattened. Both main gun units were exposed to high impact forces. The cartridges (x4) fitted to the main gun units separated during the impact sequence. The cartridges were found scattered on the accident site. The cartridges were recovered and inspected and the evidence showed that the cartridges did not fire (explode) as was required in order to have

Figure 23 & 24, shows main gun unit.

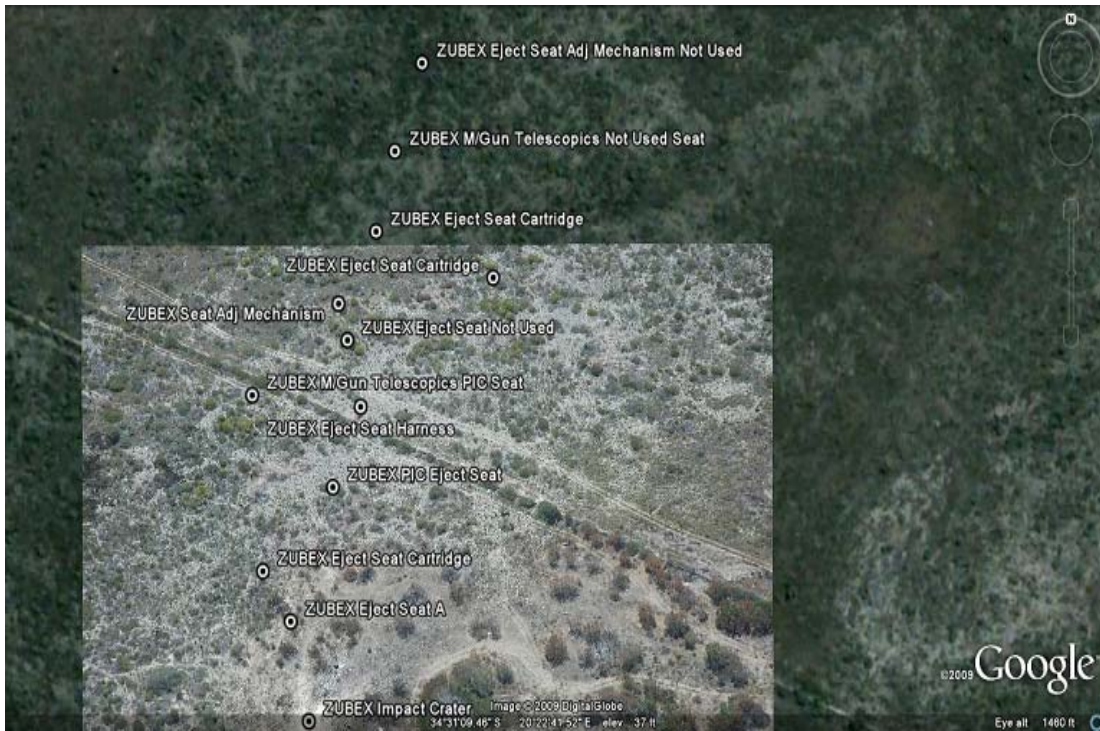
Figure 27, showing the distribution of ejection seat components.

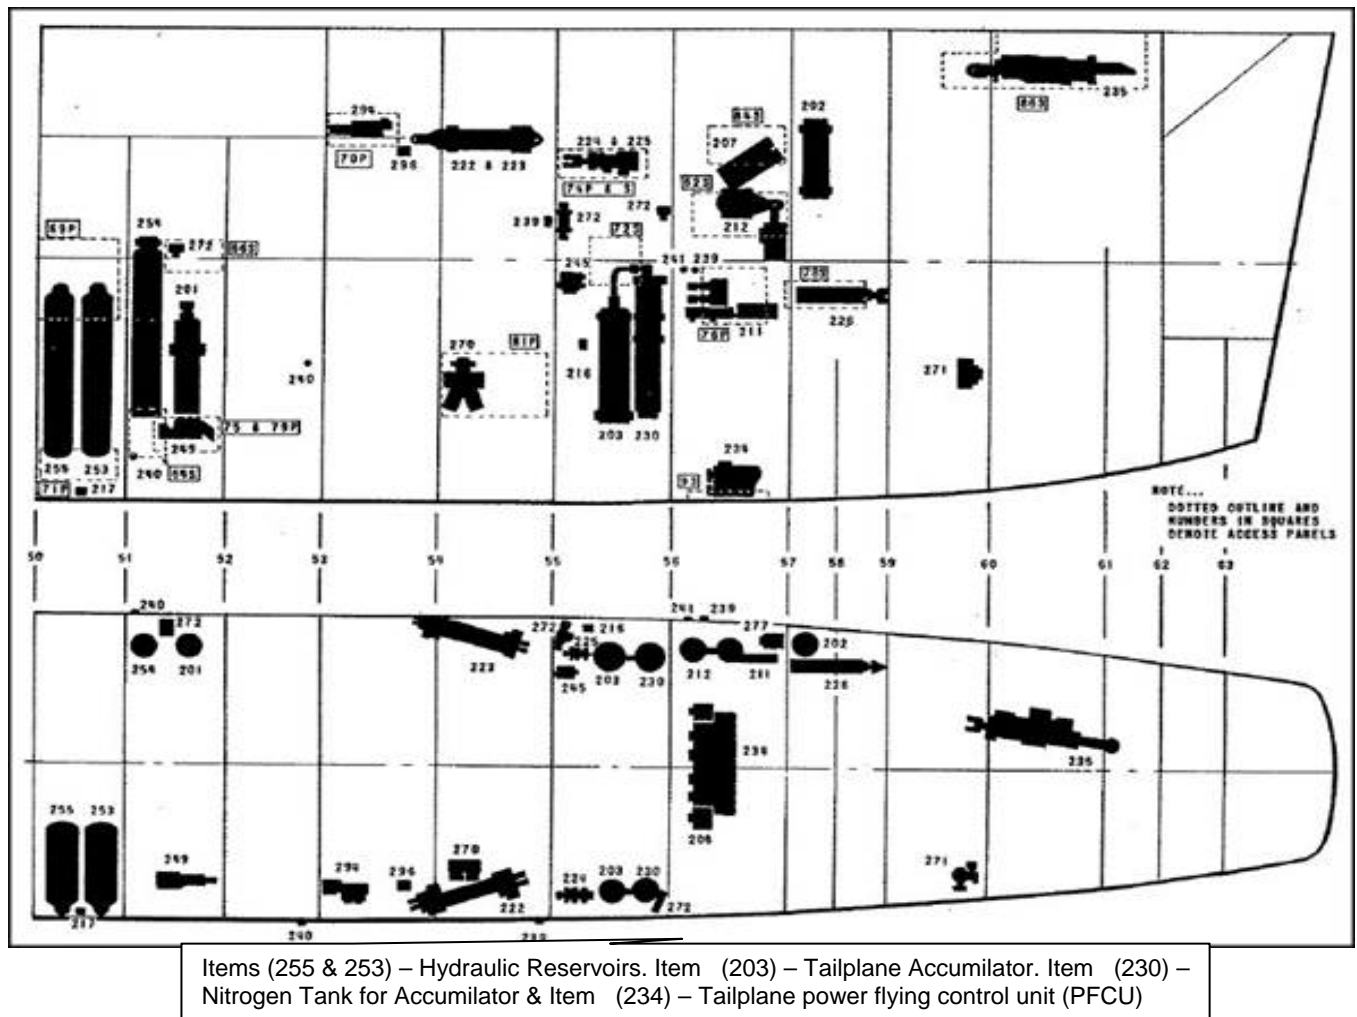
Figure 40, shows lightning hydraulic components in tail section.

1.16.15 In the case of ZU-BEX, there was proof of a tail pipe fire with flames visible at both tailplane spigots and inside the rear fuselage aft of the ventral tank fairing. An intense fire of this nature would lead to loss of the integrity of the hydraulic supplies to the PFCU and as described above the brake parachute selector would also be within the area of fire. With the loss of both control systems the pilot would experience stiffening flight controls, although the services system could remain unaffected depending how far forward the fire had originated or had spread.

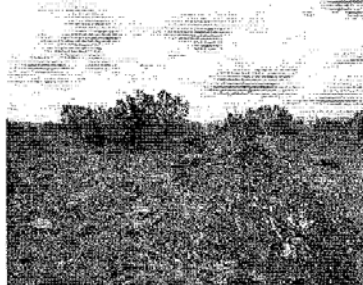
Location of impact point at GPS co-ordinates
S34 31.232 E020 22.618

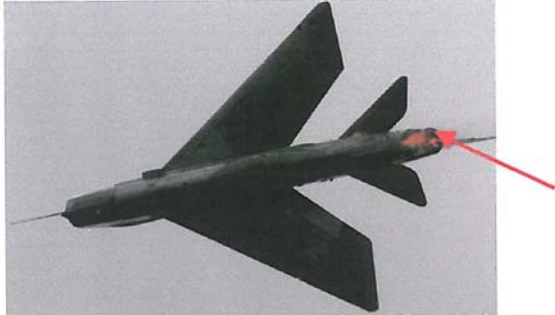
</div> <p>Photo 1: ZU-BEX in flight at Air Display (courtesy SACAA)</p> <p>1.2. ZU-BEX crashed during participation of a South African Air Force hosted Air Display at Air Force Base Overberg. The impact proved to be at a high angle and speed resulting in the total destruction of the aircraft (Photo 2). During the final moments of flight the pilot reported an emergency, followed by intent to eject but reported failure to complete the ejection sequence shortly after. The approximate time lapse from declaration of emergency to impact is reported to be 30 - 40 seconds.</p> <div style="text-align: center;">

</div> <p>Photo 2: Point of impact (digital)</p> <p>1.3. Spectator photographs indicated signs of an in-flight fire during the air display sequence (Photo 1, red arrow). This proved to be the primary causational factor for this accident but do not form part of this investigation.</p>

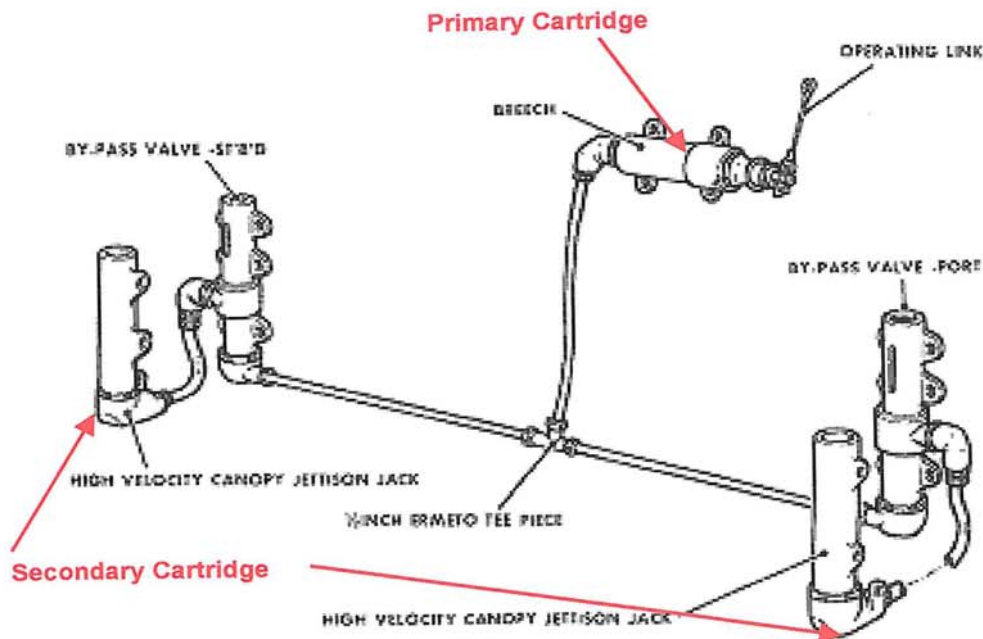
Diagram 1: Layout of the canopy jettison system

6. INVESTIGATION RESULTS																							
<p>The on-site investigation proved that the aircraft canopy did not release from the main fuselage before impact. This investigation will therefore concentrate primarily on the canopy jettison system (Diagram 1) from the English Electric Lightning.</p> <p>A section from the gas feed pipeline (Photo 4) revealed the fractured breach (Photo 5) that contained the primary cartridge. The primary cartridge could not be located. The gas feeding line from the breach to the T-piece as well as the starboard side pipeline up to the inlet side of</p>

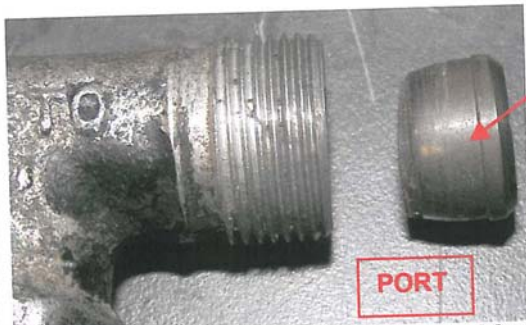
After removal of the port side ferrell from the T-piece (Photo 8, red arrow), metallic deposits were noted on the inside around the circumference of the closed side of the ferrell (Photo 9, red arrow). At higher magnification, the metallic deposit showed a geometry (Photo's 10 and 11, red arrows) corresponding with metal skimmed from the port side gas feed pipeline. An EDS analysis proved that the metallic deposit from the ferrell (EDS Result 2) compares favorable with that of the starboard gas feed pipeline base material (EDS Result 1). No clear indications of attempted 'skimming' of the same nature could be detected on the opposite starboard side ferrell/pipeline contact area (Photo 12, blue arrow).

Photo 8: Port side pipeline ferrell removed from position, as found (digital)

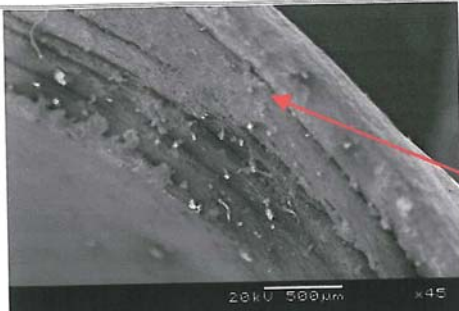
Photo 10: Port side ferrell, showing pipeline deposit (x45, SEM)

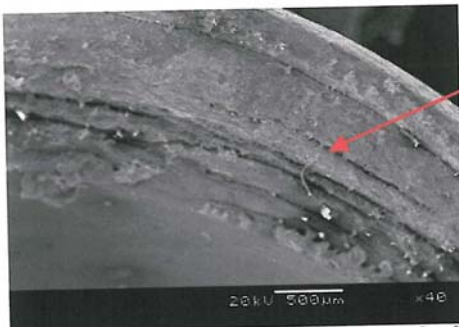
Photo 11: Port side ferrell, showing pipeline deposit (x40, SEM)

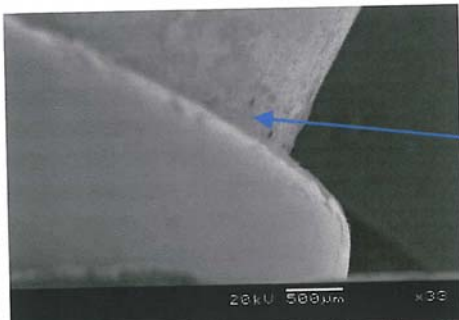
Photo 12: Starboard side pipeline ferrell showing no clear indentations (x33, SEM)

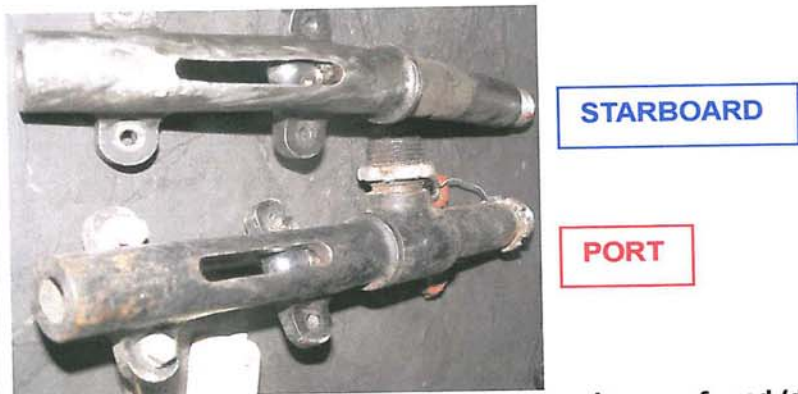
Both port and starboard side by-pass valve were located (Photo 13) showing extensive impact damages. Closer inspection revealed no clear impact marks on the portside by-pass valve piston crown (Photo 14, red arrow) while the opposing starboard side by-pass valve piston crown revealed clear impact marks (Photo 15, blue arrow). These impact marks can possibly be attributed to the crown impacting with the starboard canopy un-locking mechanism (see par. 1.6.).

Photo 13: Port and starboard side by-pass valves, as found (digital)

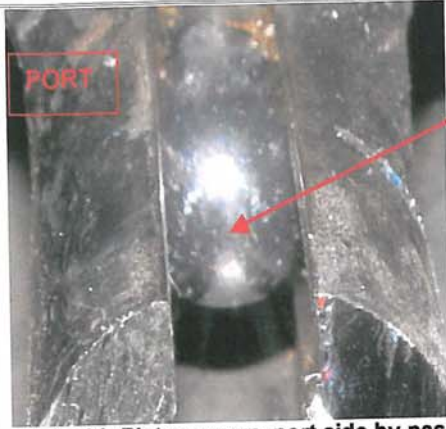
Photo 14: Piston crown, port side by-pass valve piston (digital)

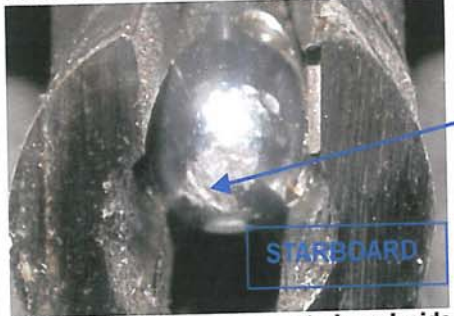
Photo 15: Piston crown, starboard side by-pass valve piston, showing indentation marks (digital)

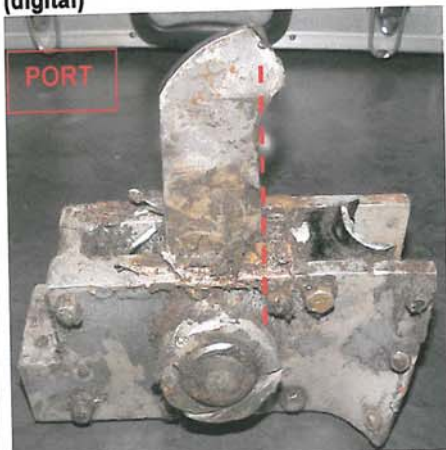
Both the retrieved port and starboard side primary canopy hooks (Photo's 16 and 17) showed extensive impact damages. Notably, the port side canopy hook was found in an angled position (Photo16, red dashed line) relating to the fully 'locked' position while the opposite starboard side canopy hook was found angled in the 'unlocked' position (Photo 18, blue dashed line). Comparing the port side canopy hook with the corresponding position on the canopy frame (Photo 17), it can be derived that the port side canopy hook were forcefully removed from the 'locked' position, most probably on impact.

Photo 16: Port side, main canopy hook, as found in locked position (digital)

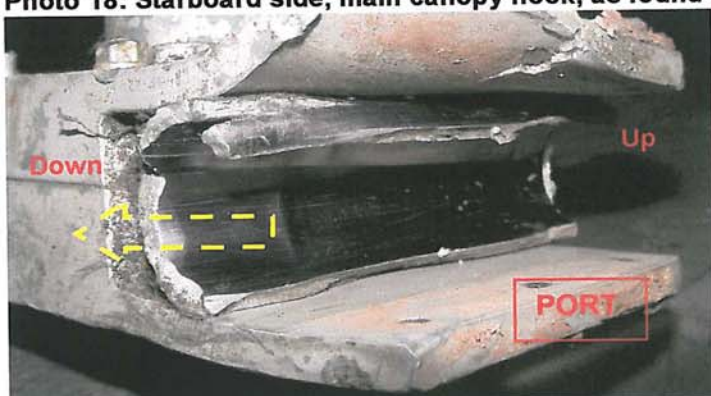
Impact and scraping marks on the port side high velocity jack sleeve (Photo 19), point towards the forceful expulsion of the jack in a downward and aft direction, most probably on impact (yellow arrow). The opposing starboard side high velocity canopy jack was found in a partially upward position with impact bending damages (Photo 20) to the jack. The sleeve revealed signs of explosion damages (Photo 21), most probably induced by the firing of the secondary cartridge. No canopy frame 'scratch plates' could be located to confirm impact marks from the two high velocity jacks.

Photo 19: Port side canopy jack sleeve (digital)

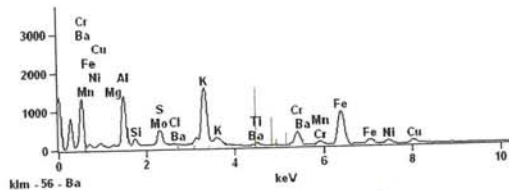
EDS Result 3: Deposits from port side t-piece ferrell

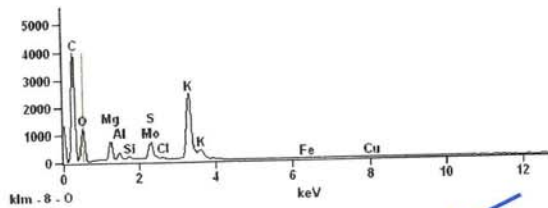
EDS Result 4: Sample from secondary cartridge holder

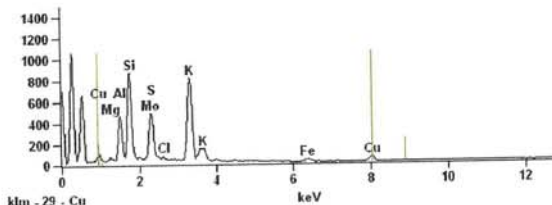
EDS Result 5: Outlet elbow, breach, primary cartridge

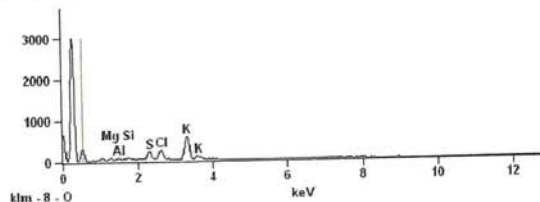
EDS Result 6: Same position as EDS 5, outlet elbow, breach

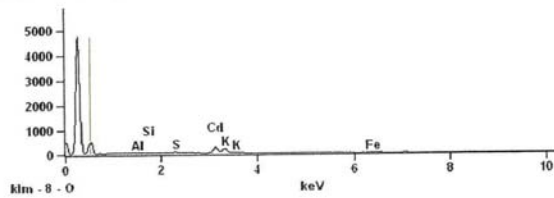
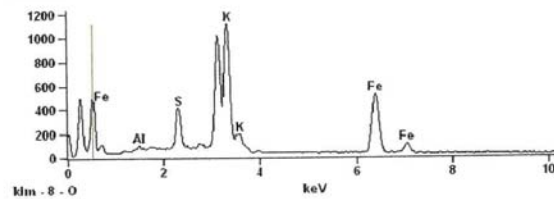
EDS Result 7: Sample from T-piece inner area

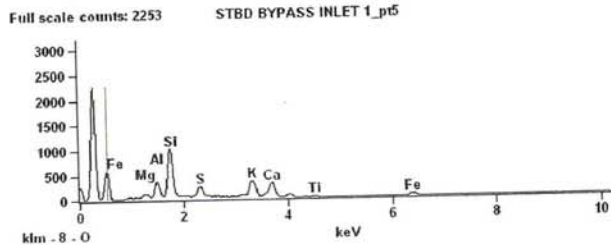
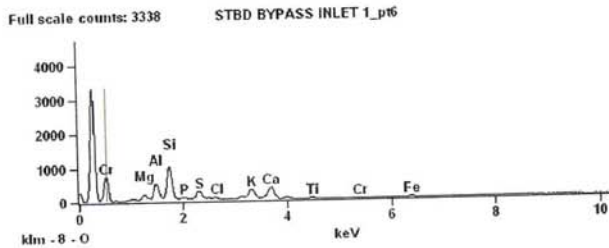
EDS Result 8: Sample from starboard by-pass valve inlet elbow

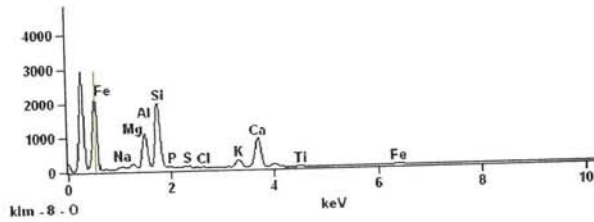
EDS Result 9: Sample from port side by-pass valve inlet elbow

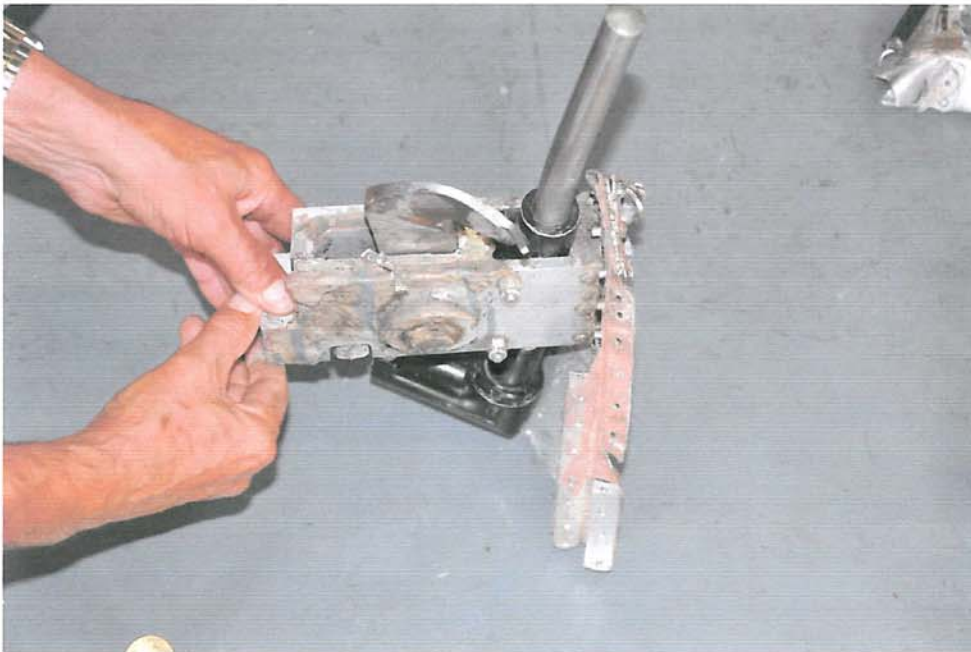
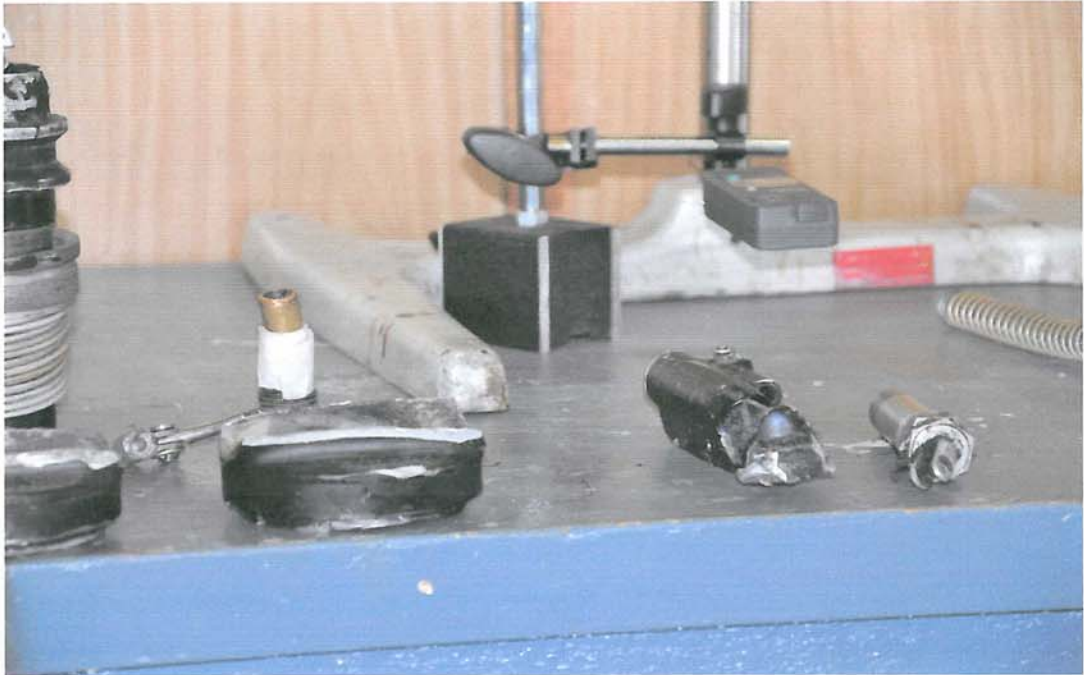
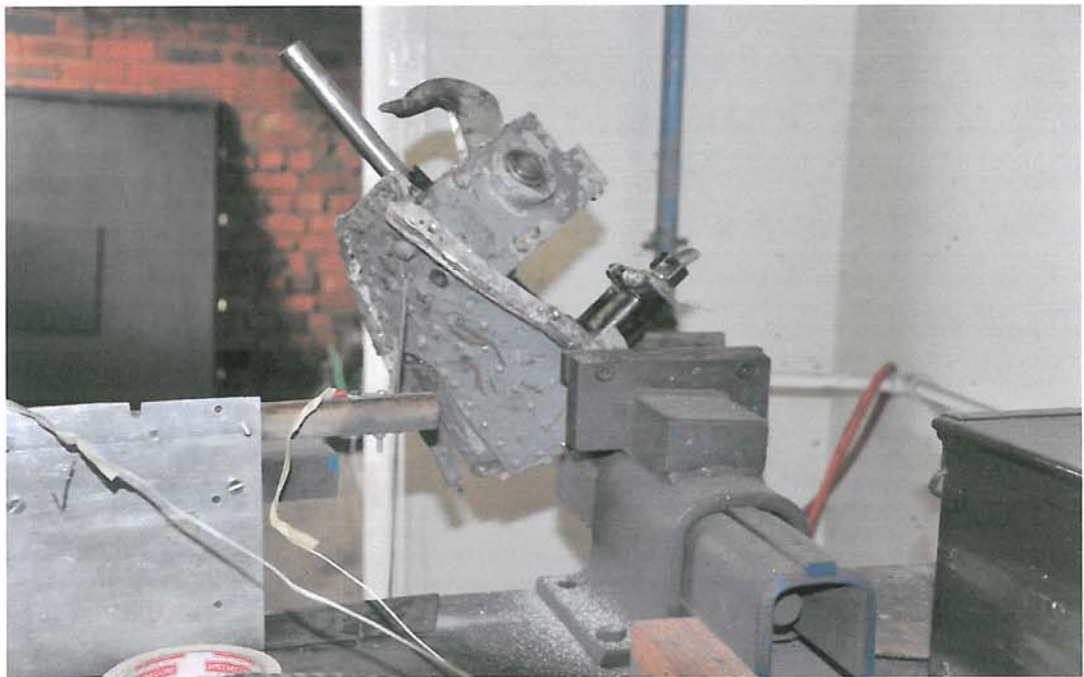
The gas chamber of the units in which the Secondary Canopy Ejection Cartridges were installed burst open and the shafts were bent. These shafts are used to push the canopy away. Photo's below.

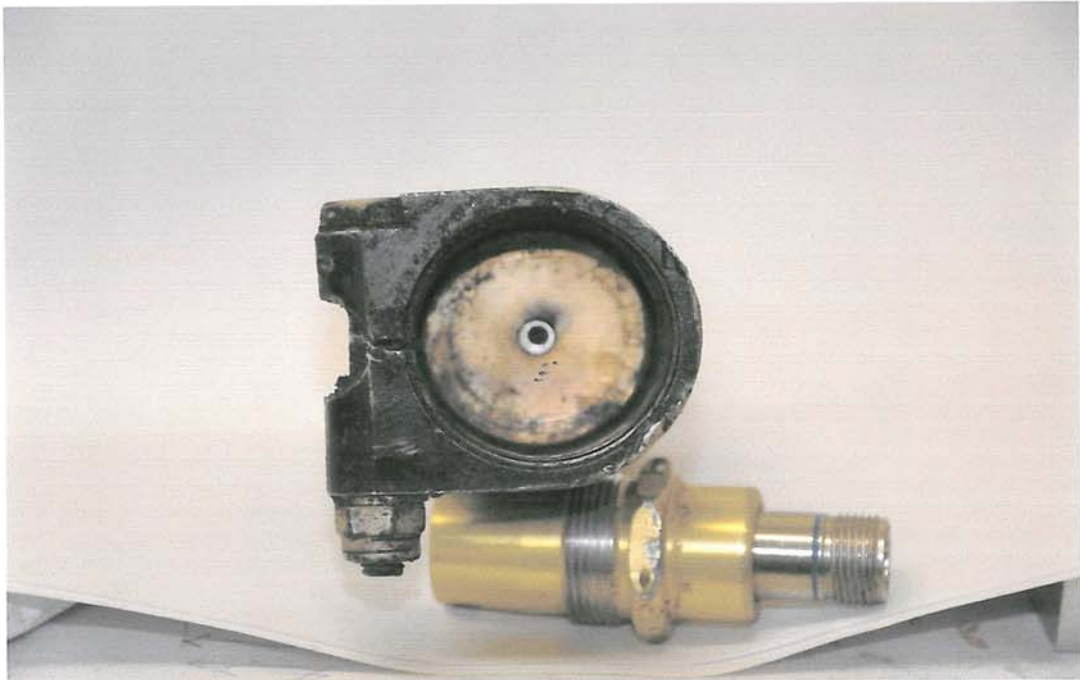
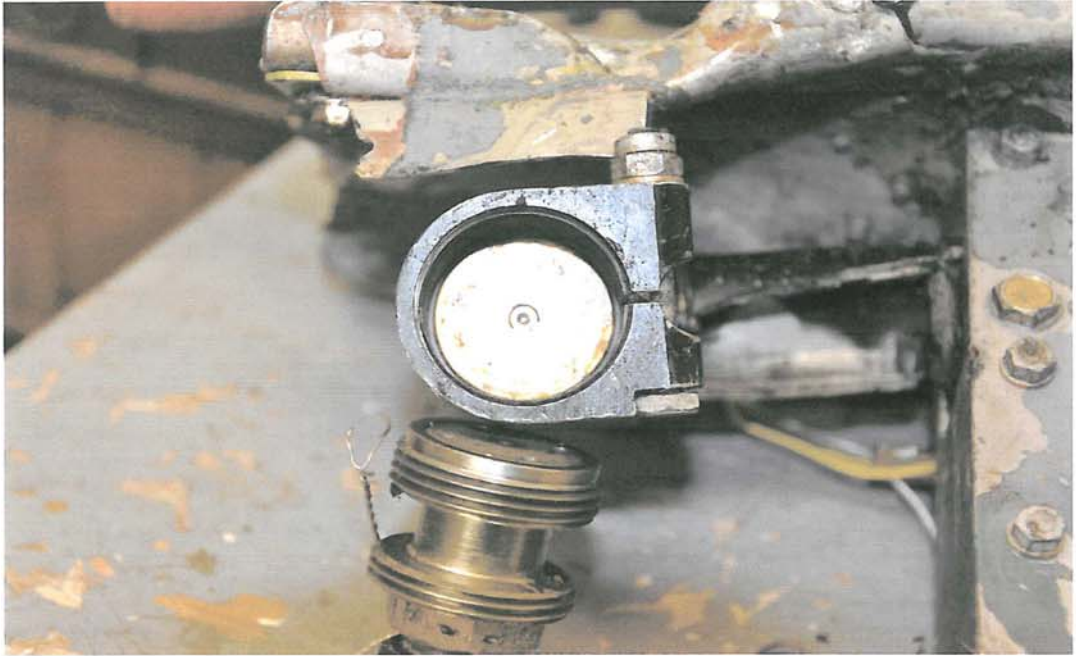
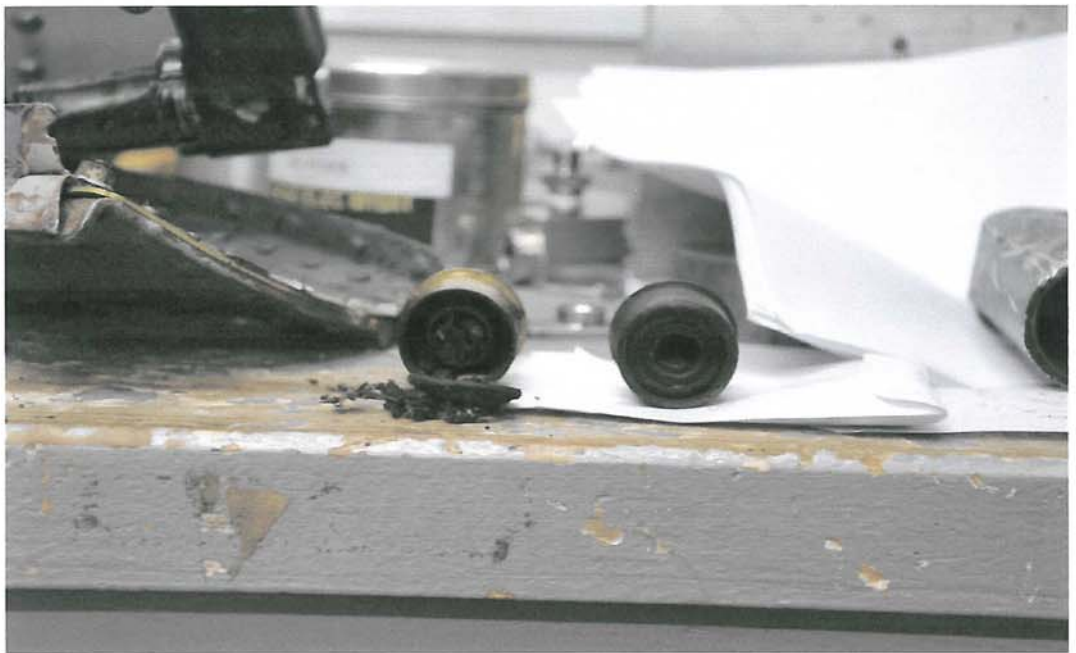
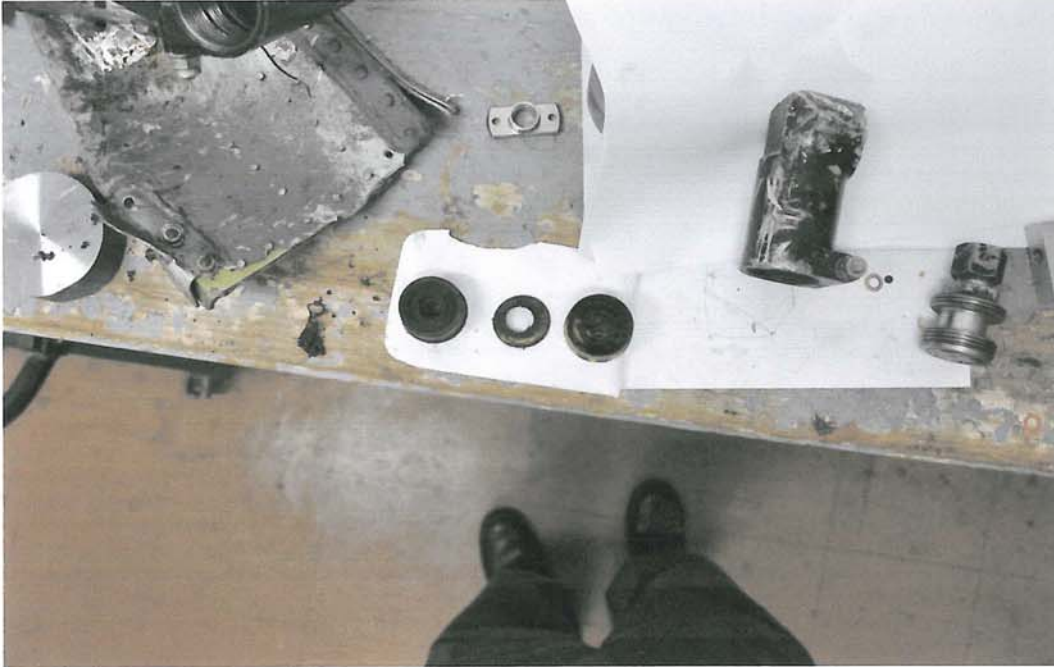
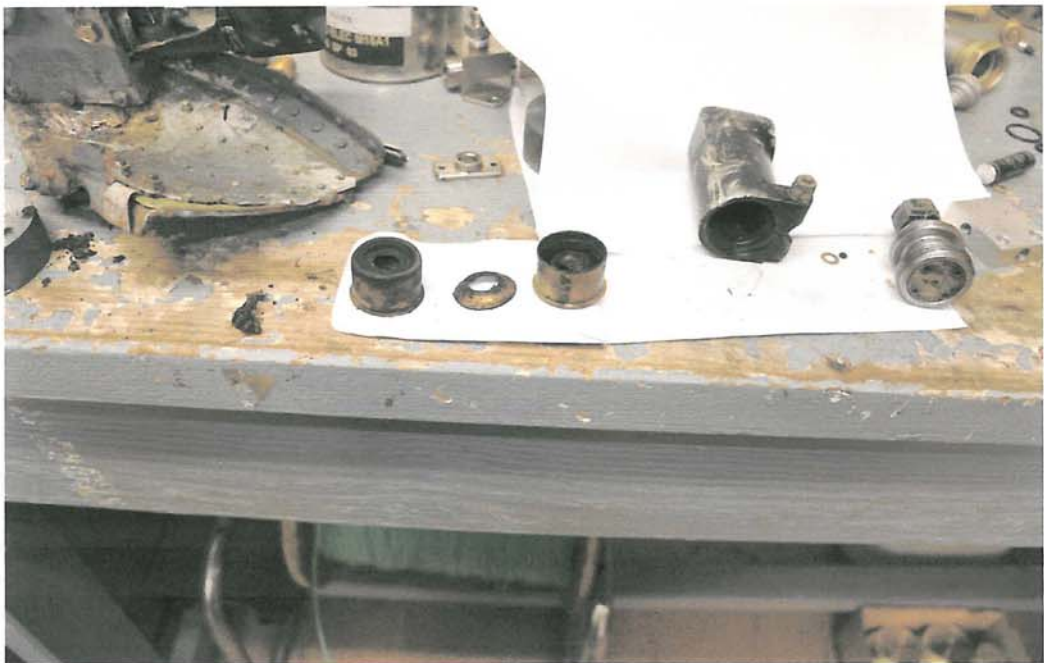
These units were dismantled and evidence was found that the two cartridges did function when the pilot selected ejection mode.

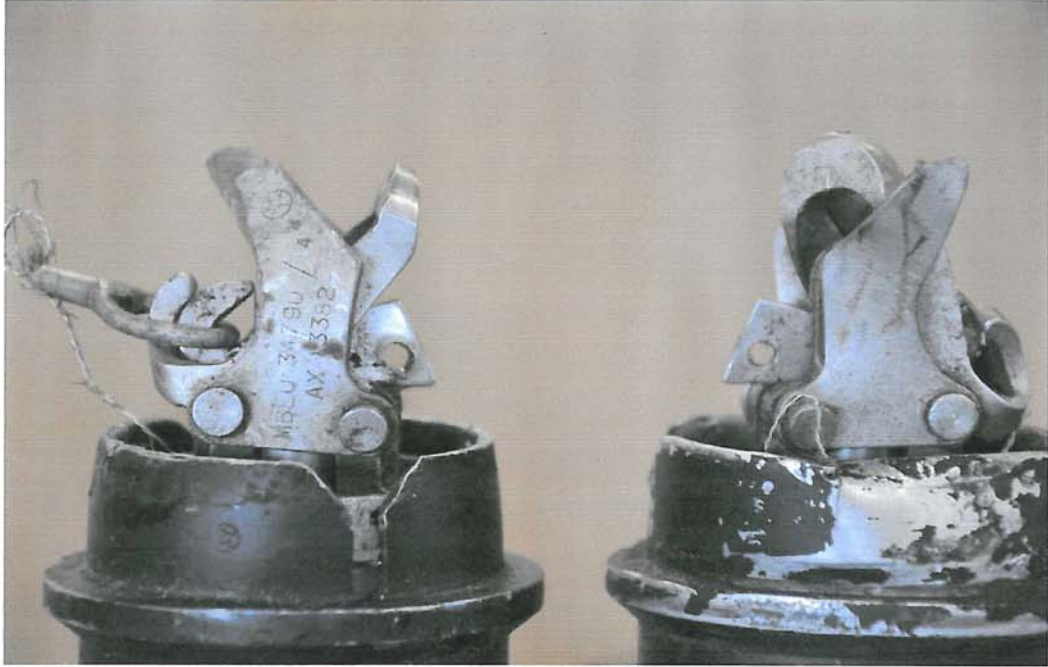
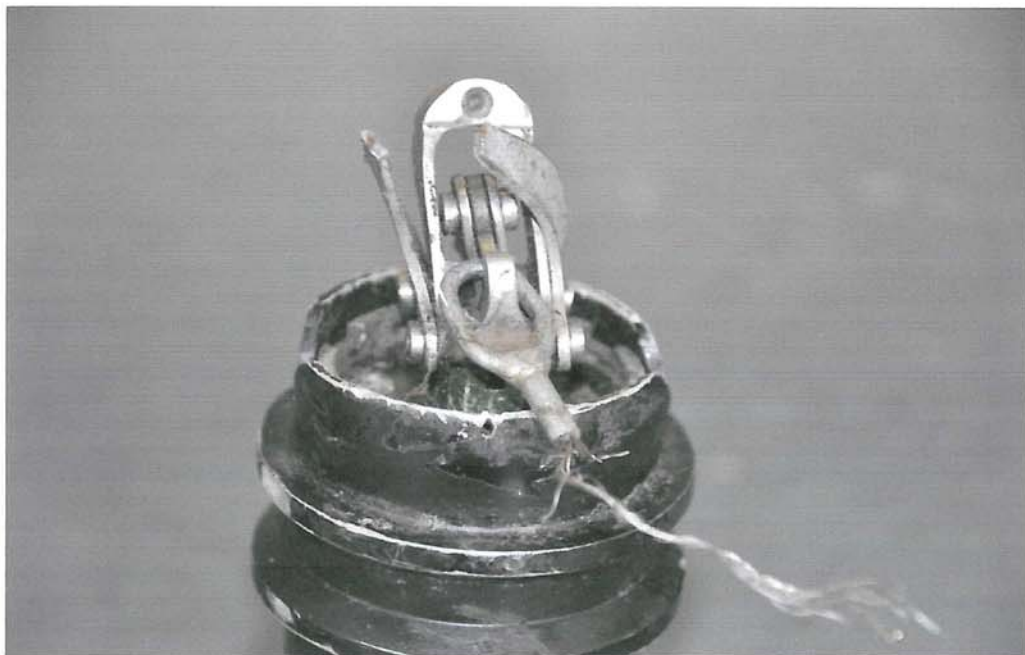
The Canopy Jettison Cartridge that ignited the two Secondary Canopy Cartridges was not recovered from the crash area. This Canopy Jettison cartridge did however function and generated enough pressure to initiate both the Secondary Canopy Jettison Cartridges.

The rest of the system could not function due to the Safety Locking Device which was not activated. The Safety Locking Device can only be activated if the canopy is ejected. Photo's below.

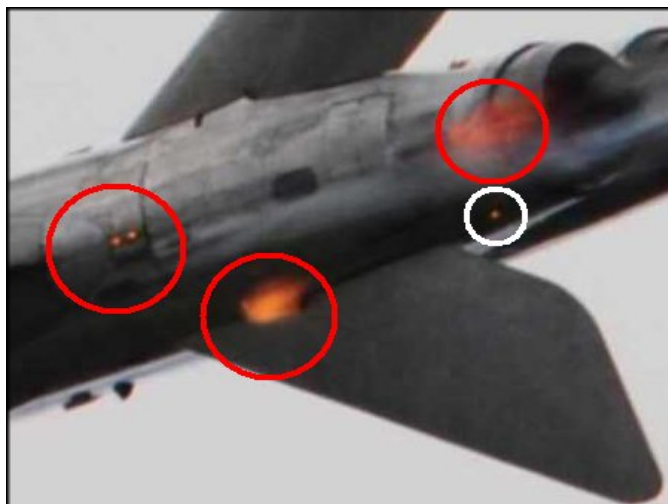
Figure 1 – Photo from CAA

The areas highlighted in red in Figure 1 depict:

- 1) Flames emanating from the starboard rear fuselage around the tailplane.
- 2) Two bright spots of fire (line astern) just aft of the ventral tank.
- 3) Flames emanating from the lower fuselage forward of the lower reheat jet pipe exit.

We believe that the 'glow' highlighted by the yellow circle is the starboard formation light.

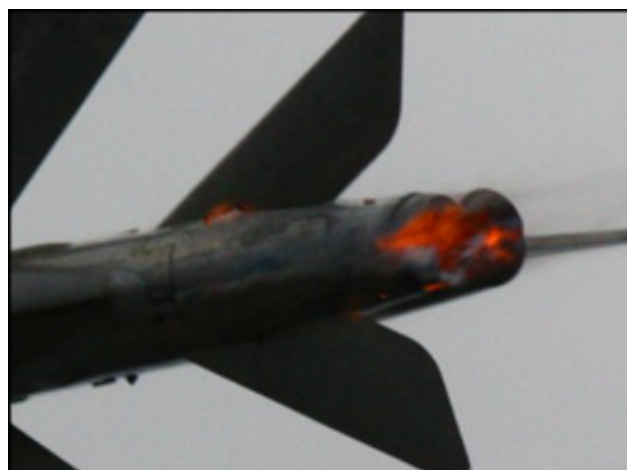
Figure 2 – Photo from CAA

Figure 2 shows evidence of flames emanating from the port side of the fuselage around the tailplane. The fire around the jet pipes appears to be more pronounced and 'fierce' than in Figure 1 but the two bright spots of fire are not visible.

We do not know the sequence in which the photos were taken but the advanced properties show that Figure 1 was taken with a Nikon D90 on 14/11/09 at 12:16. Figure 2 was taken with a Canon EOS 450D on 14/11/09 at 12:09. Assuming that the camera times were set correctly (we have no evidence either way) then it would follow that Figure 2 was taken before Figure 1, possibly explaining why the two bright spots are not yet visible. Given the extent of the fire around the jet pipes in Figure 2, however, it would seem more likely that this photo was taken after Figure 1. Without additional evidence this cannot be stated categorically.

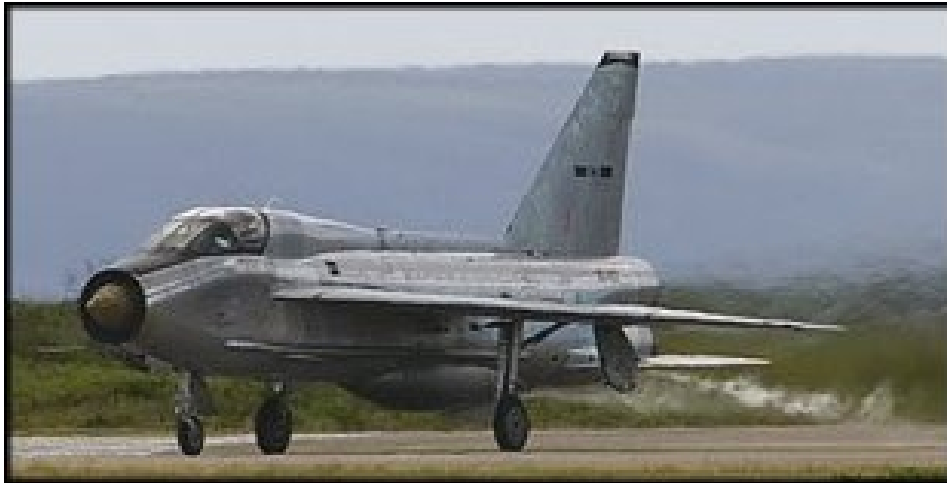
Figures 1 and 2 depict atomised fluid or smoke emanating from the rear fuselage and this is also apparent in photos on the internet, which claim to show the aircraft during take-off. It is our opinion that the photos probably depict atomised fuel and there are two separate trails, Figure 3. One of the trails appears to emanate from the fuselage slightly aft of the ventral tank with the other (possibly) emanating from the interface between fuselage and the lower reheat jet pipe exit.

Figure 3 – Two vapour trails during the take-off run

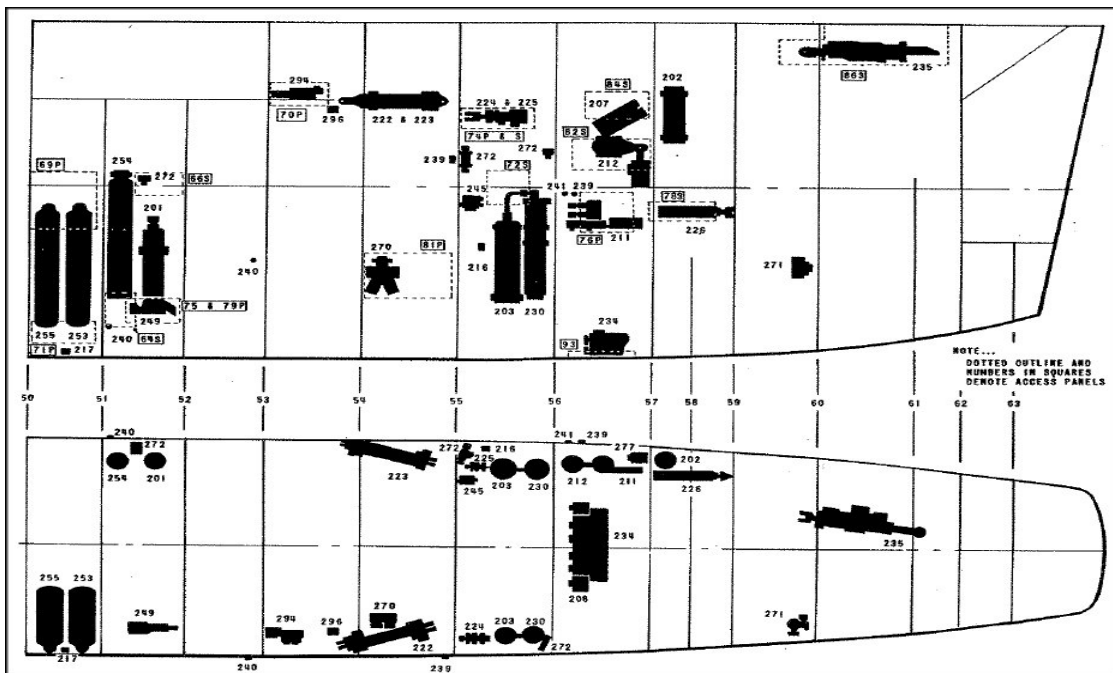
Figure 4 – Location of Major Hydraulic Components

There are many significant (and critical) items of equipment in the rear fuselage and it is our opinion that the integrity of a number of items would be compromised by a fire of the intensity shown in Figures 1 and 2. Figure 4 shows the location of significant hydraulic components.

Working rearwards, Items 255 and 253 are the hydraulic reservoirs; they are located between Frames 50 and 51, which is just aft of the centre of the ventral tank and potentially away from the immediate region of fire. Item 203 is the tailplane accumulator and Item 230 is the nitrogen tank for the accumulator; the items are located between Frames 55 and 56, which is at the rear of the ventral tank and therefore most likely in the vicinity of the fire. Item 234 is the tailplane PFCU and it is located between Frames 56 and 57; it is reasonable to assume that its integrity would have been affected by the fire.

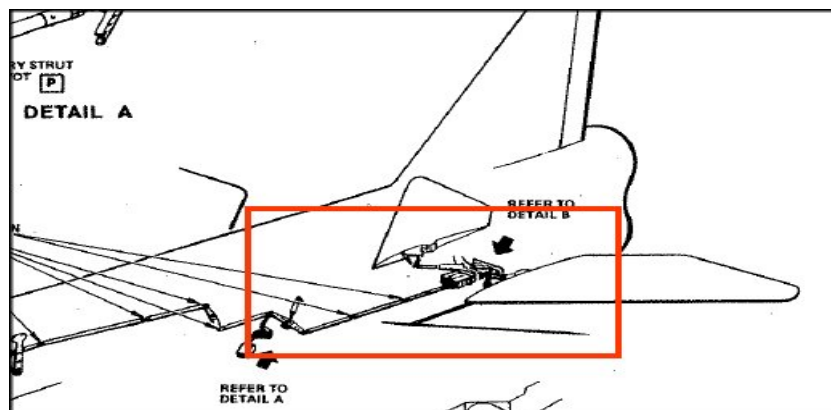
Figure 5 – Simplified view of Primary Flying Control Runs

Figure 5 shows a very simplified view of the primary flying controls in the rear fuselage. The controls run along the bottom of the fuselage and it is possible that their integrity would have been affected by the fire; a review of Royal Air Force (RAF) accident reports has shown that several aircraft were lost when the flying control runs were destroyed by rear fuselage fires (while the RAF T5 aircrew manual states that the control rods are resistant to fire, they cannot be expected to last forever).
