AIRCRAFT ACCIDENT REPORT AND EXECUTIVE SUMMARY

Reference:	CA18/2/3/8706	
Aircraft Registration	ZU-BEX	Date of Accident	14 November 2009		Time of Accident	1022Z
Type of Aircraft	English Electric Lightning MK T5		Type of Operation		Commercial – Air Show	
Pilot-in-command Licence Type		Airline Transport	Age	46	Licence Valid	Yes
Pilot-in-command Flying Experience		Total Flying Hours	10993.0		Hours on Type	unknown
Last point of departure		Overberg – Test Flying and Development Aerodrome (FAOB)				
Next point of intended landing		Overberg – Test Flying and Development Aerodrome (FAOB)				
Location of the accident site with reference to easily defined geographical points (GPS readings if possible)						
Overberg – Test Flying and Development Aerodrome (FAOB) at GPS co-ordinates: S 34°31.232 E020°22.618						
Meteorological Information		Wind direction: 250° , Wind speed: 10 kts , Temperature: 20°C, Visibility: Good, Cloud cover: 5/8, Cloud base: 2500 ft.

Probable Cause						
Uncontrolled flight due to double hydraulic failure.						
Contributory Factors						
<p>There was evidence found indicating that the aircraft was exposed to a pre impact fire in flight and the heat from the fire pro

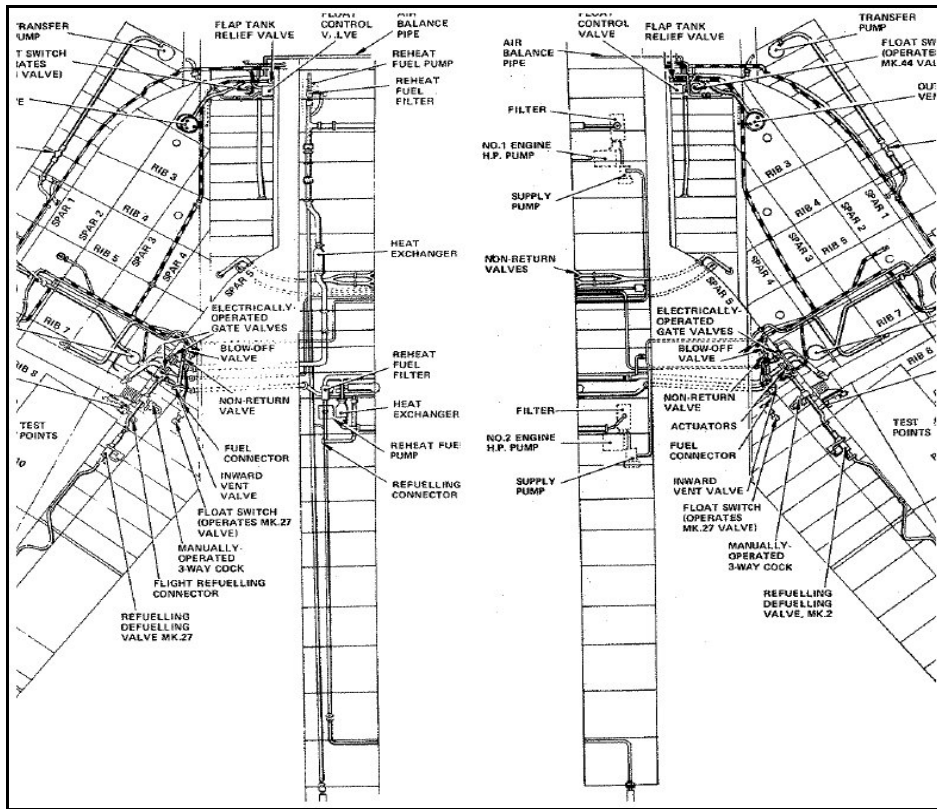
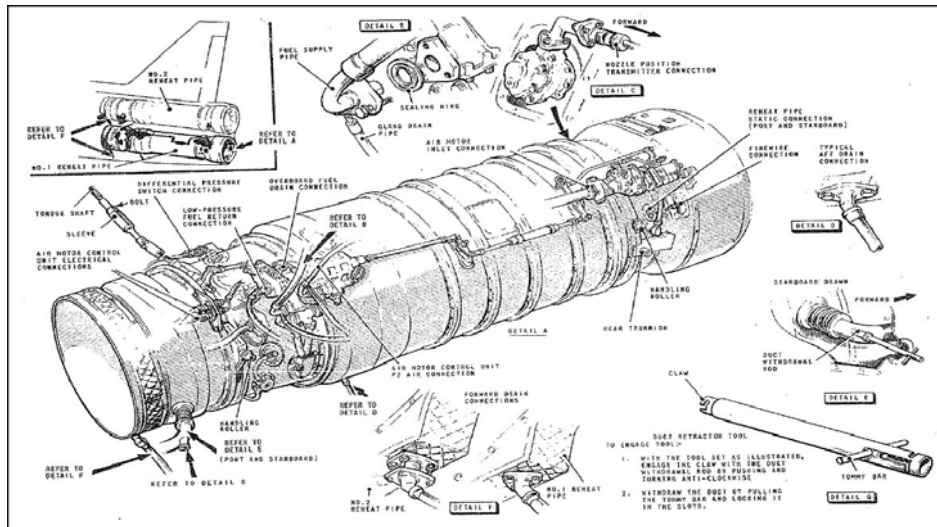
The location of the reheat jet pipe relative to the engine and the fact that reheat ignition relies on a 'hot streak' method requires fuel pipes throughout the central and rear fuselage, Figures 7 and 8. There are numerous couplings in the pipe runs in close proximity to hot surfaces that could readily act as ignition points in the event of a leak (this was a well known and respected fact when the aircraft were in RAF service).

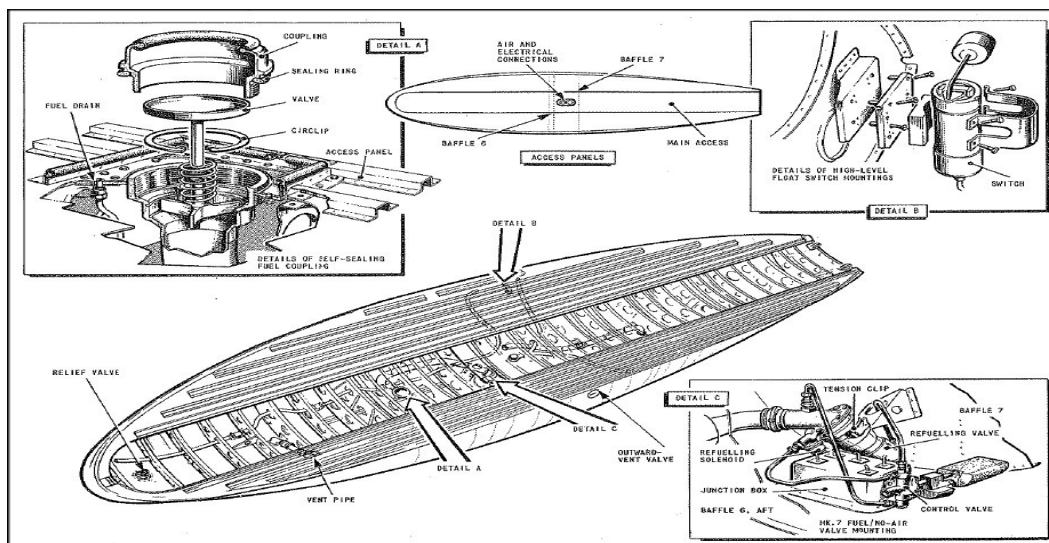
Figure 9 – Schematic of the ventral tank and the fuel coupling arrangement

Whether or not the tank on ZU-BEX contained fuel is unknown but a leak from the tank or coupling could, potentially, result in a fire.

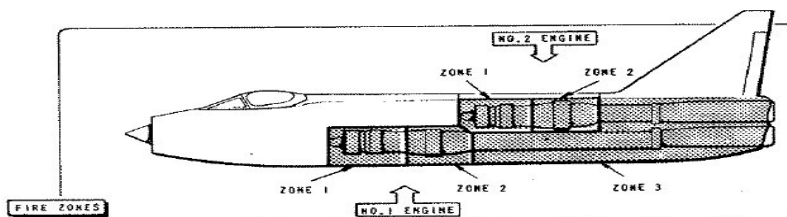
Figure 9 - Fire Zones

In RAF service the aircraft was equipped with a fire detection and protection system with each engine bay divided into two fire zones separated by a fire-wall. The area between the engine compressor and the fire-wall was Zone 1, the area between the fire-wall and the turbine exhaust was Zone 2. The space surrounding the jet pipes was Zone 3. Zones 1 and 2 were protected by fire extinguishers but Zone 3 was unprotected, Figure 9.

A fire in Zone 1 or 2 of the number 1 engine resulted in the illumination of the FIRE 1 warning in the cockpit; in the case of the number 2 engine FIRE 2 would illuminate. A fire in Zone 3 would result in either RHT 1 or RHT 2 illuminating. On the basis of the photographic evidence at Figures 1 and 2 it is probable that either RHT 1, RHT 2 or both would have illuminated if the detection system on ZU-BEX was still installed and operational, although this is merely our opinion.
