SERIOUS INCIDENT INVESTIGATION FINAL REPORT

REF: CA18/3/2/0755

**Jetstream Aircraft 4100 ZS-OMZ
Runway Excursion during Take-off from
Port Elizabeth Airport,
SOUTH AFRICA.
18 November 2009**

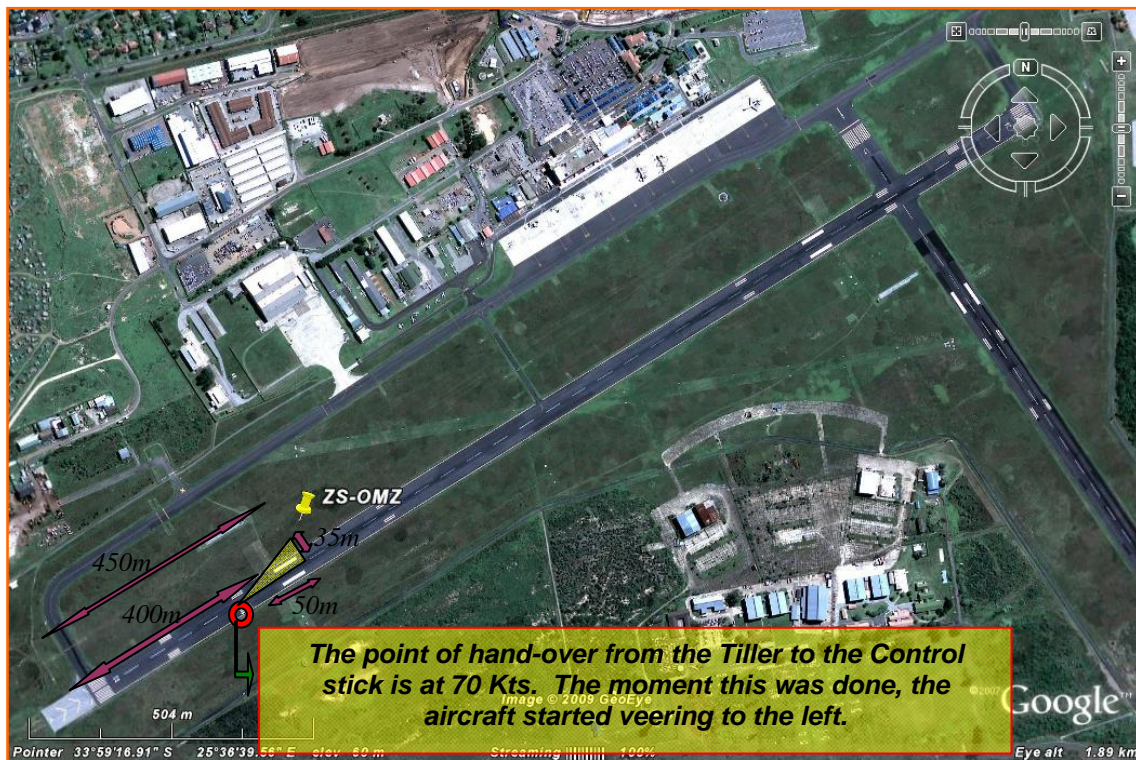
1.12.2.3 The aircraft stopped 35m from the runway edge, after it departed the runway. This was done with the brakes. The engines were shut down after the aircraft stopped.

Fig 3: A view of the airport and an indication where the aircraft finally stopped
