Statens haverikommission
Swedish Accident Investigation Board

Final report RL 2011:16e

**Serious incident to aircraft SE-MAP
at Helsinki/Vantaa Airport in Finland,
on 11 January 2010**

Case L-07/10

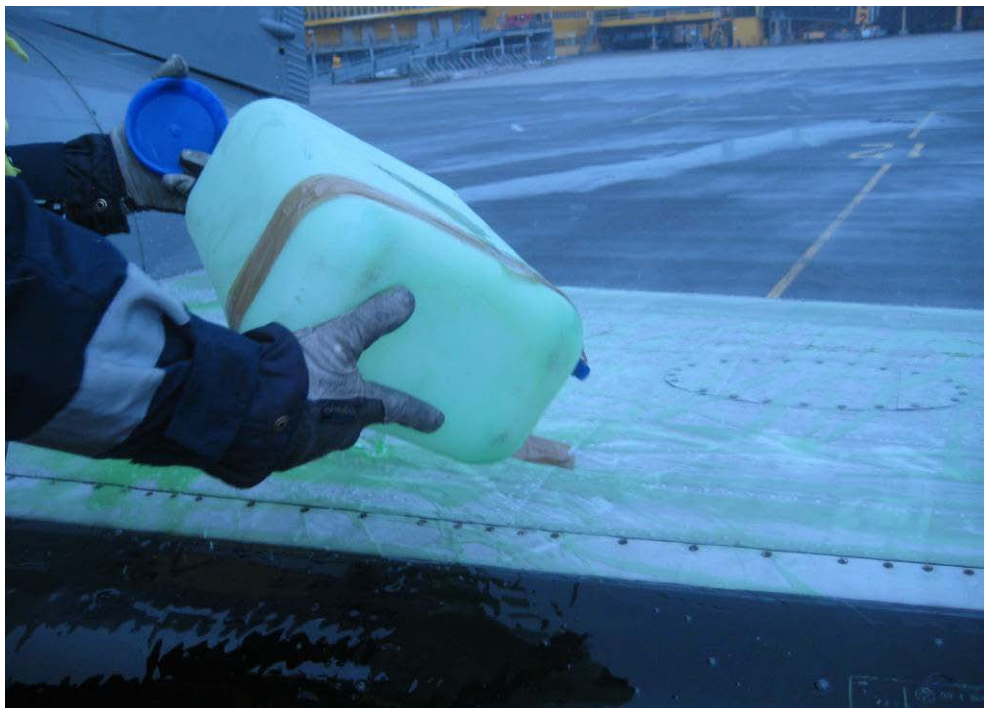
Fig. 11. Application of Type IV fluid in connection with the tests.

For the first test, Type IV fluid was applied to the aircraft. Prior to the tests, checks had been made by the handling agent to ensure that the fluids used conformed to the specifications given. The test was carried out using the aircraft SE-MAP, with a mass of 17250 kg and a centre of gravity index of 55. Rotation speed, V_r , had been calculated to 99 kts.

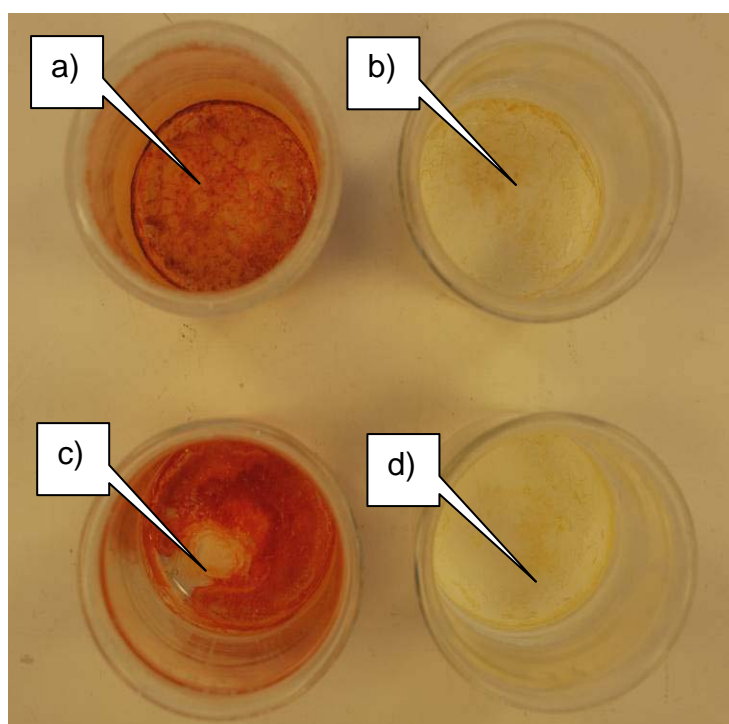
Fig. 19. Fluid testing.

- a) Safewing® MP I Eco Plus
- b) Safewing® MP II Flight
- c) Type I fluid, Kilfrost ABC 2000
- d) Type II fluid, Kilfrost ABC 2000

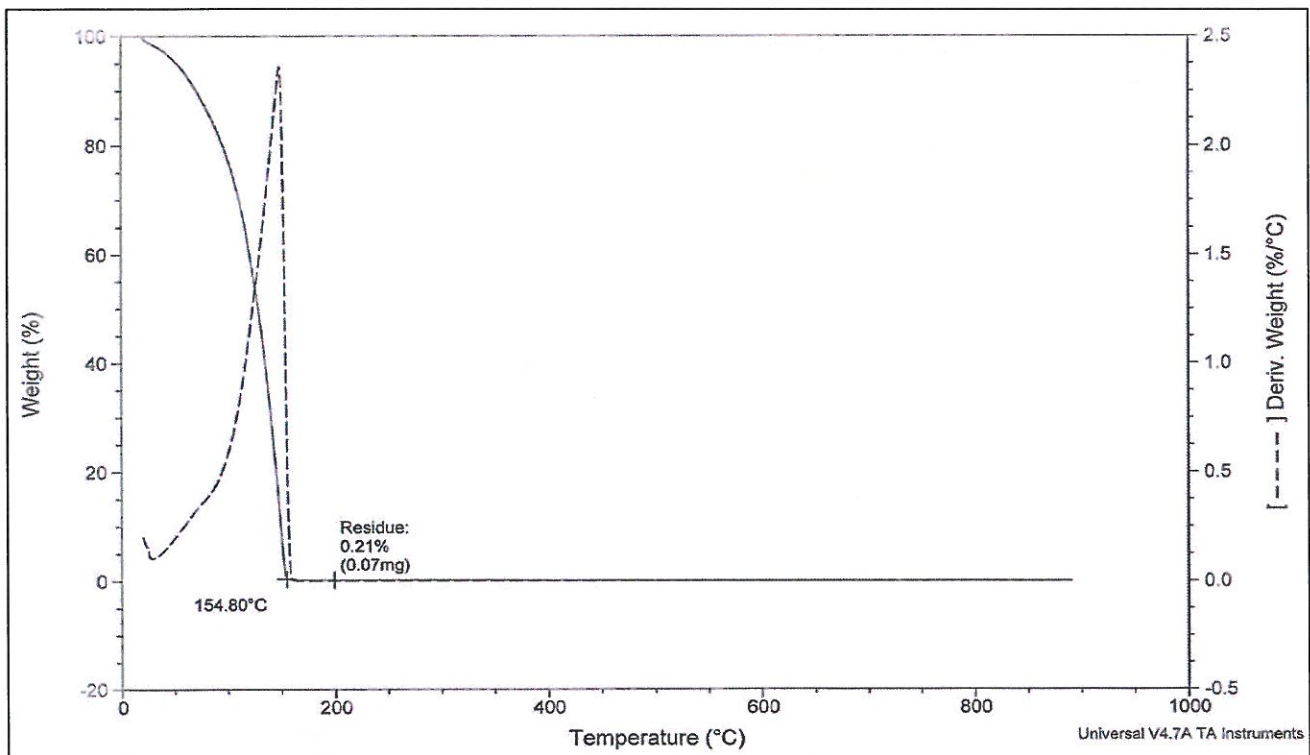
Figur 1. TGA-profil för Safewing® MP I Eco Plus (80) med provnummer 2010-9178.

Provmängd var ursprungligen 35,032 mg. Den heldragna kurvan visar provets vikt under värmningen. Den streckade kurvan visar derivatan för vikten, d.v.s. viktförändringar, under värmningen. Resultaten visar att majoriteten av provet dunstar bort under värmning från RT till 154,80°C, varefter det återstår en rest (0,21 mass%, 0,07 mg). Denna rest påverkas inte av värmning upp till 900°C.

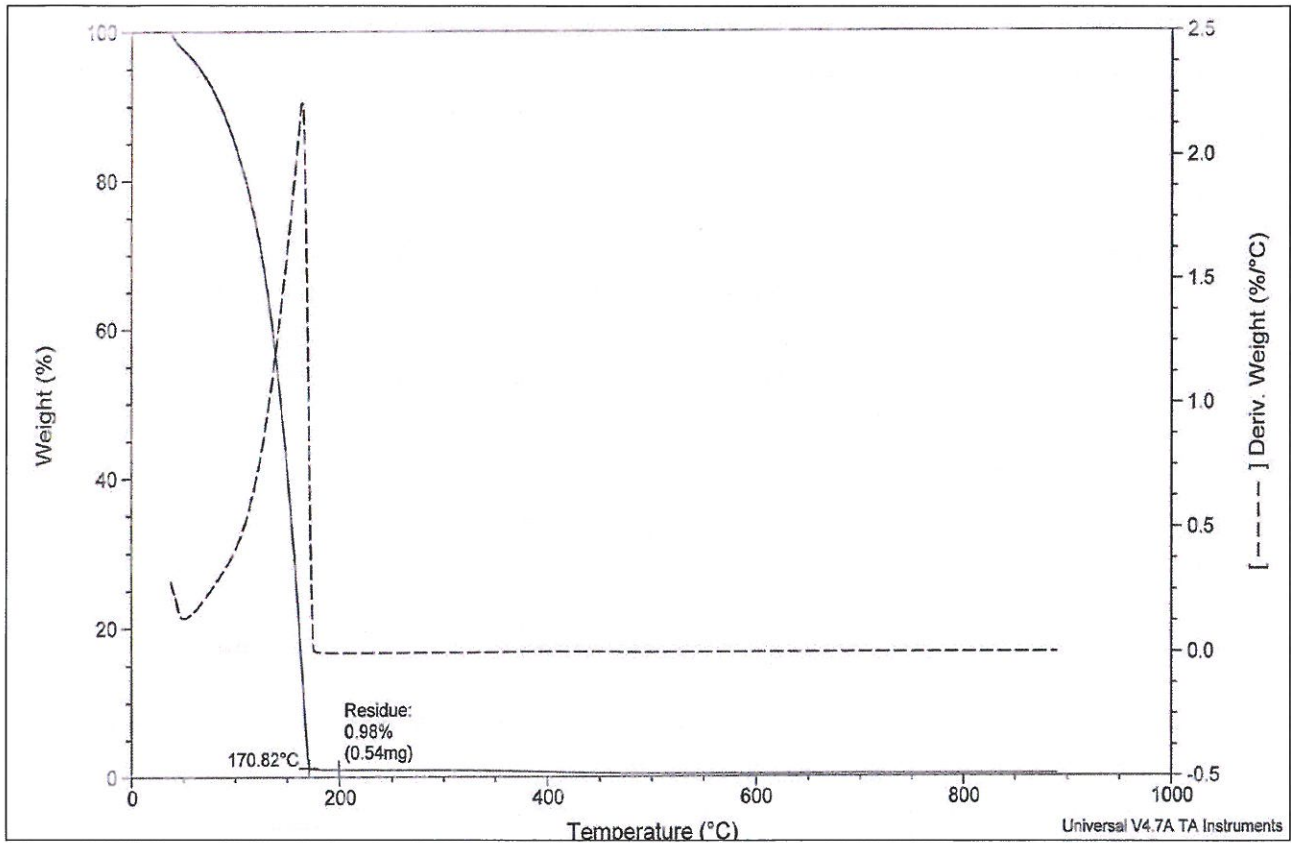
Figur 2. TGA-profil för Safewing® MP II Flight med provnummer 2010-9179.

Provmängd var ursprungligen 54,849 mg. Den heldragna kurvan visar provets vikt under värmningen. Den streckade kurvan visar derivatan för vikten, d.v.s. viktförändringar, under värmningen. Resultaten visar att majoriteten av provet dunstar bort under värmning från RT till 170,82°C, varefter det återstår en rest (0,98 mass%, 0,54 mg). Denna rest påverkas inte av värmning upp till 900°C.

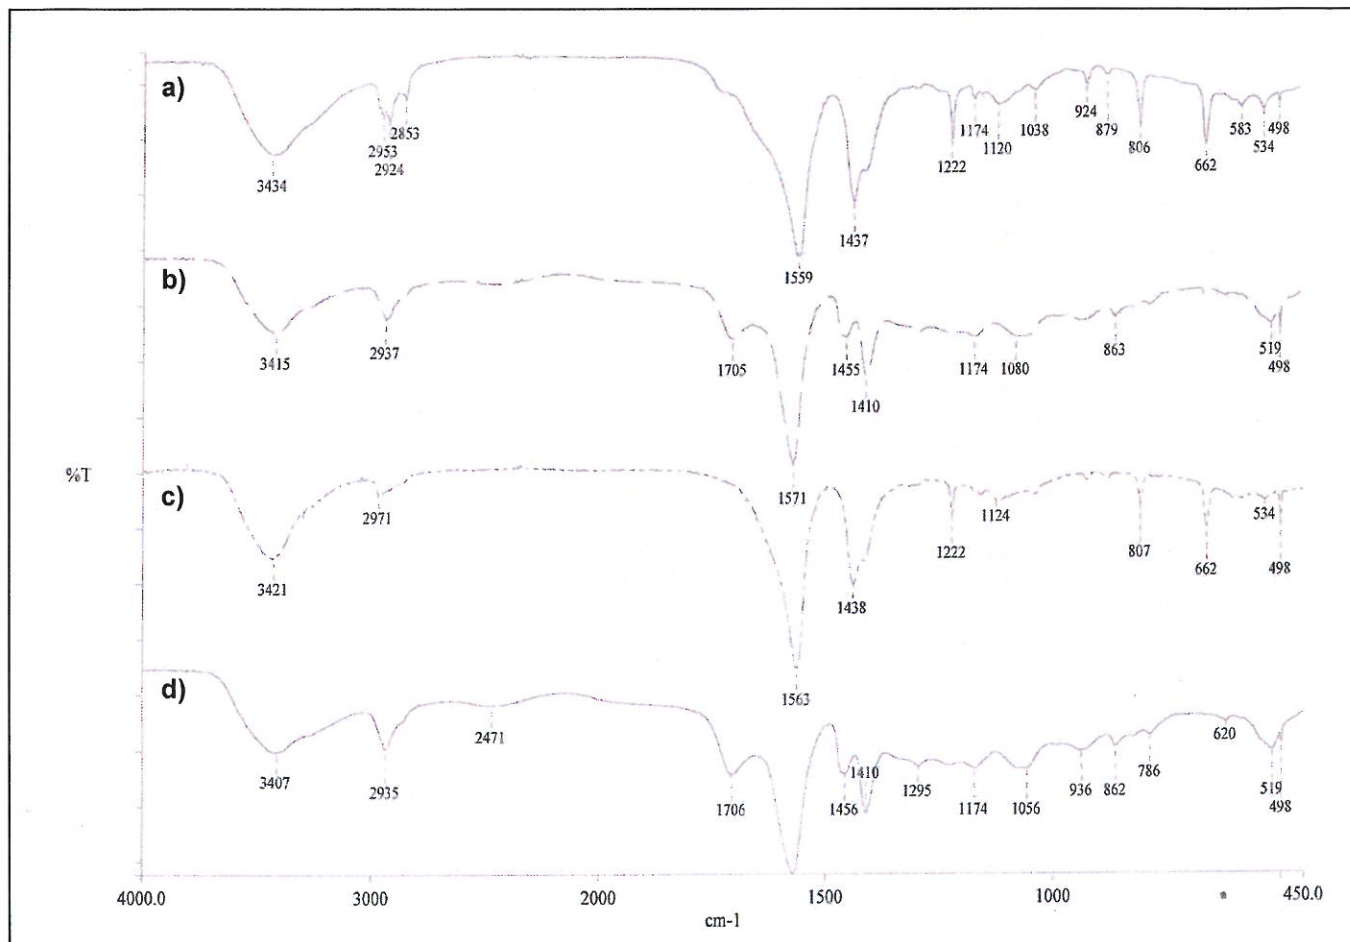
Figur 4. FTIR spektra för indunstningsrester.

FTIR-spektran visar inga stora skillnader mellan 2010-9178 och 2011-797 respektive 2010-9179 och 2011-798. Samtliga spektran tyder på att resterna består av organiska föreningar. Vad gäller skillnader mellan vätskorna av typ I och typ II kan man konstatera att de största skillnaderna avser absorbans vid 1705 cm^{-1} och 1410 cm^{-1} som är mer tydligt för typ II jämfört med typ I. Absorbans vid 1705 cm^{-1} tyder på att karbonylgrupper (eventuellt karboxylsyra, keton, aldehyd) förekommer i resten. Ingen identifiering av föreningarna var möjlig.

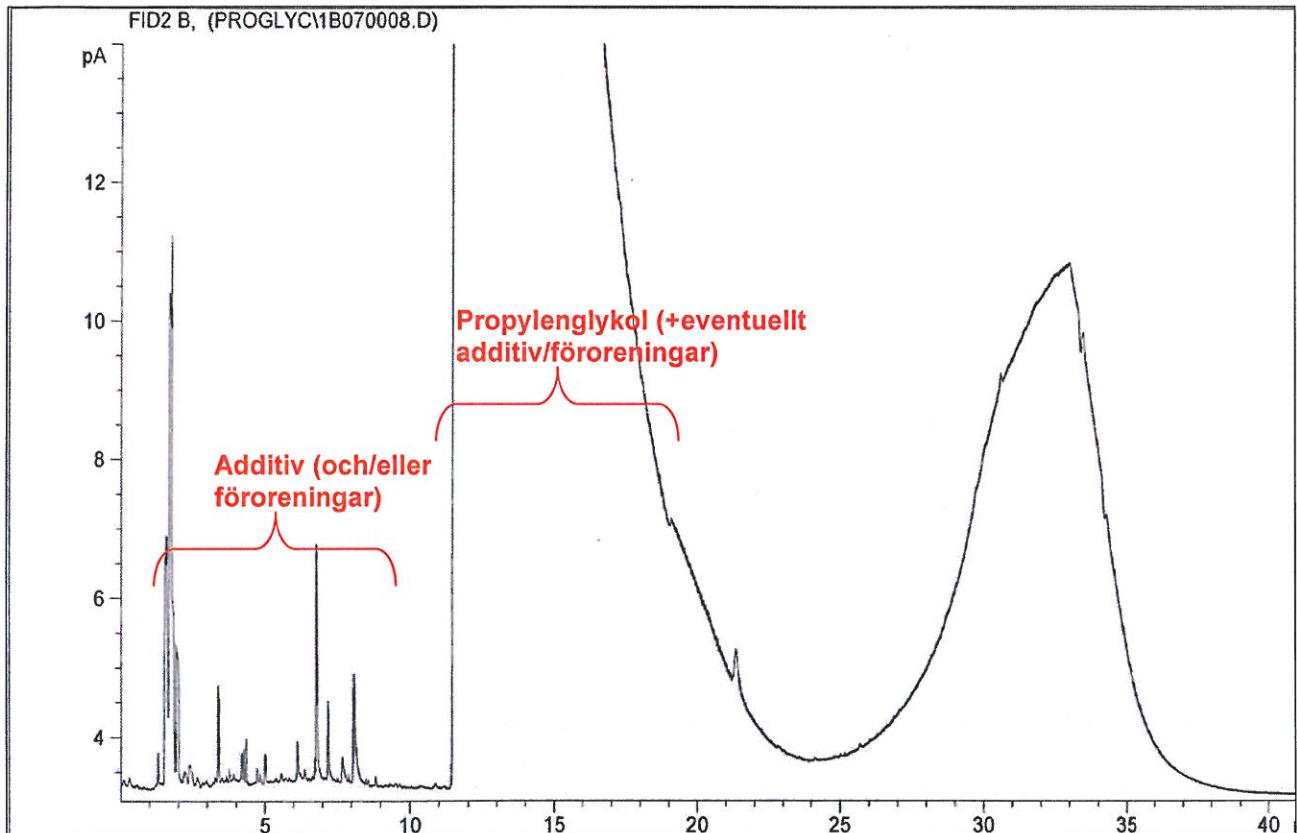
Figur 5. HS-GC-FID för Safewing® MP I Eco Plus (80) med provnummer 2010-9178.

Flyktiga föreningar (vid 150°C) injicerades på GC-kolonnen. Kromatogrammet visar att produkten dels innehåller flyktiga komponenter (de första topparna) samt propylenglykol. Med FID-tekniken är det ej möjligt att identifiera vilken typ av föreningar som förekommer i provet. Det är således möjligt att föreningarna i inledningen av kromatogrammet består av både additiv och/eller föroreningar. Propylenglykoltoppen är bred, vilket kan innebära att additiv och föroreningar förekommer i toppen.

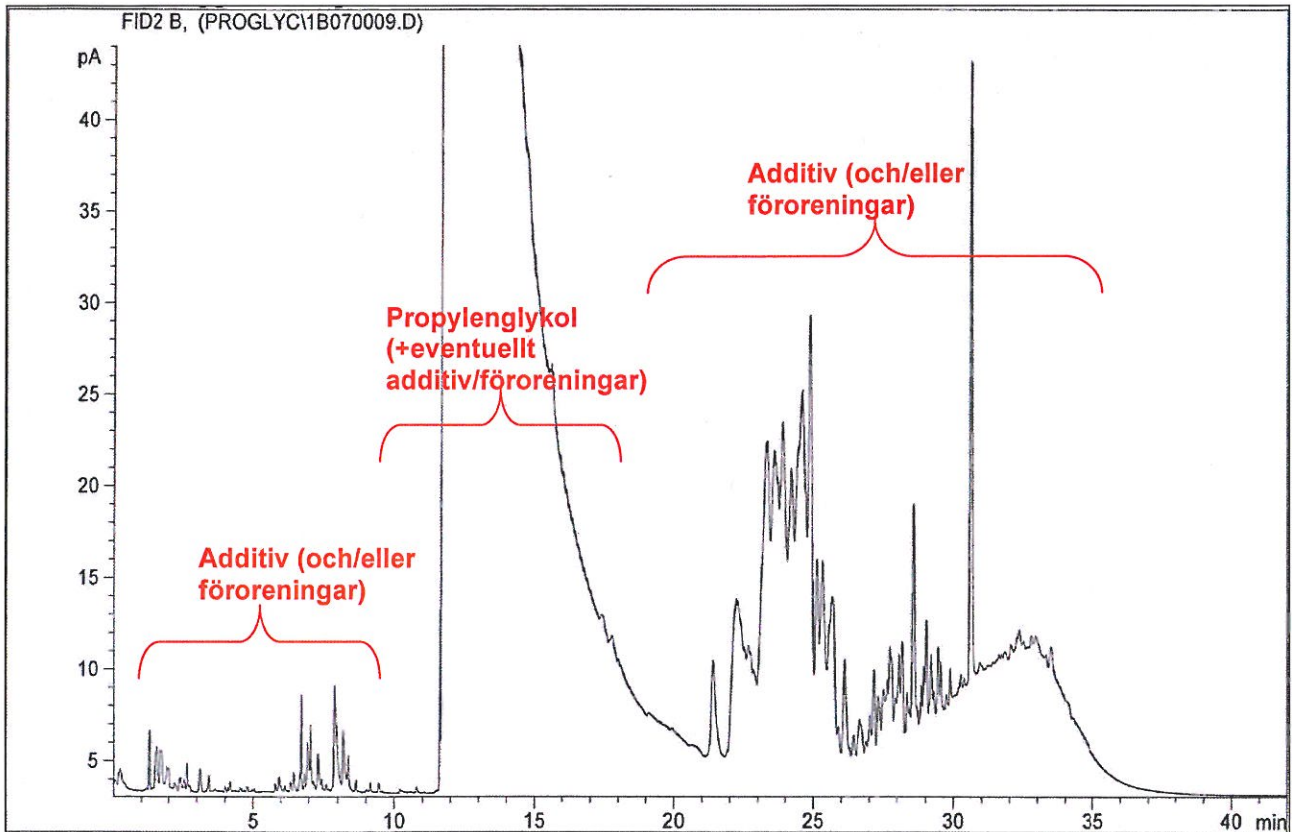
Figur 6. HS-GC-FID för Safewing® MP II Flight med provnummer 2010-9179.

Flyktiga föreningar (vid 150°C) injicerades på GC-kolonnen. Kromatogrammet visar att produkten dels innehåller flyktiga komponenter (de första topparna) samt propylenglykol. Till skillnad från kromatogrammet i figur 5, förekommer här flera toppar efter att propylenglykolen eluerat. Med FID-tekniken är det ej möjligt att identifiera vilken typ av föreningar som förekommer i provet. Det är således möjligt att föreningarna i kromatogrammet består av både additiv och/eller föroreningar. Propylenglykoltoppen är bred, vilket kan innebära att additiv och föroreningar förekommer i toppen.
