Final report RL 2012:21e

**Serious incident on 16 of January 2010 to
aircraft EP-IBB at Stockholm/Arlanda
Airport, Stockholm county, Sweden**

Ref.no. L-02/10

2012-12-28

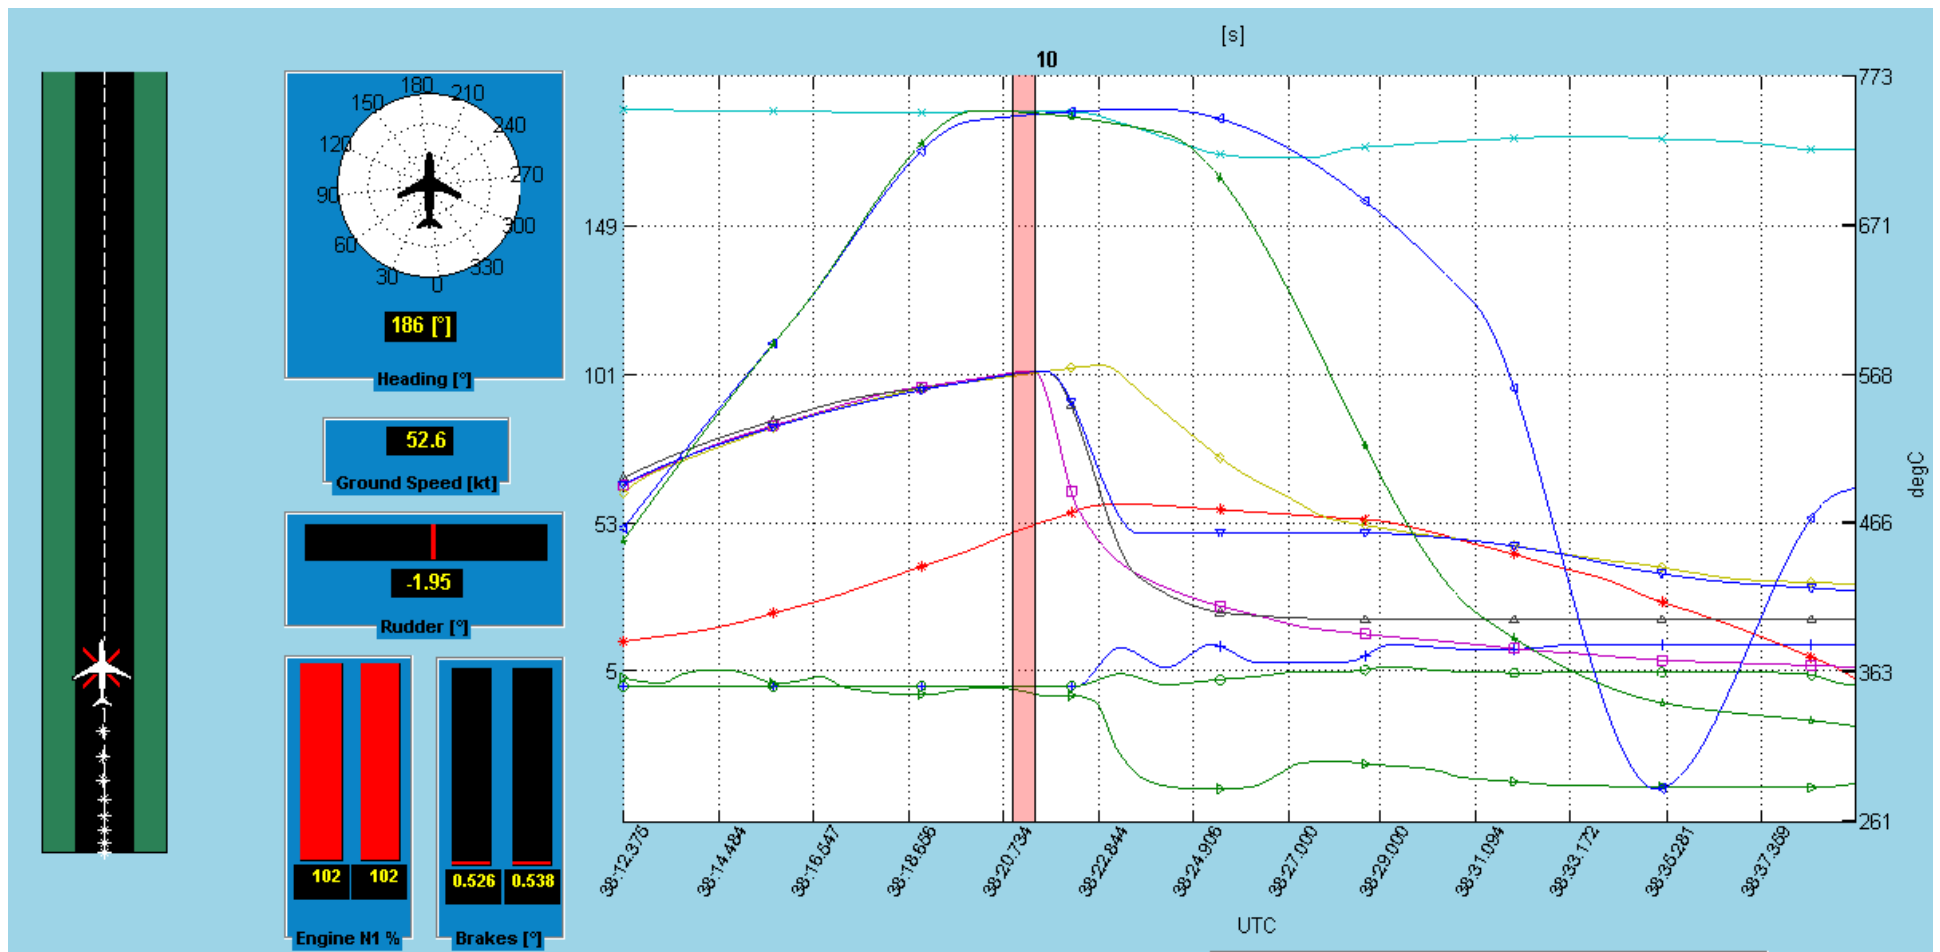
Fig. 4. Point of time for loss of engine power. Based on FDR data.

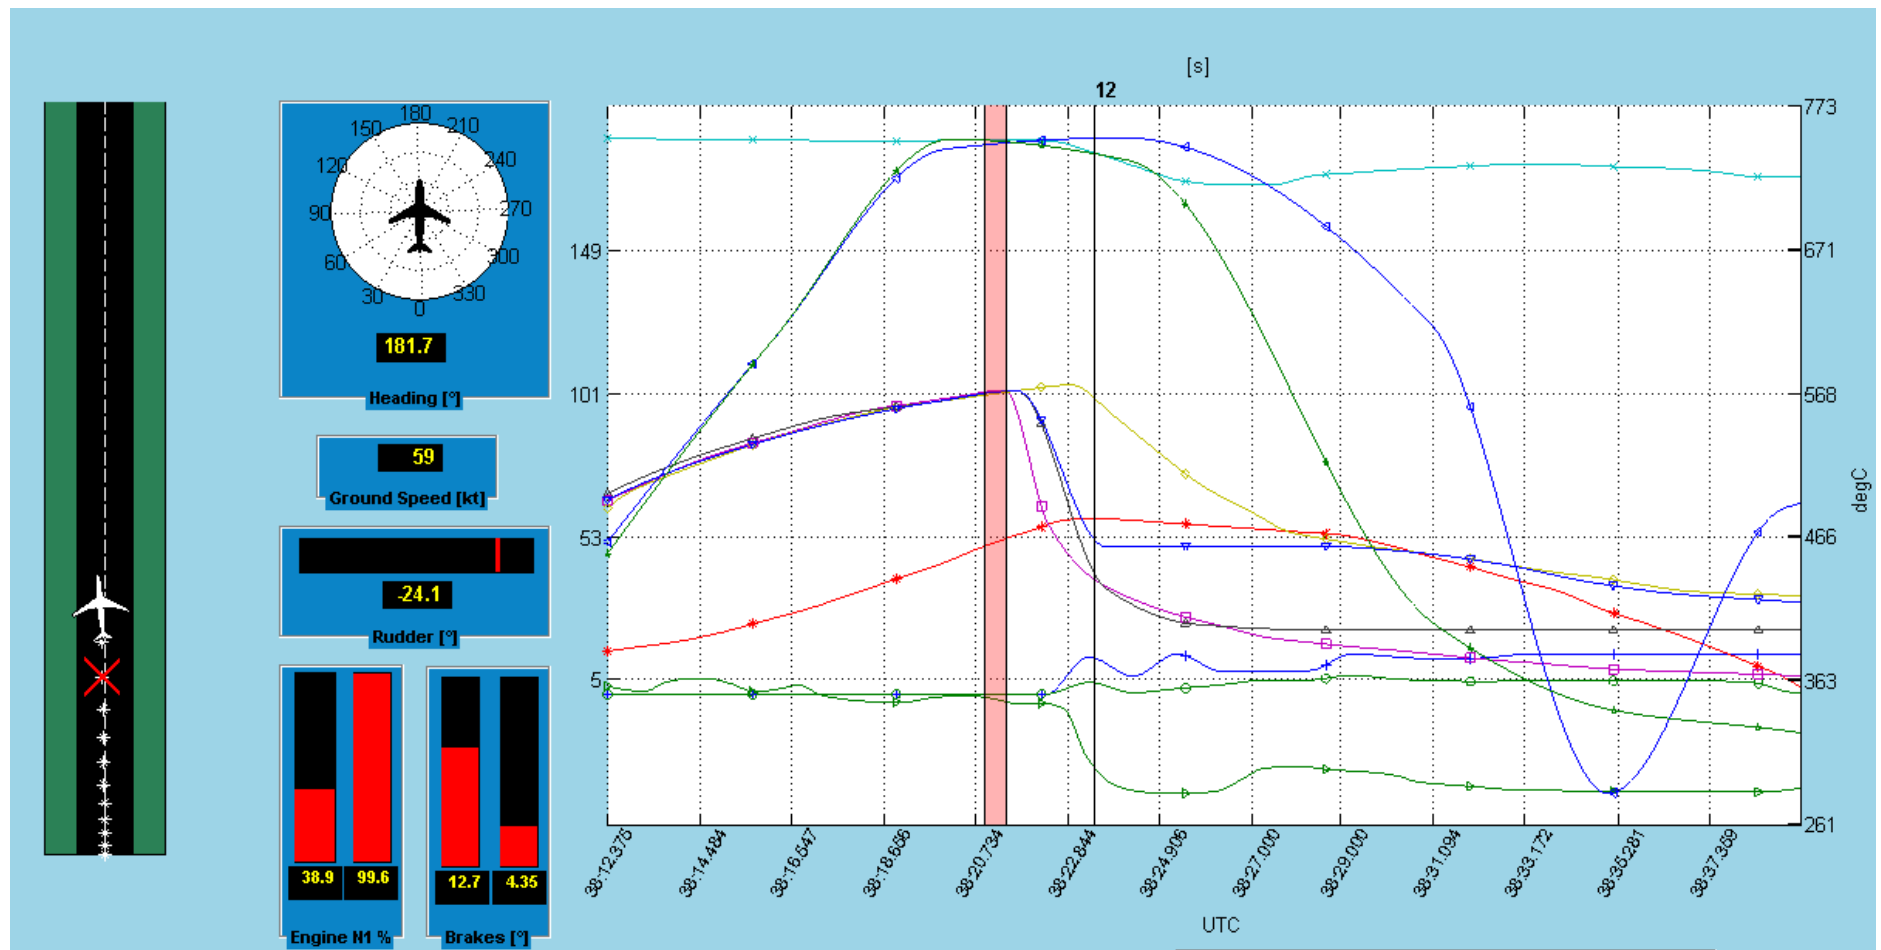
Fig. 5. Approximately 2 seconds after loss of engine power. Based on FDR data.

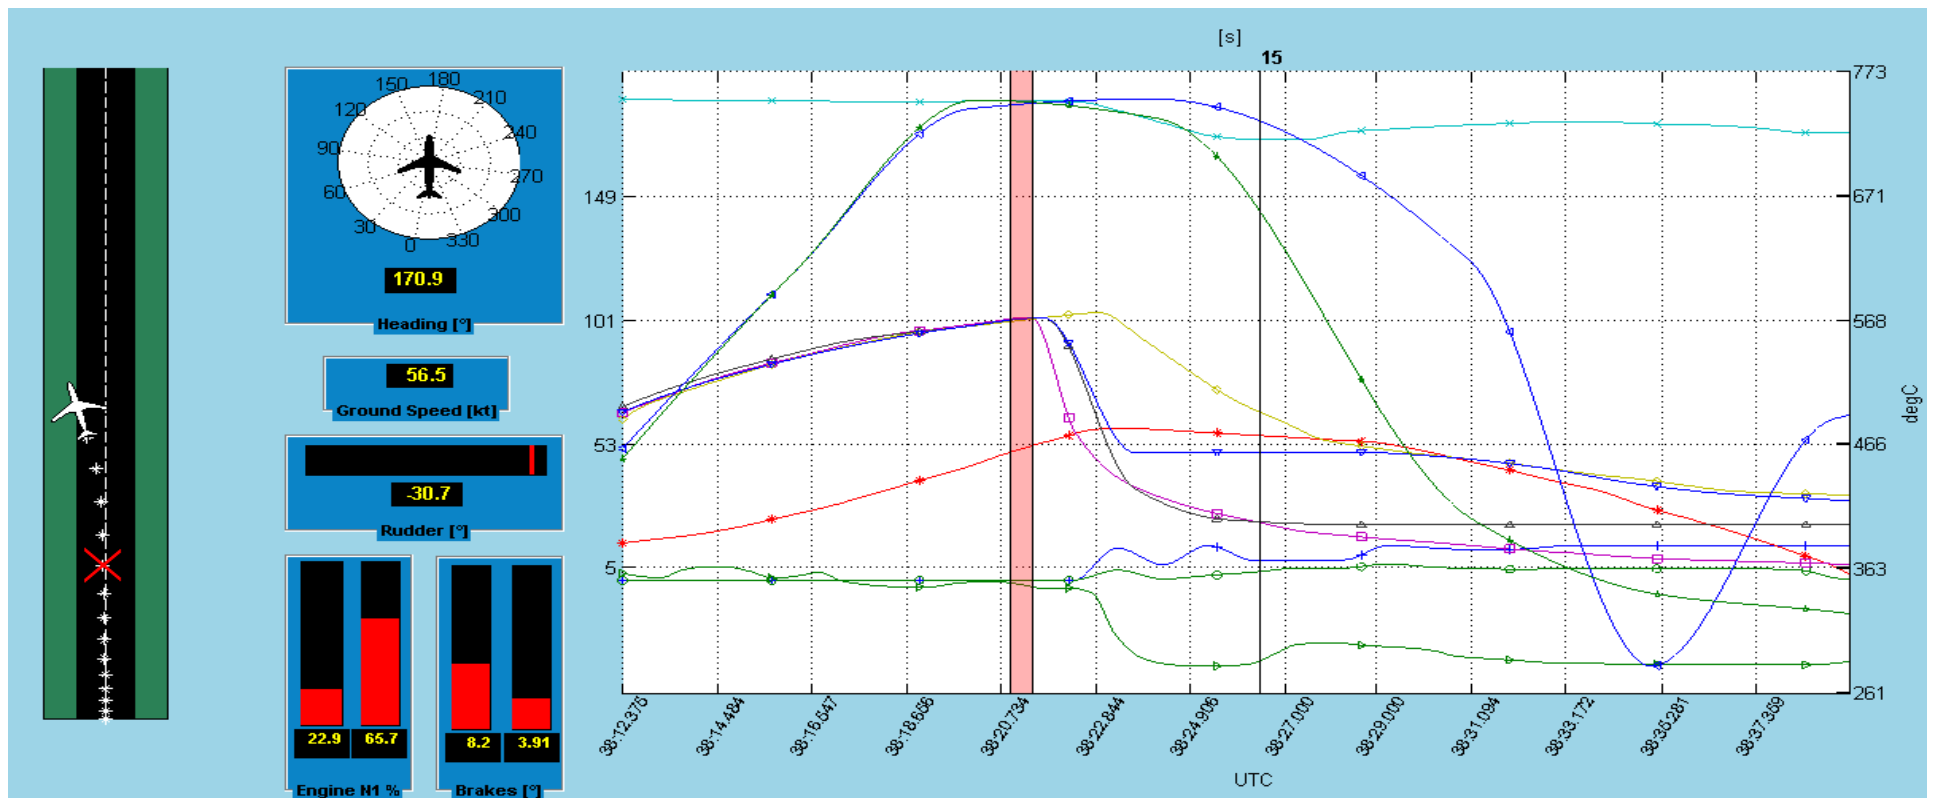
Fig. 6. Approximately 5 seconds after loss of engine power. Based on FDR data.

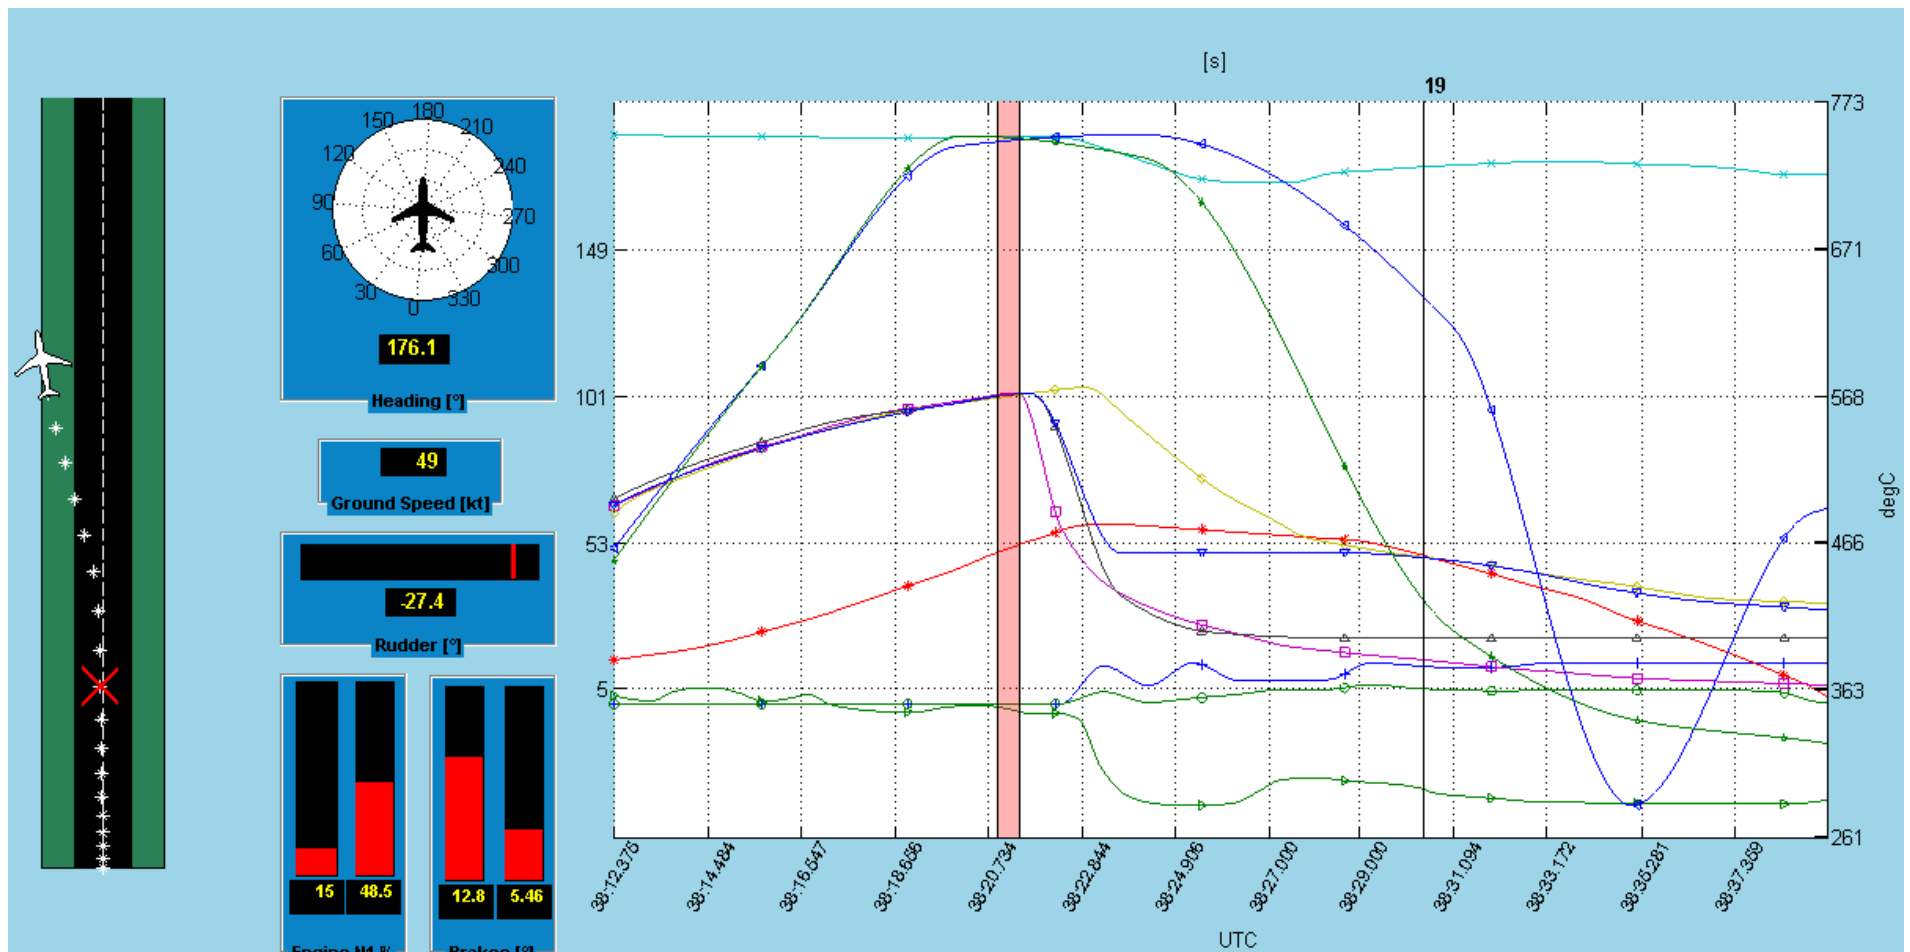
Fig. 7. Approximately 8 seconds after loss of engine power. Based on FDR data.

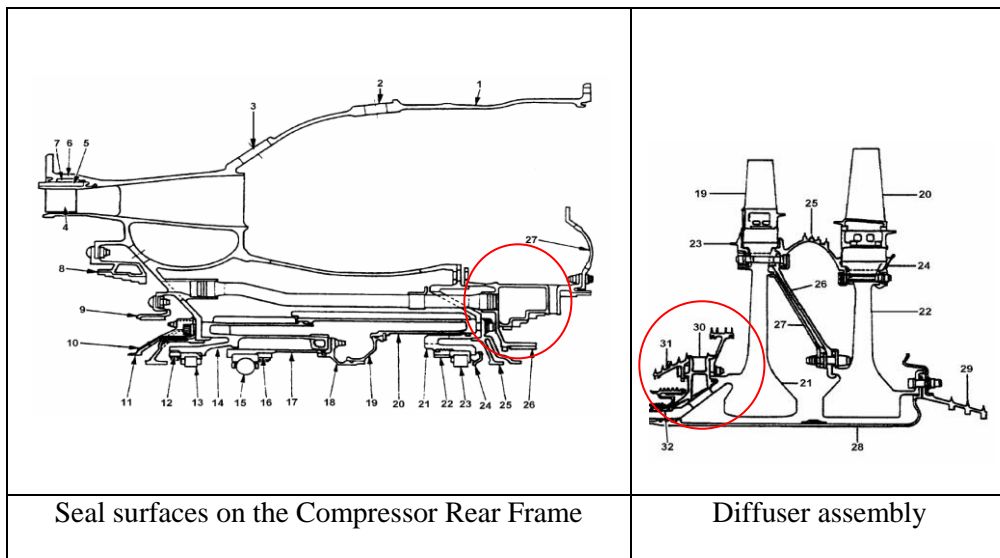
Fig.12. Diffuser Assembly and Compressor Rear Frame.

If the aft air seal separates, seal debris which enters the core flowpath in addition to the loss of pressure balance will result in an engine stall event by the result of the disruptive core airflow. In the investigated incident, the separated debris which entered the core flowpath resulted in significant downstream damage which resulted in high exhaust gas temperature (EGT) and loss of fan speed (N1 system) from the LPT blade damage.

In the drawing below, a red circle marks the static seal surfaces on the Compressor Rear Frame and the rotating Diffuser Assembly on the High Pressure Turbine.

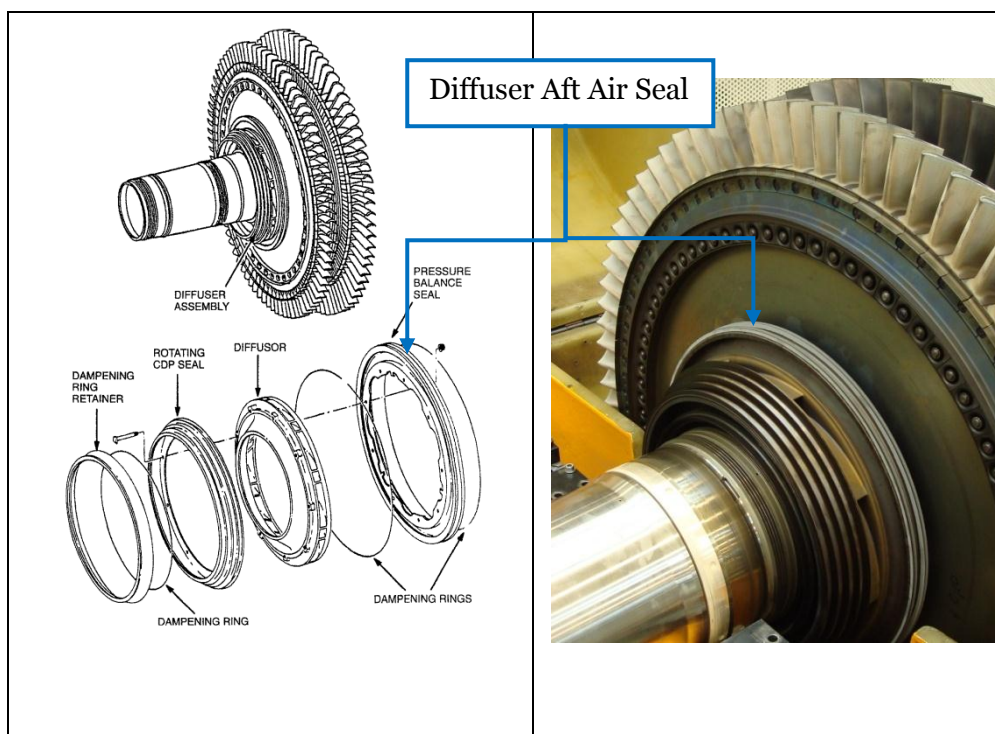
Fig. 13. Diffuser Aft Air Seal.

The seal teeth on the air distributor's aft seal (Diffuser Aft Air Seal), termed Pressure Balance Air Seals (see Fig. 13.), become worn and can in some cases be repaired. Engine Manual section 72-53-07, repair 003, provides a Dabber TIG Weld Repair of the aft seal teeth which adds material to the teeth edges in the form of weld beads on the flange, which are then turned down on a lathe to the correct tooth dimensions. Section 1.18.1 describes the procedure schematically.

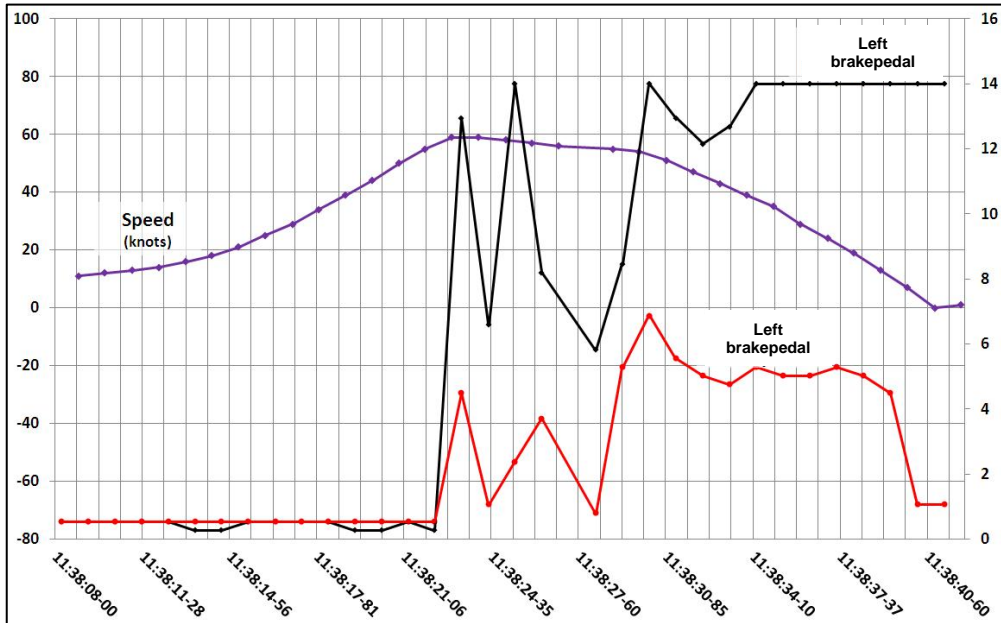
Fig. 21. Brake pedal angles.

From the diagram in Fig. 21, it can be noted that the recorded pedal displacements follow each other at different levels during the sequence, where the right pedal has been recorded with values corresponding to around half of the value for the left pedal.

Maximum displacement has been recorded from the left brake pedal during the final phase until the point when the aircraft stops. During this phase, the value from the right pedal decreases and approaches zero when the aircraft stops.

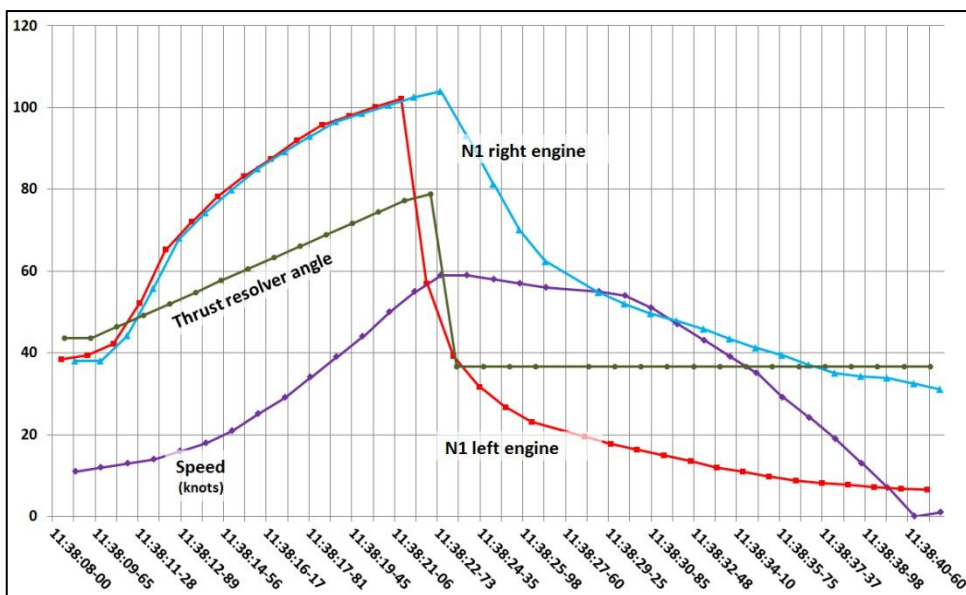
Fig. 22 Rpm N1, throttle angle, aircraft speed.

The engines' rpm N1, thrust lever angle, and the speed of the aircraft are presented in Fig. 22 below. The red line represents the left engine, i.e., the engine that failed.

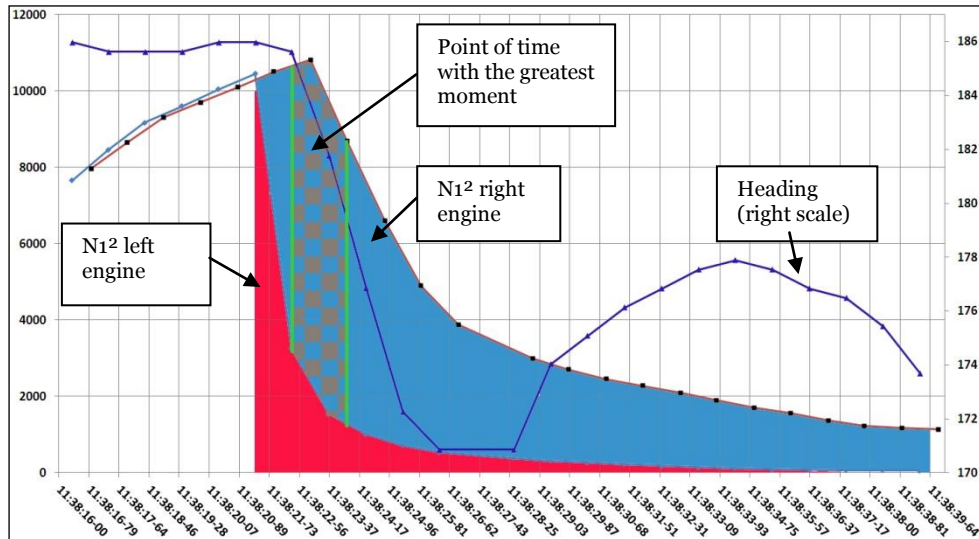
Fig. 23. Illustration of the energy from the engines.

Fig. 23 also shows N1 for the left and right engines, though it is the square of N1 that is presented as this better represents the amount of energy developed by the engines. The red area represents the energy output of the left engine from the loss of engine power until the aircraft was close to a standstill. The blue area represents the energy output of

the right engine over and above that of the left engine, i.e., the energy which contributed to the yawing moment of the aircraft.

The greatest yawing moment was at the time when the right engine's rpm was at its highest, i.e., when the thrust lever angle was reduced to minimum and the right engine's rpm began to decrease. Between 38:22.34 hrs and 38:23.84 hrs, the yawing moment was greatest, followed by a rapid decrease as the right engine's rpm decreased. This area is marked as a checked area in Fig. 23 below.

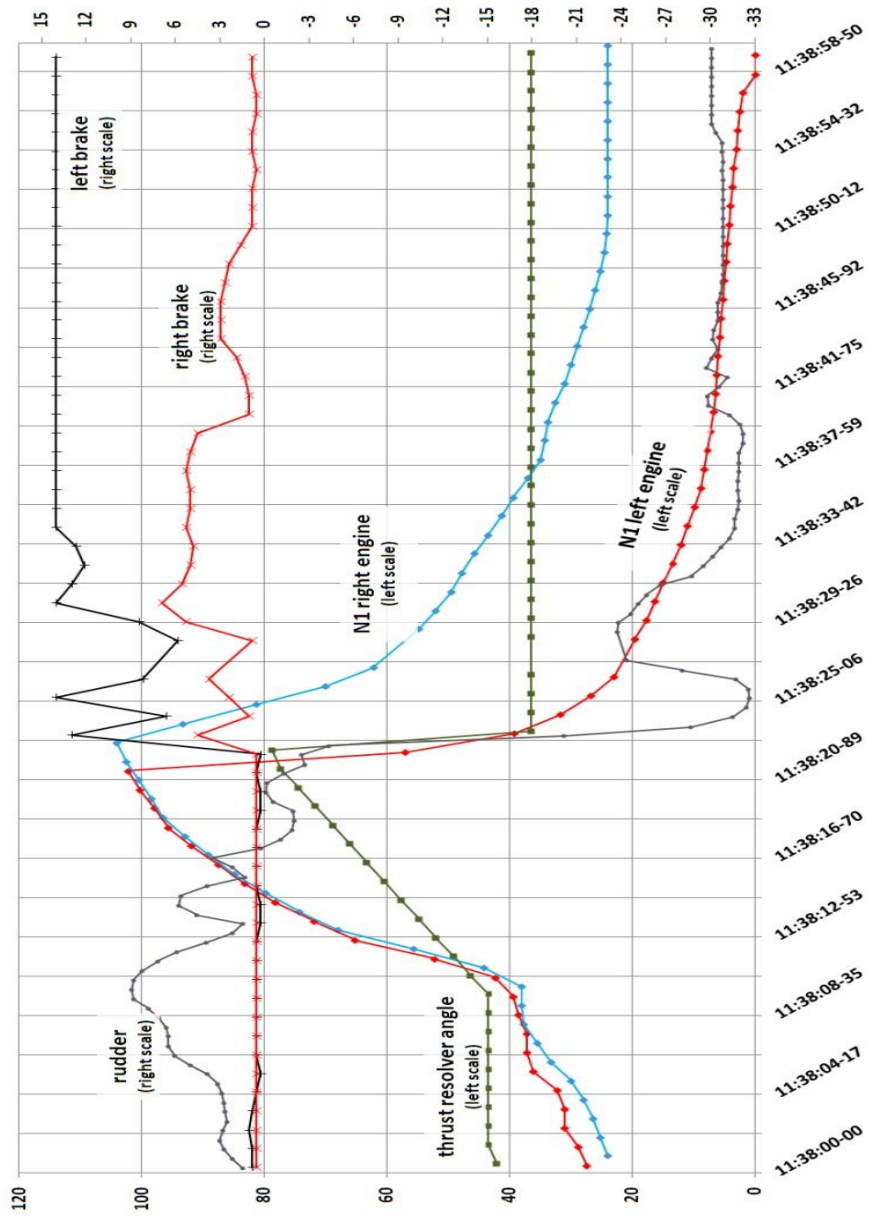
Fig. 24. Data from the FDR.

The point of time for the loss of engine power can be determined by means of the parameters for the aircraft's acceleration, engine speed and fuel flow. As the longitudinal acceleration is recorded at the highest frequency (4 Hz), this parameter provides the best means to establish the point of time. Between 38:21.79 hrs and 38:22.04 hrs, a decrease in the acceleration takes place, i.e., the loss of engine power begins at 38:21.79 hrs at the earliest and at 38:22.04 hrs at the latest.

The enlarged diagram overleaf – Fig. 24 – illustrates the times with raw data from the FDR at the time of the loss of engine thrust itself, from 38:21 to 38:25. The first point on the N1 line is also the highest point (102.25%).

Among other parameters which could be noted from the FDR readouts, it can be seen that aileron was applied (the steering wheel on the steering column was moved to the right),

and that the steering column was pulled back a little. These actions were initiated when the aircraft had already begun the veer to the left.

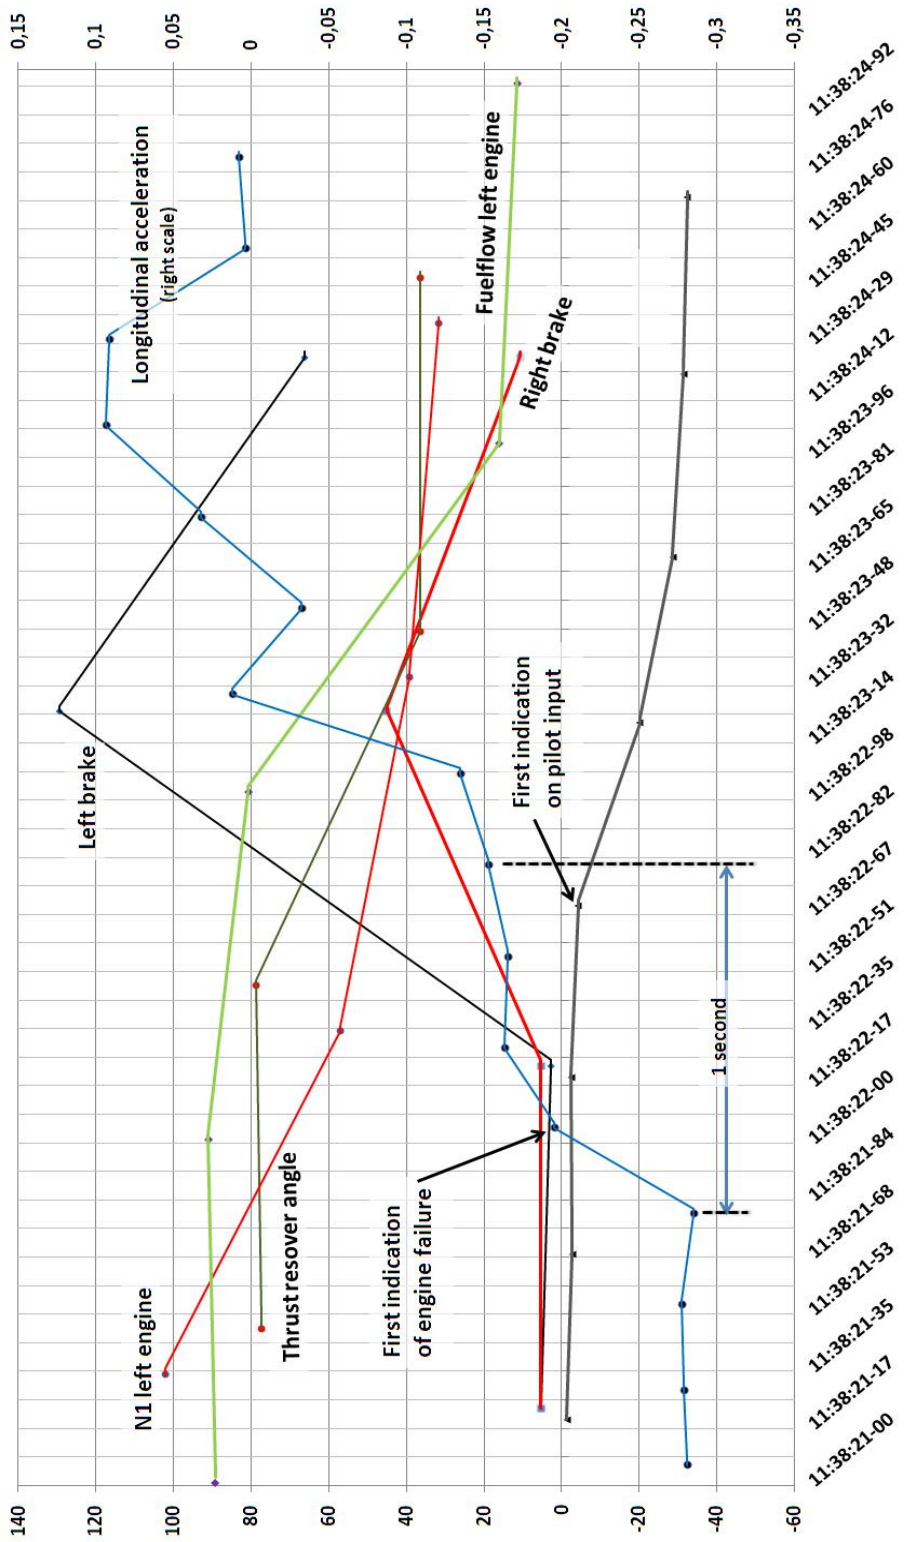
Fig. 25. Data from the FDR.

The pilots' reaction to the loss of engine thrust can be seen in the thrust lever angle, rudder and the brake pedal angles. The pilots' reaction begins at 38:22.18 hrs at the earliest (rudder) and at 38:22.68 at the latest (rudder position recorded at 2 Hz, i.e., two times per second). At 38:22.18 hrs, the rudder passes -20° (turn right). The first value recorded when the brake pedals had begun to be used is at 38:23.25 hrs (they are recorded at 1 Hz). The left brake pedal was at that point depressed at around 92% of maximum displacement, and the right pedal at around 29%. The thrust lever angle is recorded at 1 Hz, and at 38:22.46 hrs, the thrust lever positions were still unchanged. At 38:23.46 hrs, the thrust levers had been retarded down to ground idle. The sequence can be seen in Fig. 25.

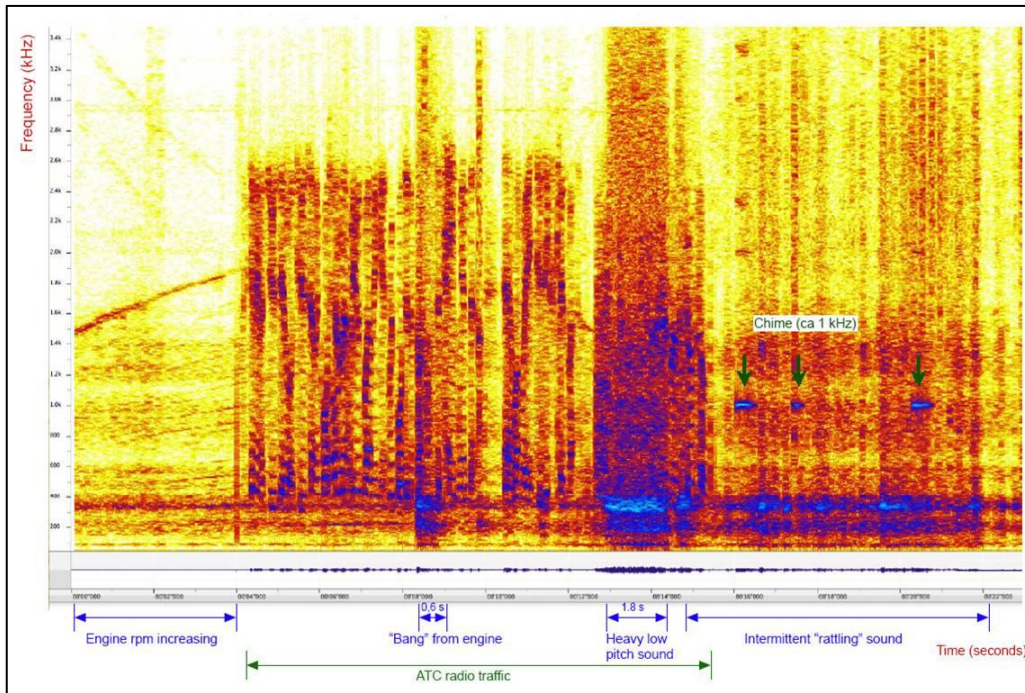
Fig. 27. Sonogram from channel 2 of the CVR. Graphics: Magnic AB.

The sonogram describes how sound can be visualized in the frequency plane, with time on the horizontal axis, where in addition to the “bang”, the low-frequency sound recorded approximately 4.5 seconds after the engine failure can also be noted.

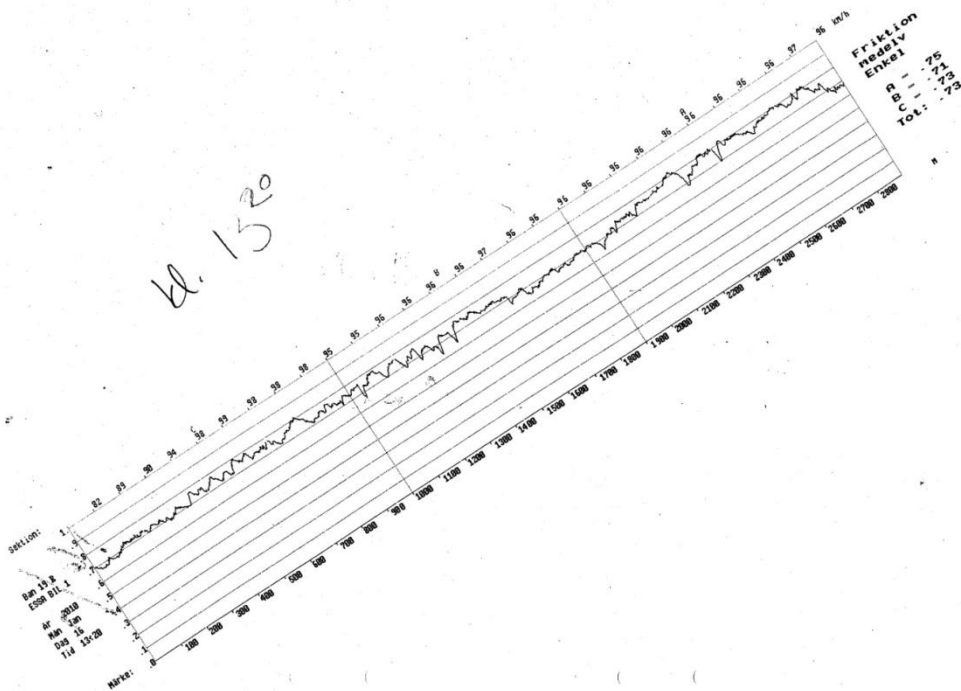
Fig. 33. Friction measurement at 13.20 hrs on runway 19R.

Approximately 35 minutes after the incident, a new friction measurement was carried out on runway 01L/19R, Fig. 33. This friction measurement shows generally higher values, 75, 71 and 73 for the respective sections and a mean value of 73. The difference between the highest and lowest friction values was on that occasion approximately 19.

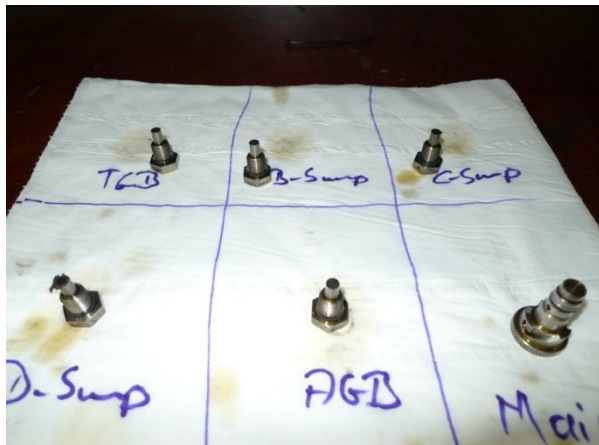
Initially, before the sequence of the engine failure was clarified, impurities in the oil system were a lead in the investigation. Inspection of the chip plugs⁴⁶ gave a clear indication that the oil system was not contaminated and that no bearing race was on the way to being damaged.

Fig. 41. The oil system's chip plugs; only the D sump (LPT) plug had traces of magnetic material. The number of chips was normal for the operating time. Photo: SHK.

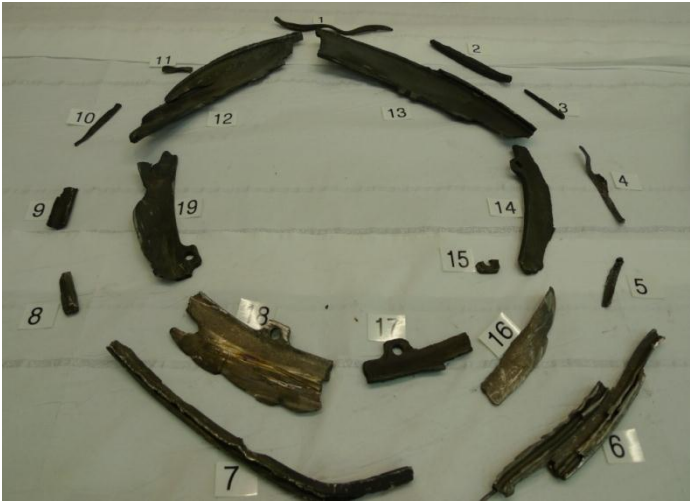
After the engine components behind the high pressure turbine's guide vanes had been removed, a number of issues arose. Apart from the diffuser aft air seal, see Fig. 42, there was a need to analyse the sequence of failure on the high pressure turbine blade bolts in stage one (Hook bolts), the high pressure turbine stage one (3 blades were inspected), the bolts which hold the aft and forward diffuser seals and a number of fragments from the oil system's D sump.

Of the parts analysed, it was discovered that the majority had secondary damage and that the sequence of failure on the diffuser aft air seal was the primary damage in a sequence of failure that is unknown at this time. LHT concluded that the seal came loose due to micro cracks in the nine attachment lugs that hold the seal against the diffuser. The attachment lugs are to have come loose, and the ring to have expanded radially outwards and come into contact with the stationary honeycomb seal. See Fig. 42.

Neither GE, SHK nor Volvo Aero (VAC) were in agreement with the LHT's conclusions in this regard.

Fig. 42. Fragments of the diffuser aft seal analysed by LHT.
Photo: LHT.

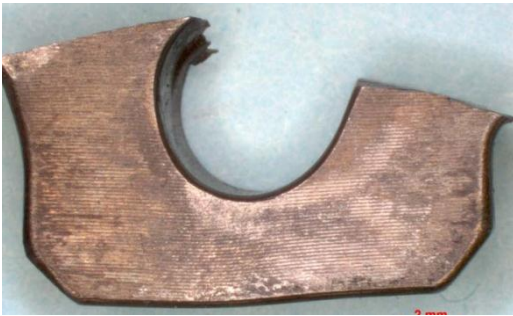
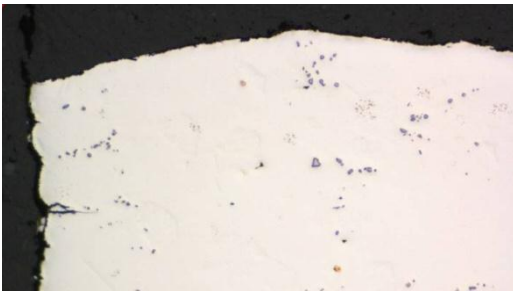
Fig. 43. Cross sections of the attachment lug with micro cracks, diffuser aft air seal. Photo: LHT.

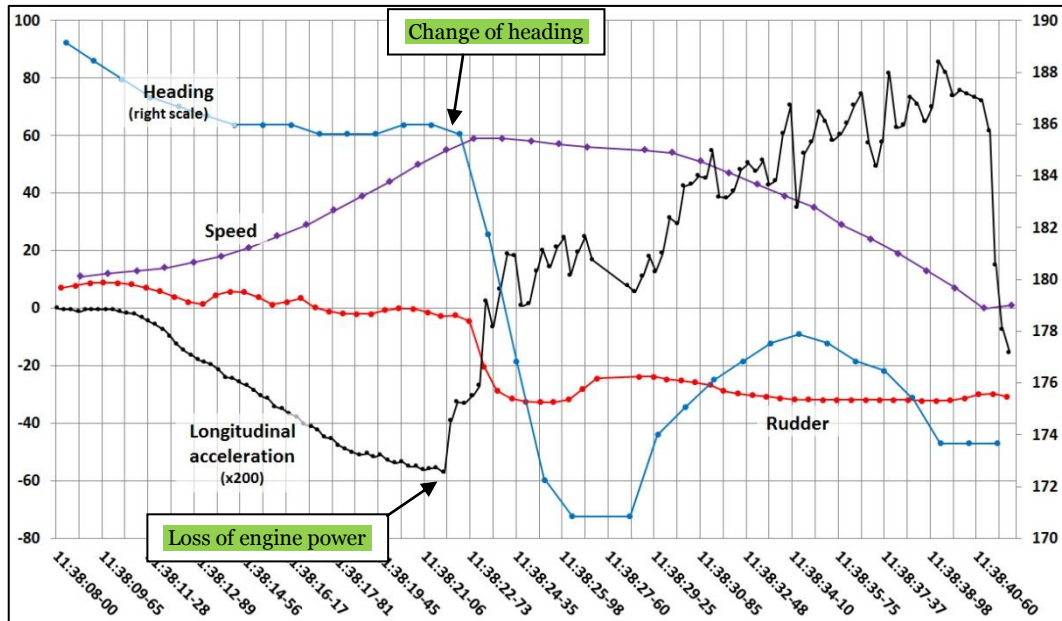
Fig. 53. Data from the FDR. (See also fig. 19.)

Following evaluation of the available parameters, SHK has chosen to use the decreasing acceleration as an indicator of the point in time of the engine failure. According to this parameter, the point in time of the engine failure can be established at 38:21.9 (± 0.12 seconds). Apart from the higher frequency at which the values were recorded, this parameter can be verified in comparison with other data from the engine. In other words, the time of the engine failure has been determined as the point in time when the acceleration decreases due to reduced thrust from the left engine.

However, because the rudder deflection (see Fig. 53) is a pilot induced reaction to the change of heading, the latest point in time for the change of heading cannot be after the latest time of the rudder deflection. This reduces the possible interval for the change of heading to have taken place to between 22.46 and 22.68.

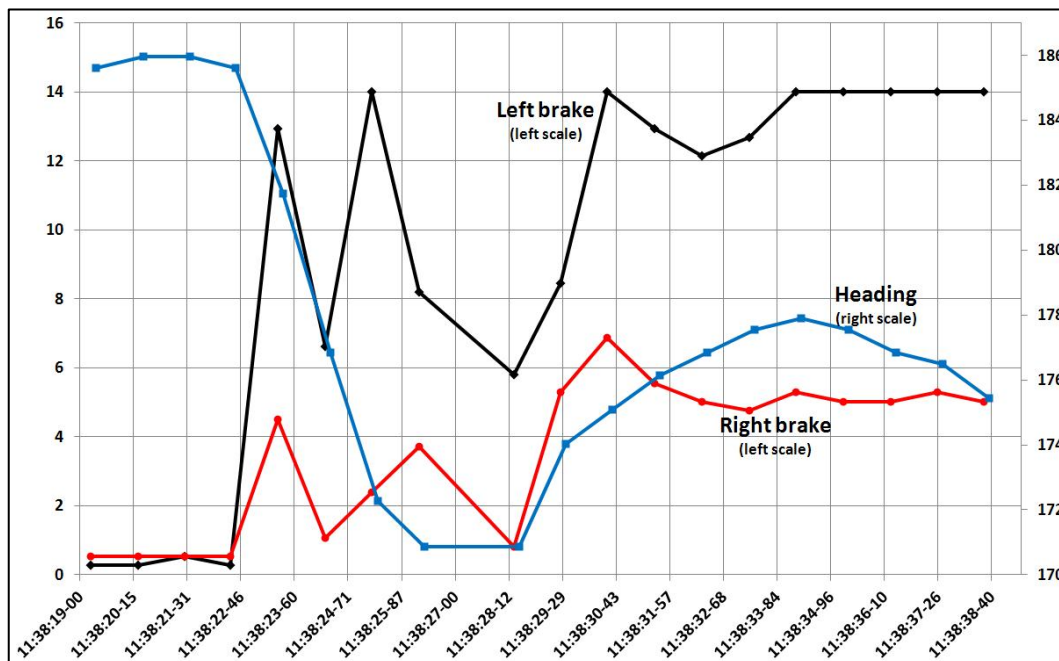
Fig. 55. Brake angles vs change of heading.

As can be seen from the graphical presentation in Fig. 55 above, the main change of heading – and the rate of the change of heading of approximately 4° per second – has not changed discernibly compared with the asymmetric braking values recorded during the same period. The first recorded change of heading began before the first recorded brake angle increases. After this first heading change, the heading follows an almost linear

The overall conclusion is that no measurable variation of the heading change rate is observable in connection with the recorded brake values. Even though the possibility that the asymmetric braking had a certain effect on the turning moment cannot be excluded, such an impact has, however, not been possible to determine with any reasonable degree of certainty.

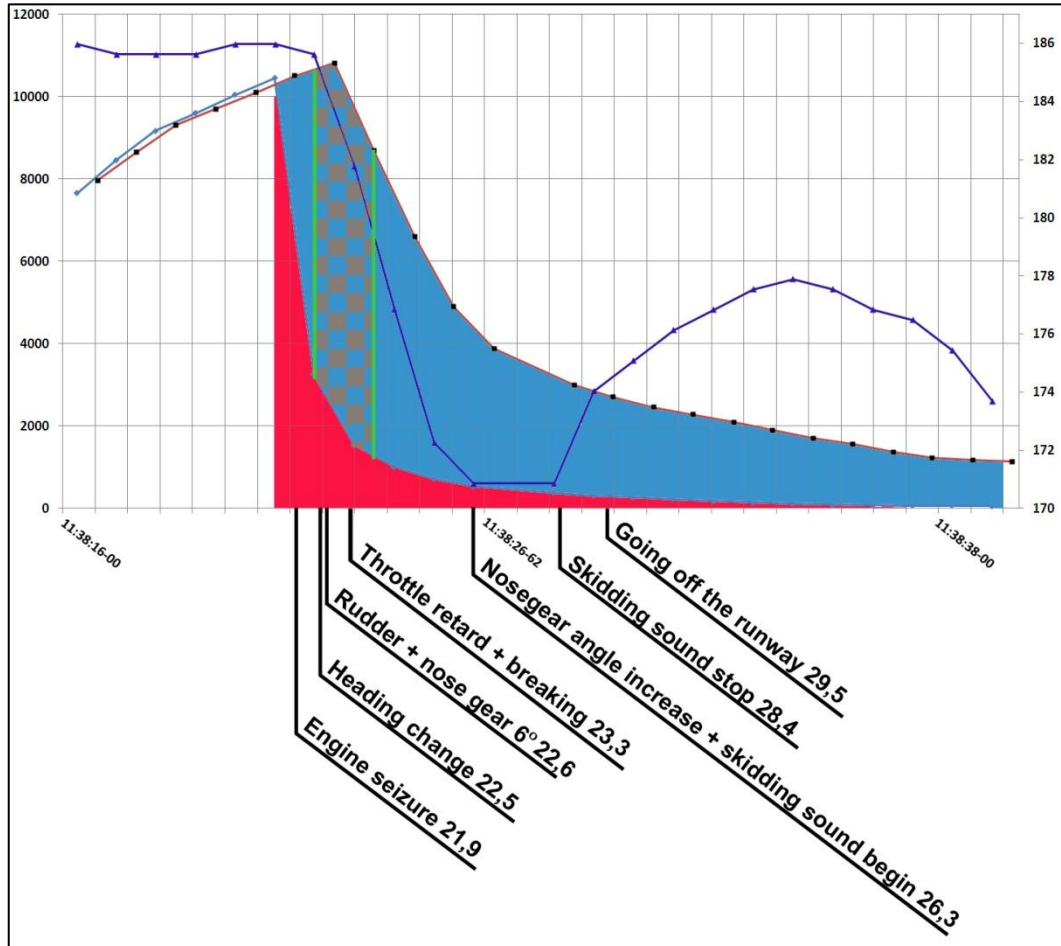
Fig. 56. Illustration of the energy from the engines including timeline. See also fig. 23.

In the diagram in Fig. 56, relevant data from the FDR, with the area of high yawing moment inserted, has been combined with the analysed timeline of the incident. The diagram shows clearly that the force from the excess moment from the situation of asymmetric thrust almost immediately produced the veer.

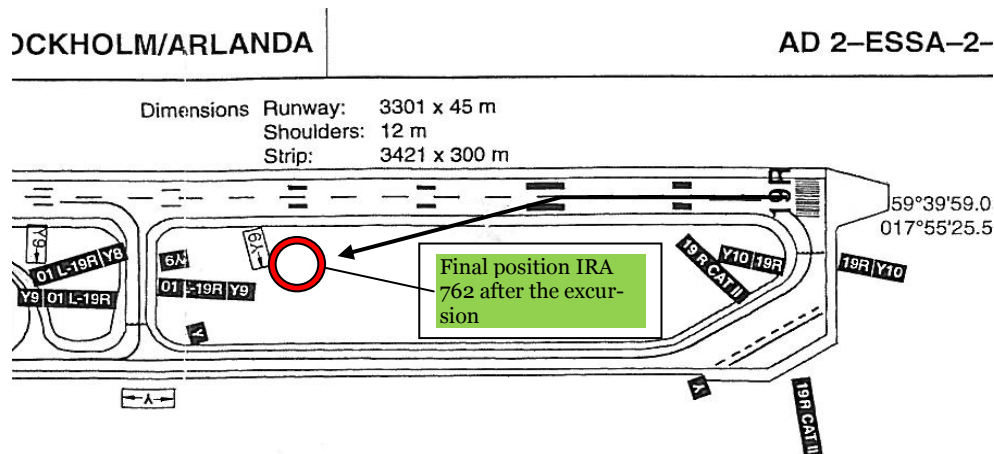
Fig. 59. Overview of the incident area at the airport.

Had the incident occurred just a few seconds later, the aircraft would most probably have run onto taxiway Y9. At the holding point on this taxiway, aircraft are often lined up awaiting take-off. On average, 40% of all take-offs from runway 19R are carried out from the intersection at taxiway Y9.

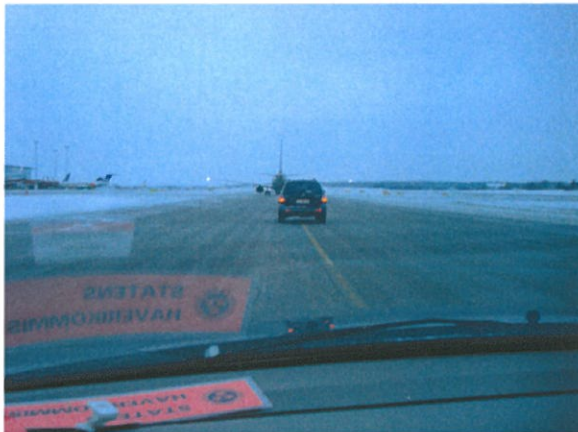
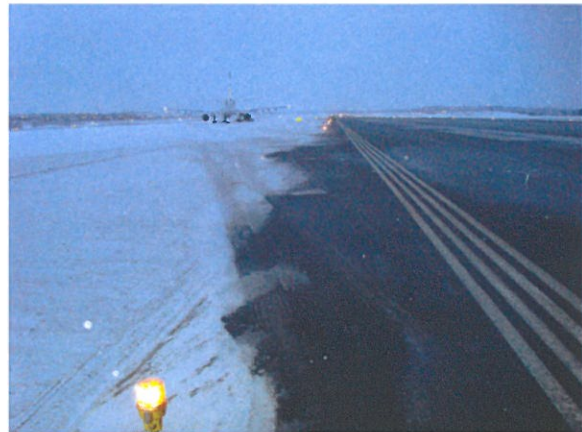
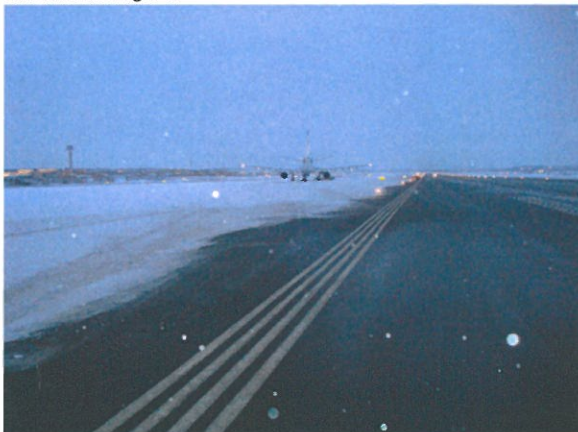
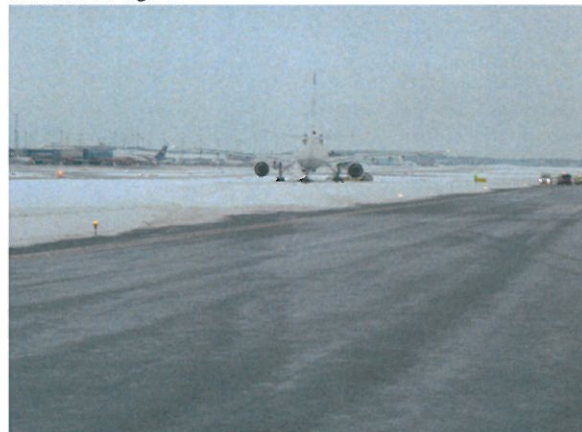
Figur 1. De fyra digitala fotografierna.

Bilderna DSC01834.JPG och DSC01835.JPG visar rullbana som mörkare än på bilden P1020238.JPG. Detta skulle kunna bero på att bilderna är tagna med olika kameror som exponerat bilderna olika. På bilderna iaktogs vita molnliknande områden på asfalten samt mörka hjulspår i dessa, se figur 1. Även ljusa hjulspår har iakttagits i de mörkare områdena på körbanan. Dessa observationer förväntas i större utsträckning om det är snö, is eller slask på rullbanan än om rullbanan är fri från beläggningar.

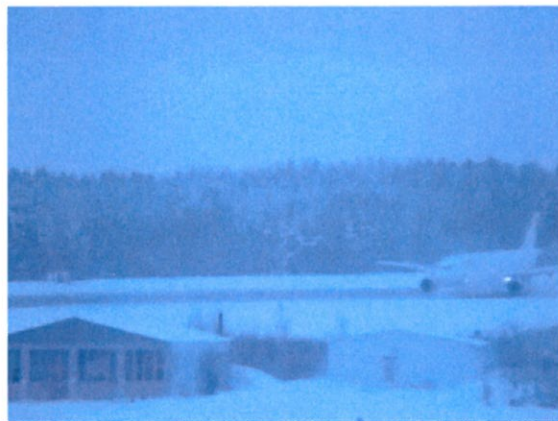
För att det ska vara möjligt att bedöma om snömolnet uppstår innan flygplanets hjul lämnar banan krävs det att båda banan och planetes hjul är tydligt synliga i filmerna. I detta fall är filmernas kvalitet av sådant slag att laboratoriet inte kan uttala sig i frågan.

Figur 2. Bild från "Video takeoff.mp4" när planet lämnar banan.
