Final report RL 2012:21e

**Serious incident on 16 of January 2010 to
aircraft EP-IBB at Stockholm/Arlanda
Airport, Stockholm county, Sweden**

Ref.no. L-02/10

2012-12-28

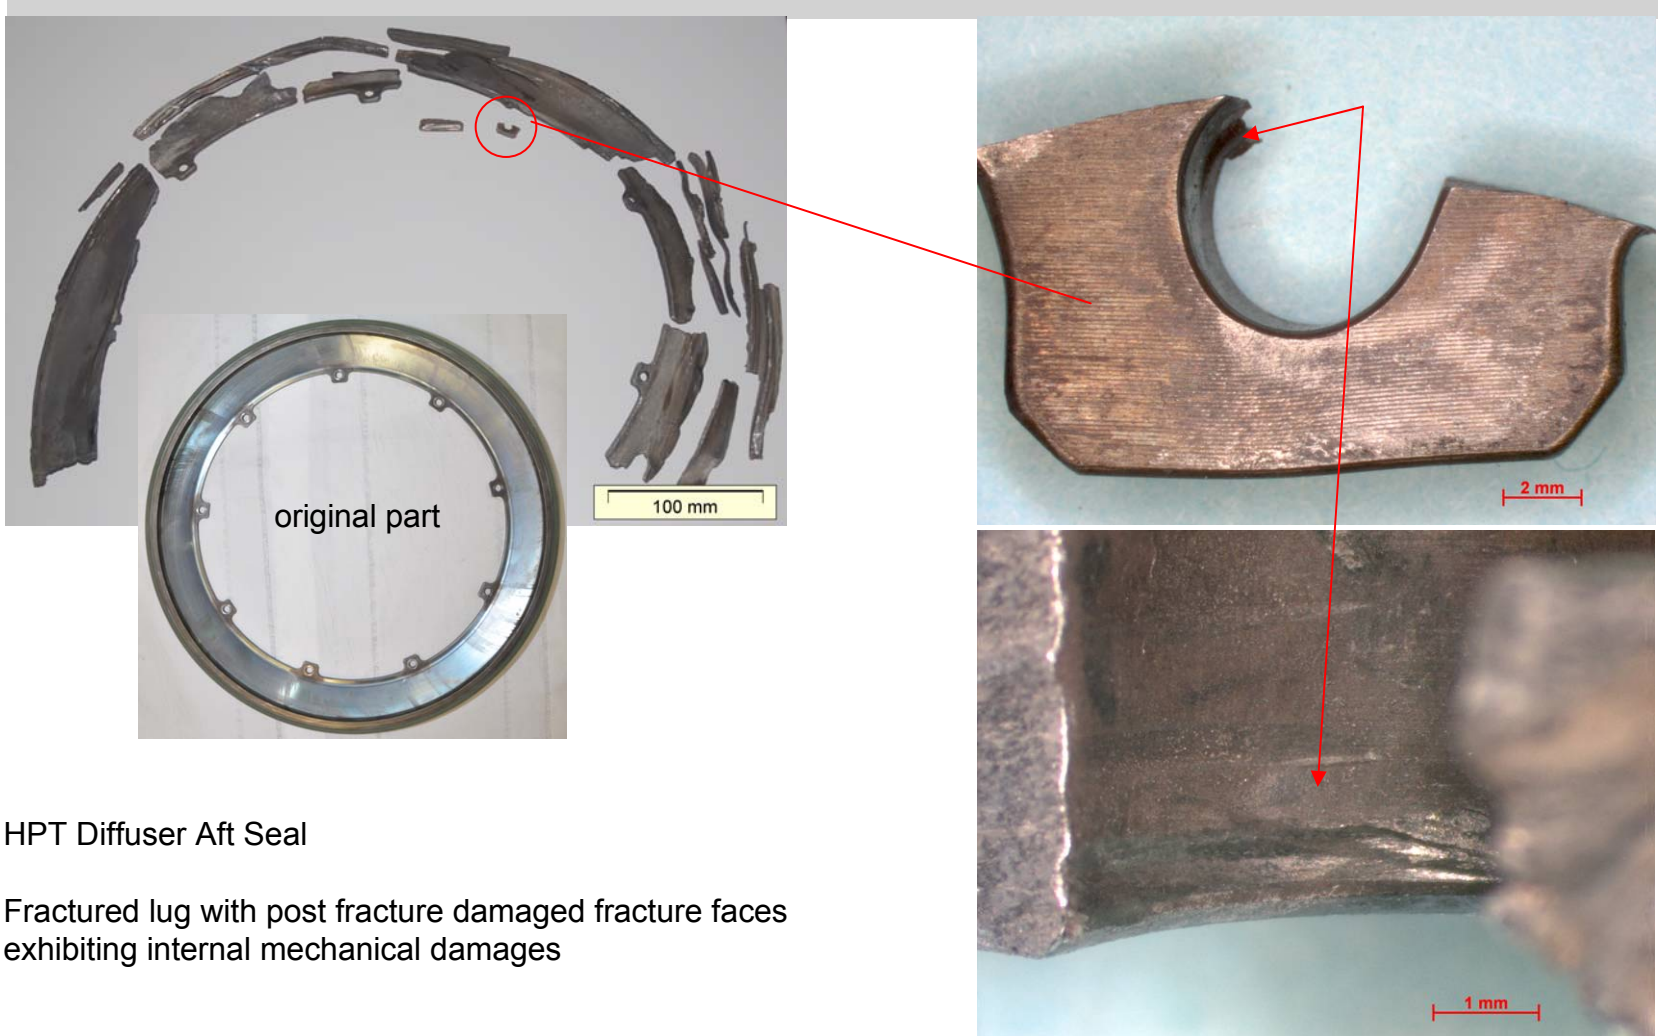
HPT Diffuser Aft Seal

Fractured lug with post fracture damaged fracture faces exhibiting internal mechanical damages

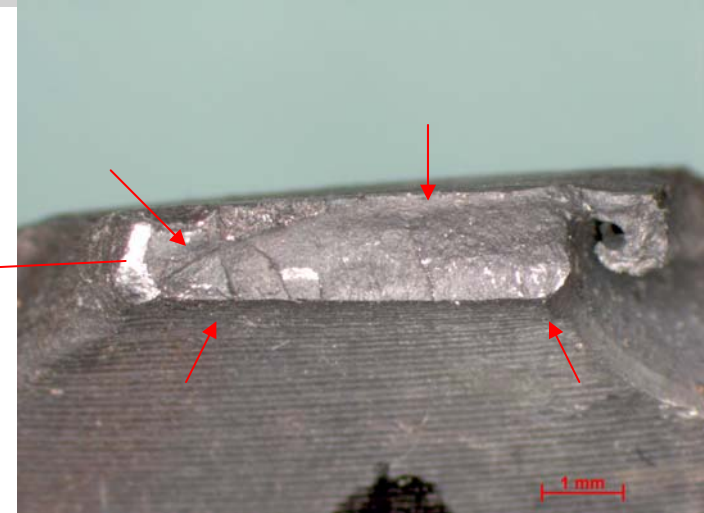
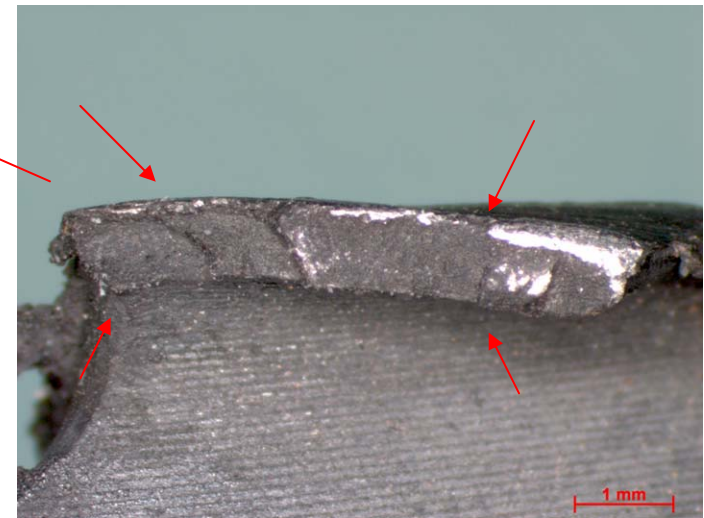
HPT Diffuser Aft Seal

Fractured lug with fatigue fracture indications

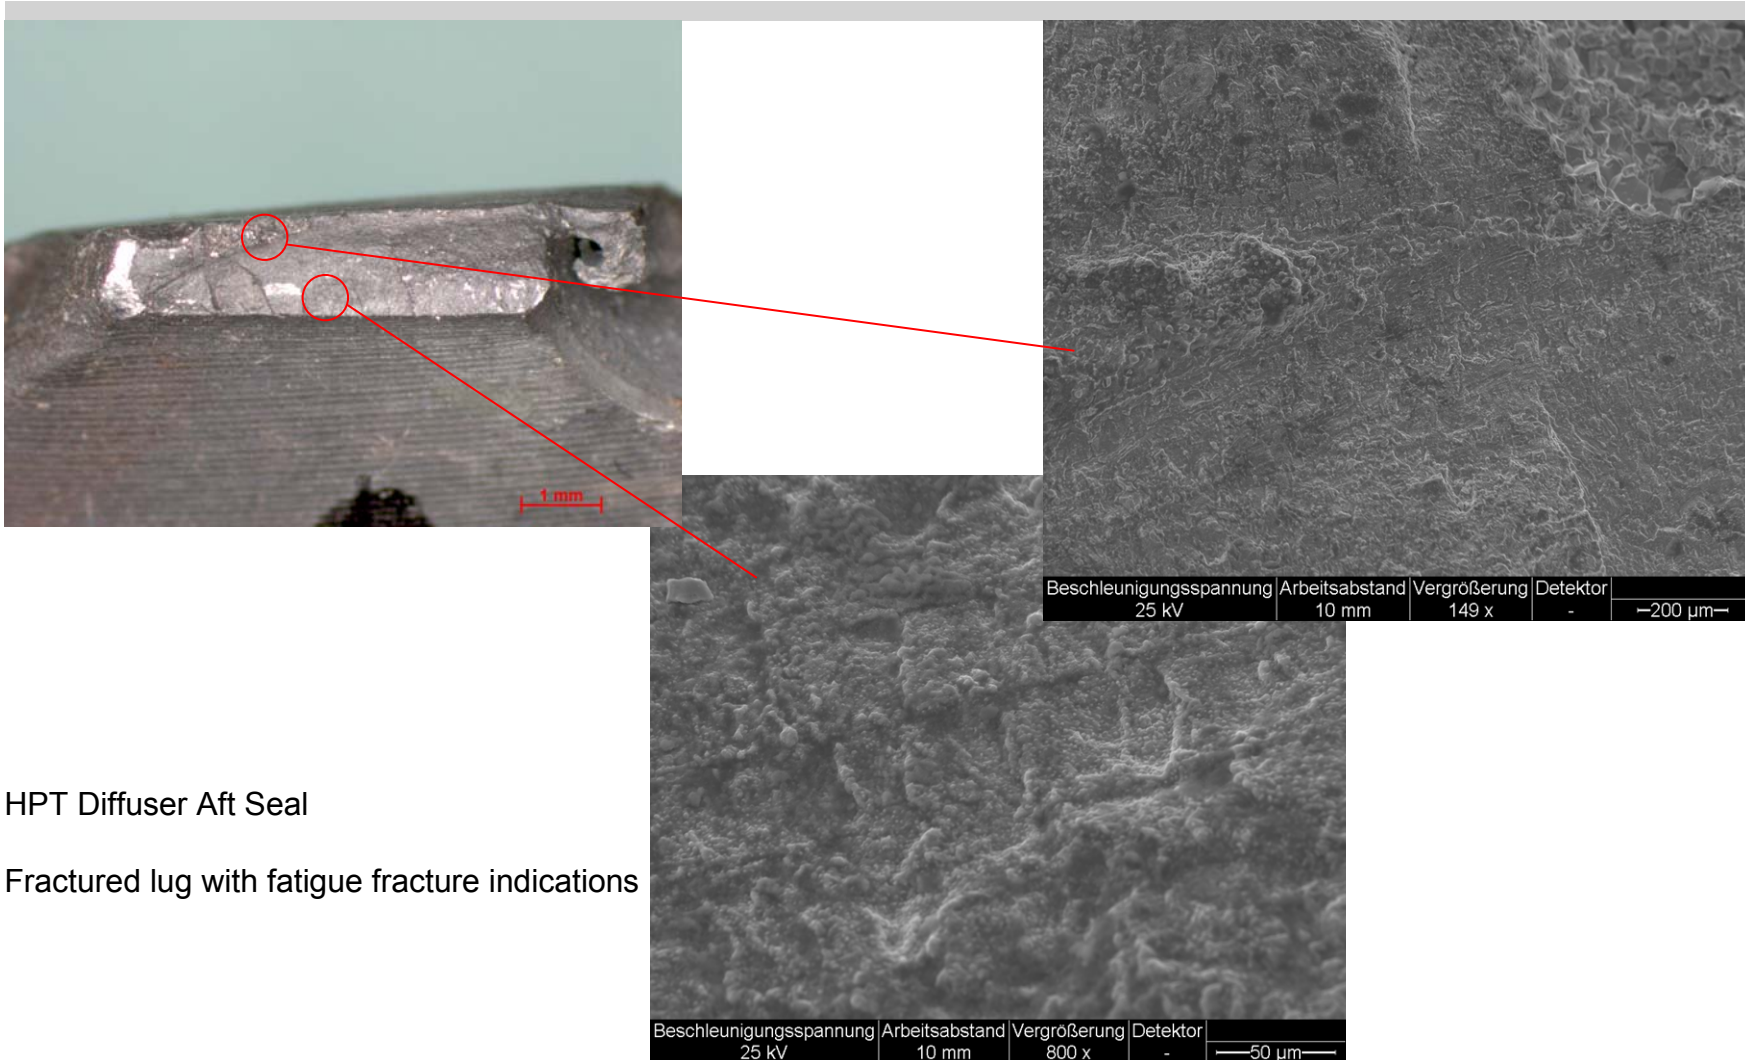
HPT Diffuser Aft Seal

Fractured lug with fatigue fracture indications

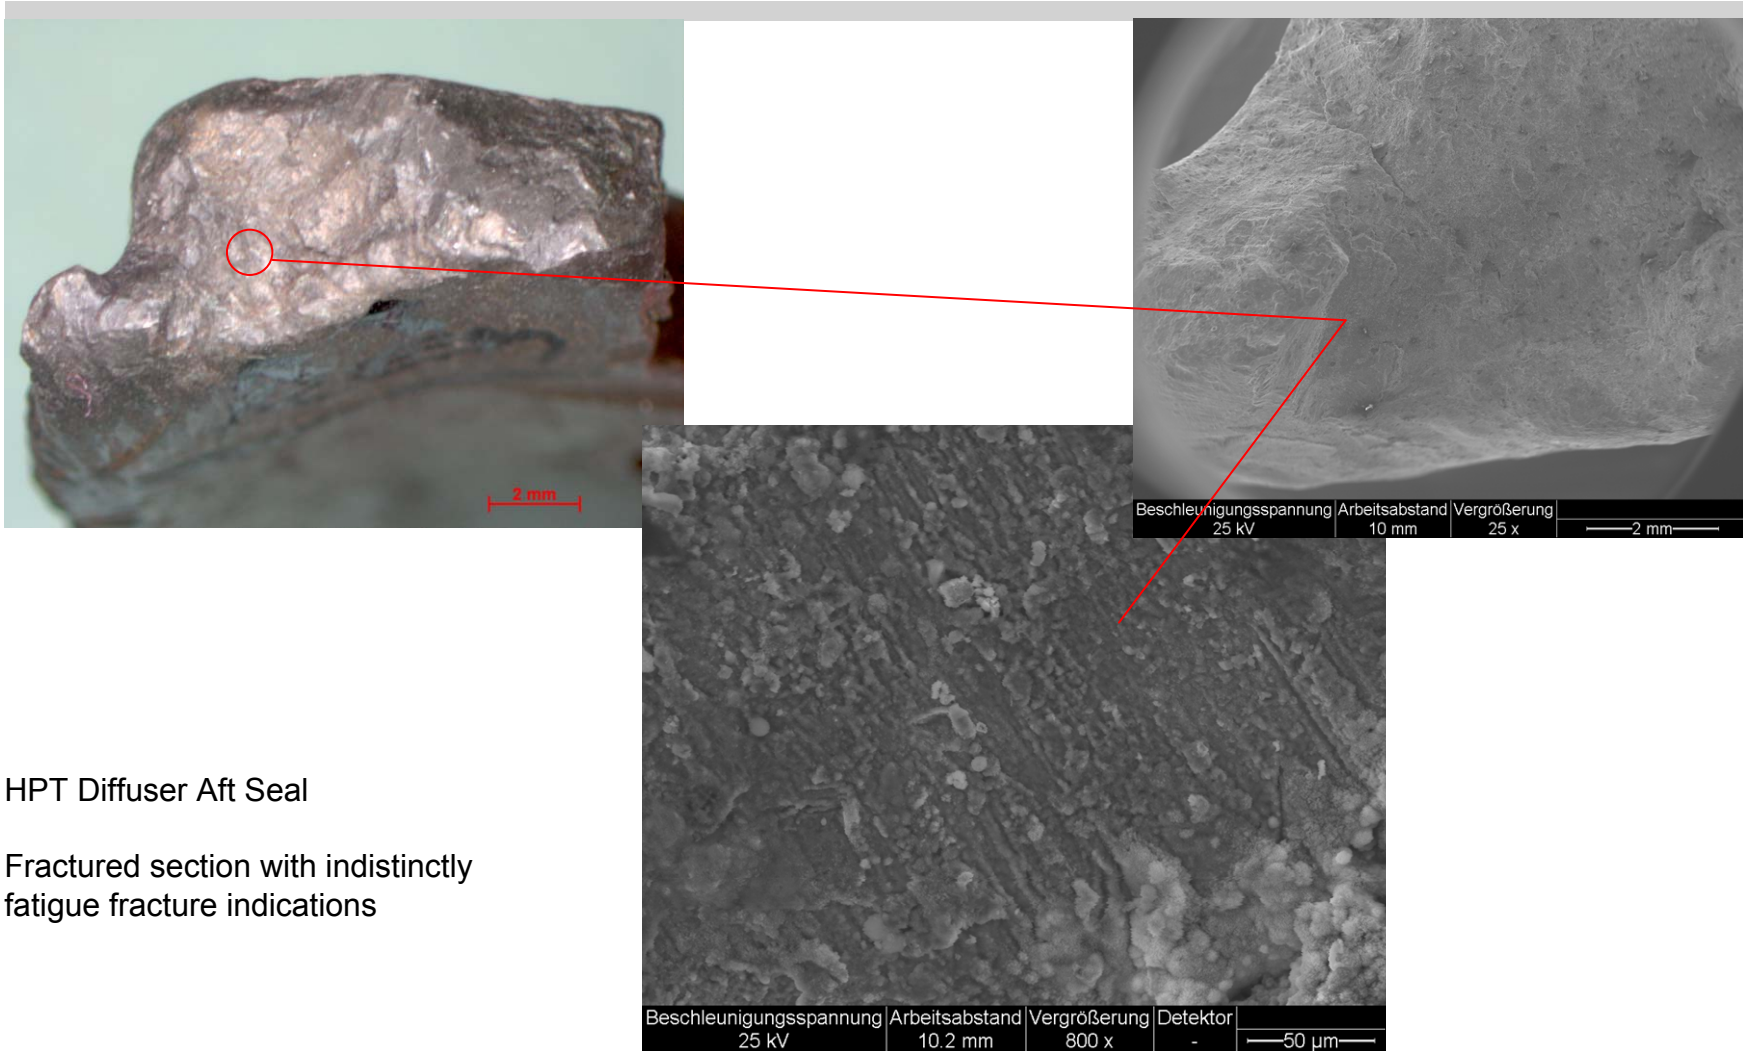
HPT Diffuser Aft Seal

Fractured section with indistinctly
fatigue fracture indications

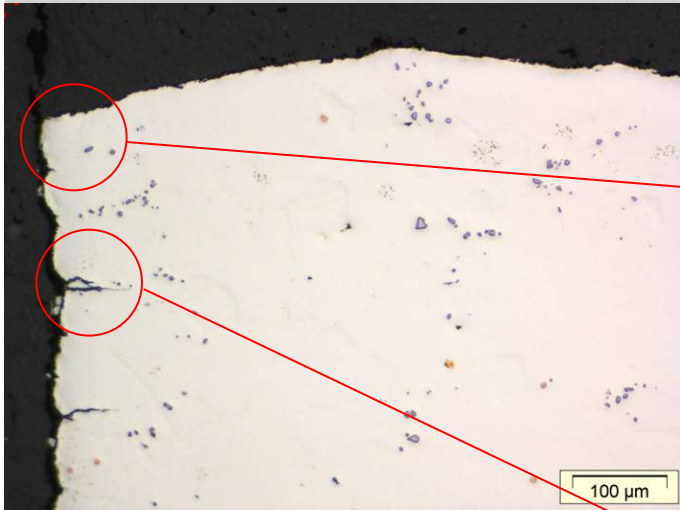
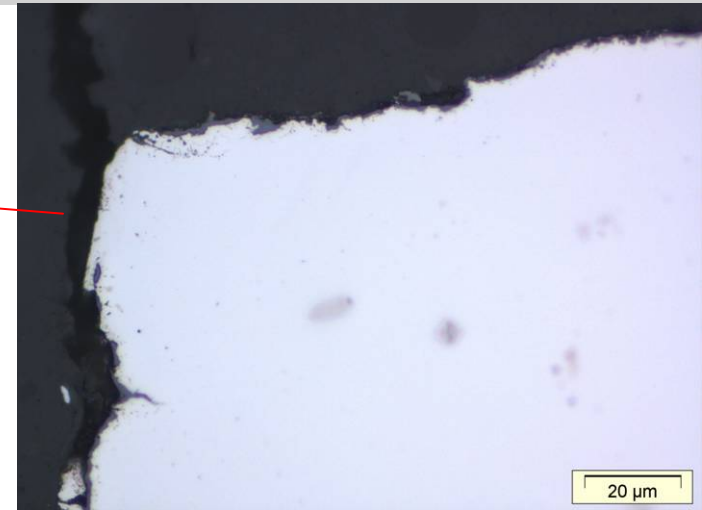
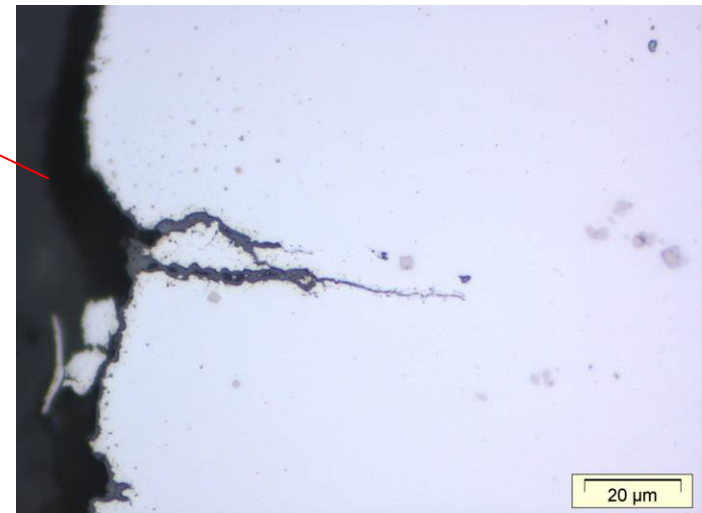
HPT Diffuser Aft Seal

Lug fracture origin exhibiting thermal fatigue and secondary thermal fatigue cracks next to fracture origin

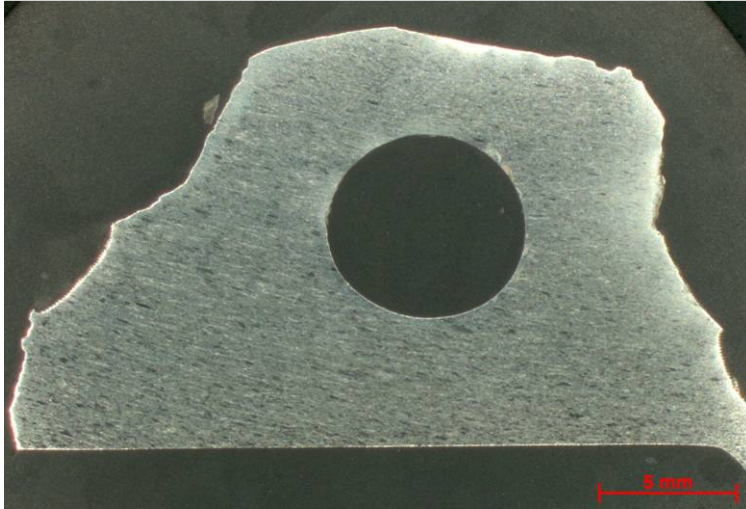
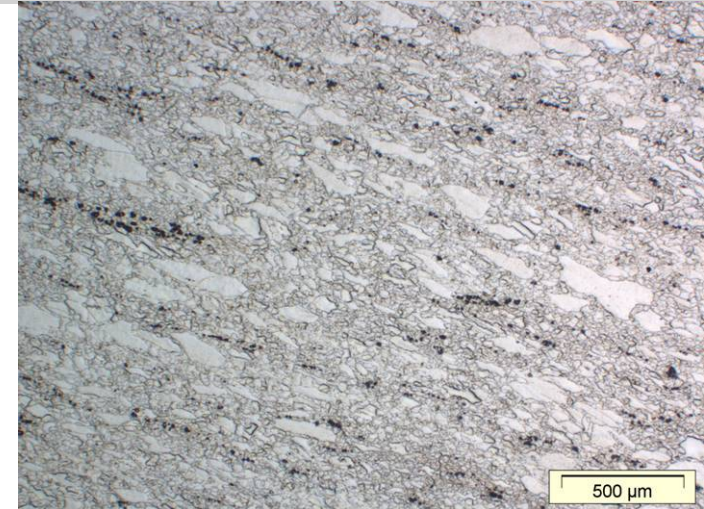
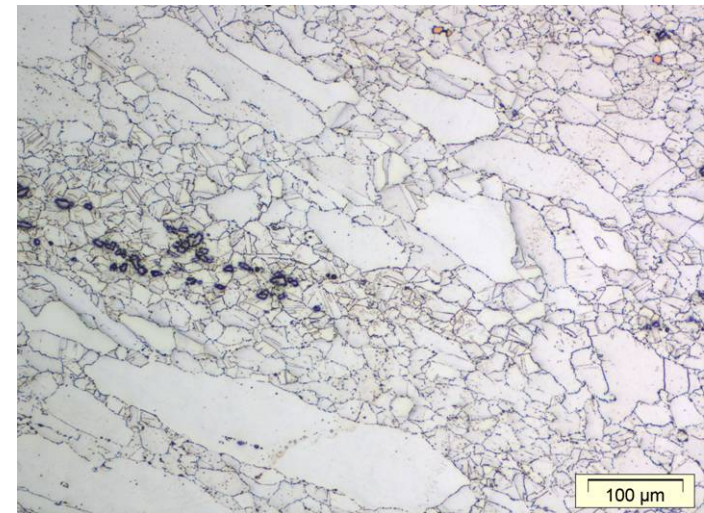
HPT Diffuser Aft Seal

Slightly ovalized seal lug (top left)
and general microstructure (right)

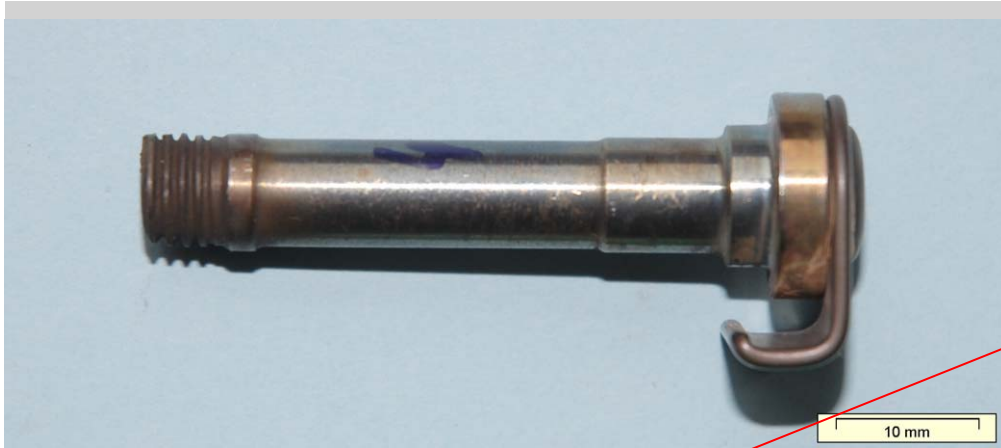
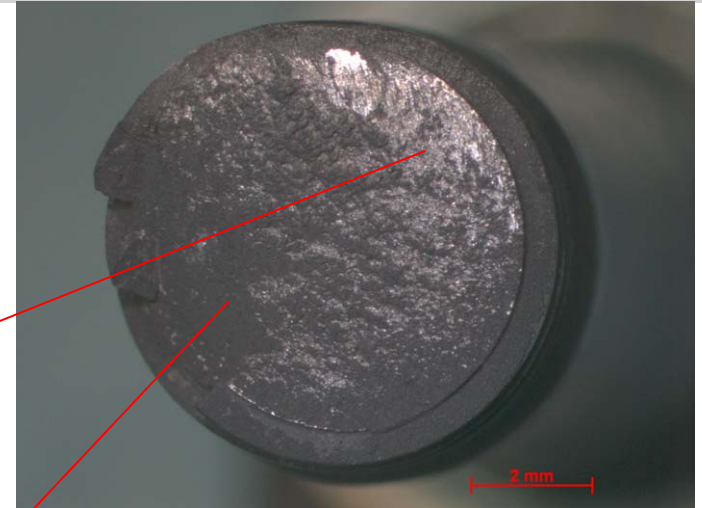
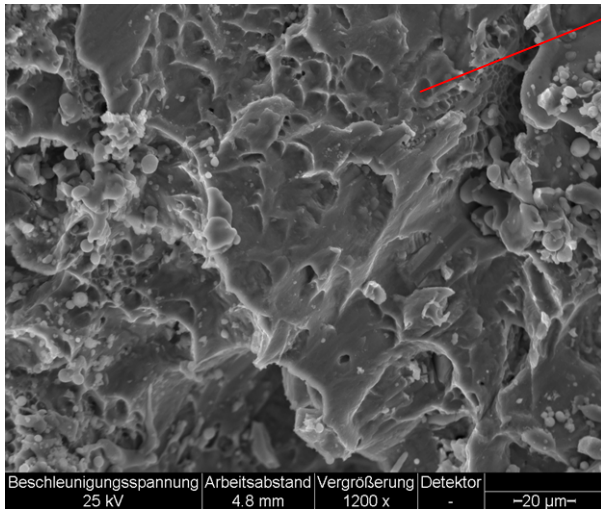
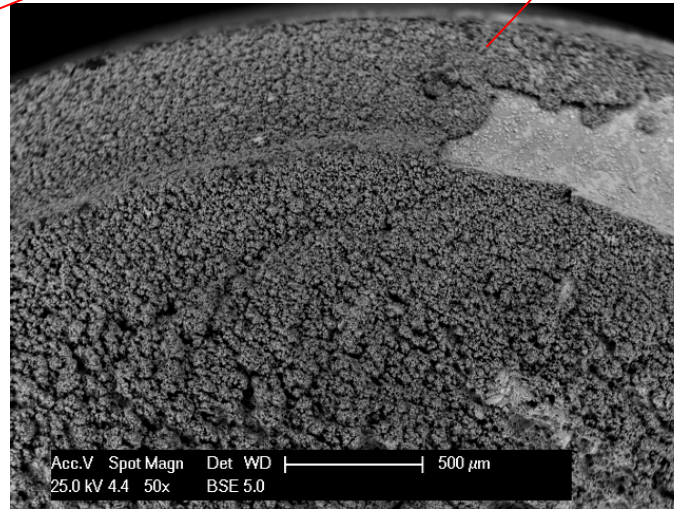
Hookbolt

Fractured hookbolt and fracture face (top) detailed SEM views of shear structure (bottom left) and foreign material overspray (bottom right)

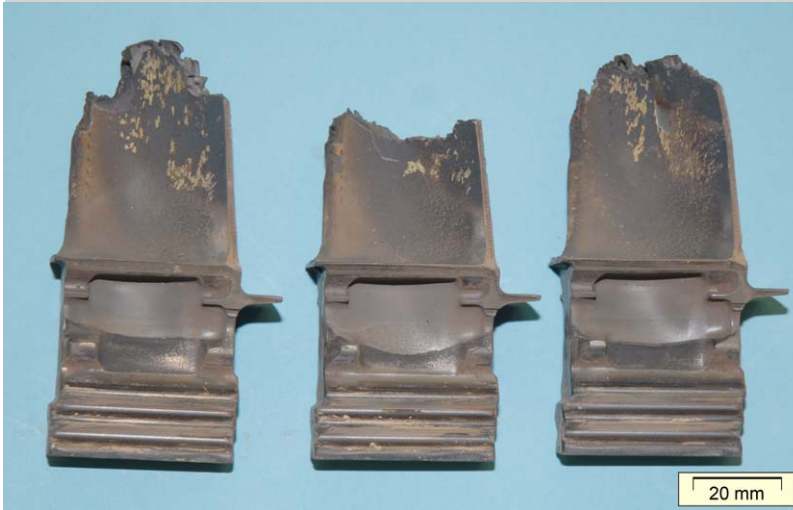
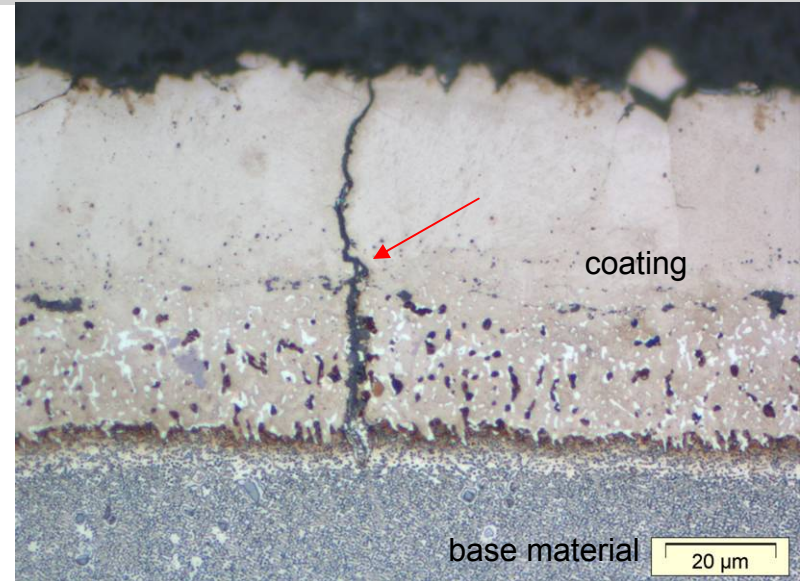
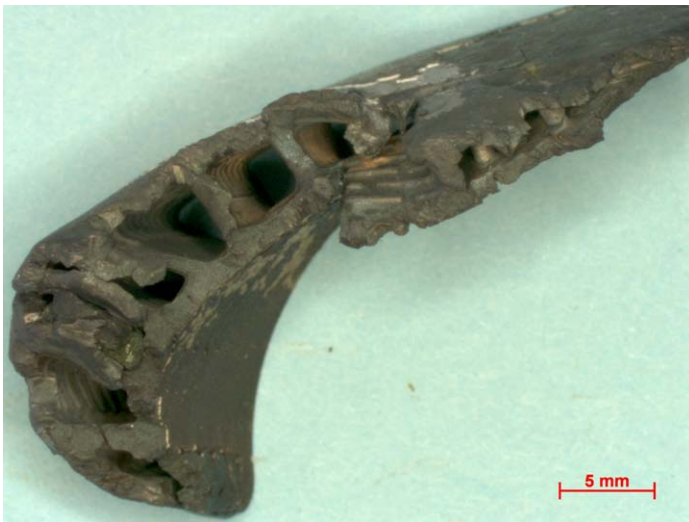
HPT Blade

Fractured blades (top left), fracture face of blade airfoil (bottom left) and oxidized / sulfidized crack through the airfoil coating (top right)

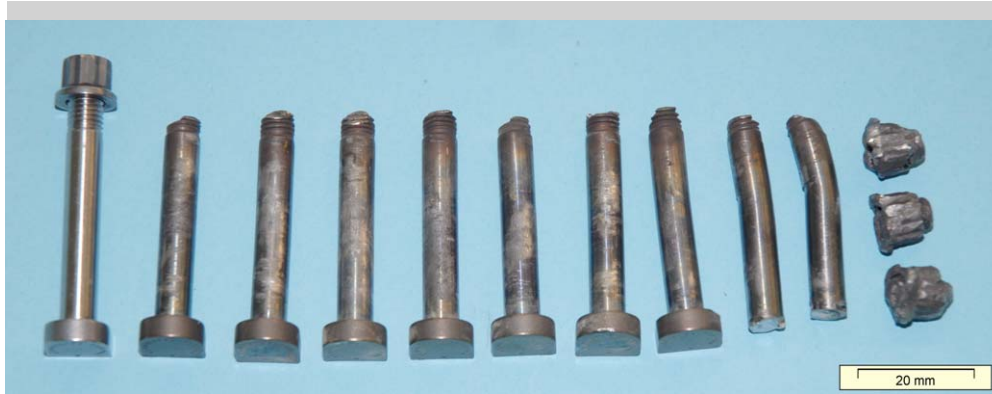
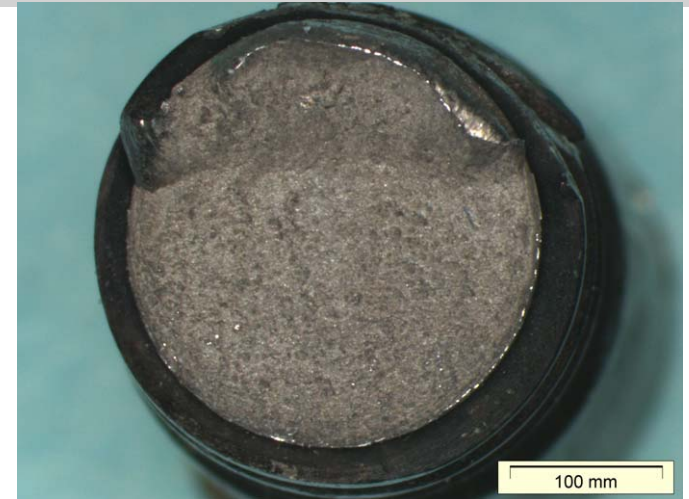
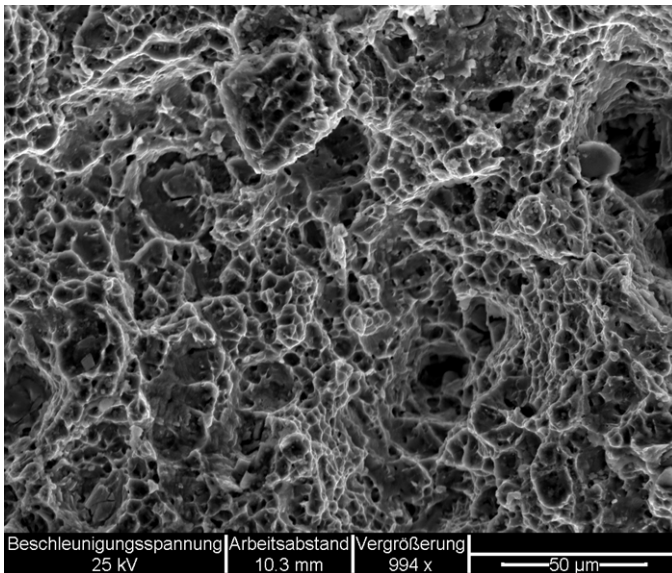
Ring Bolt

Fractured ring bolts (top), typical fracture face (top right) and SEM view depicting the ductile structure of the fracture (bottom left)

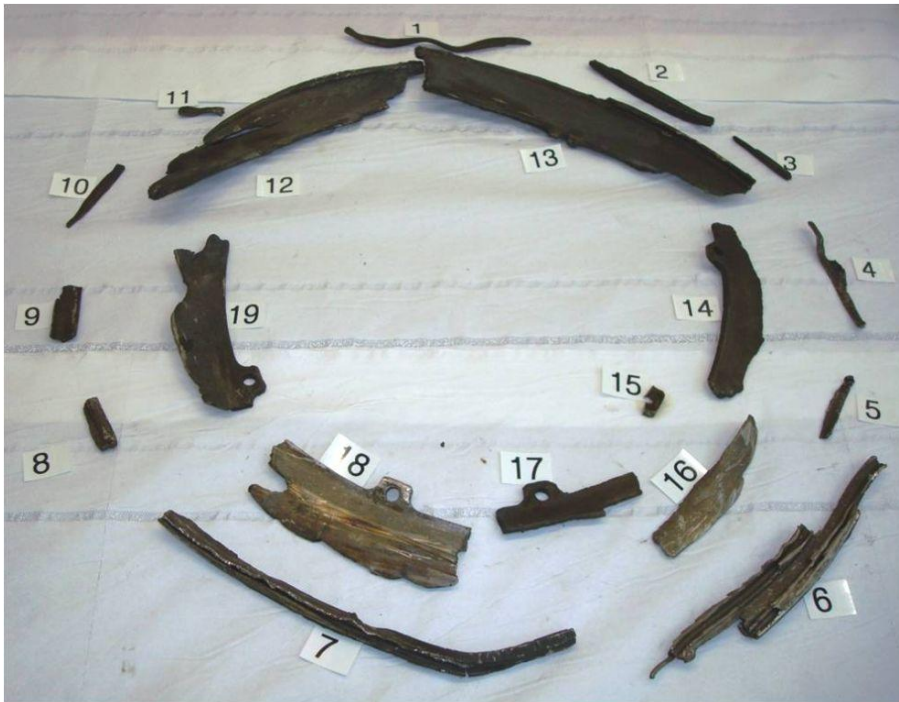
Photo No 2. LHT photo showing Diffuser Aft Seal fragments.

Pieces 4, 5, 9, 10 and 11, on photo no 2, are not believed to come from the Diffuser Aft Seal, based upon visual appearance and geometry.

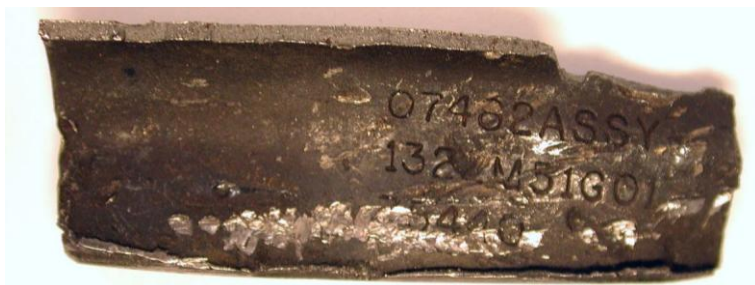
Piece No 9 is confirmed by GE Aviation to be a HPT Stage 1 Nozzle air cover baffle.

Photo No 4. Piece no 9, HPT Stage 1 Nozzle air cover baffle.

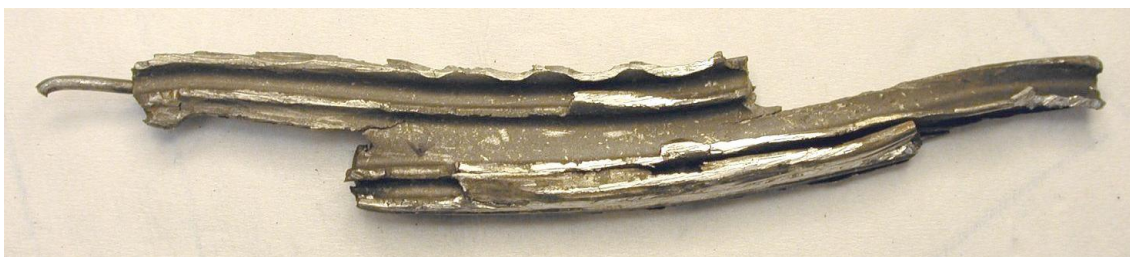
Photo No 5. Piece No 6 is the only fragment with the four seal teeth in the same piece.

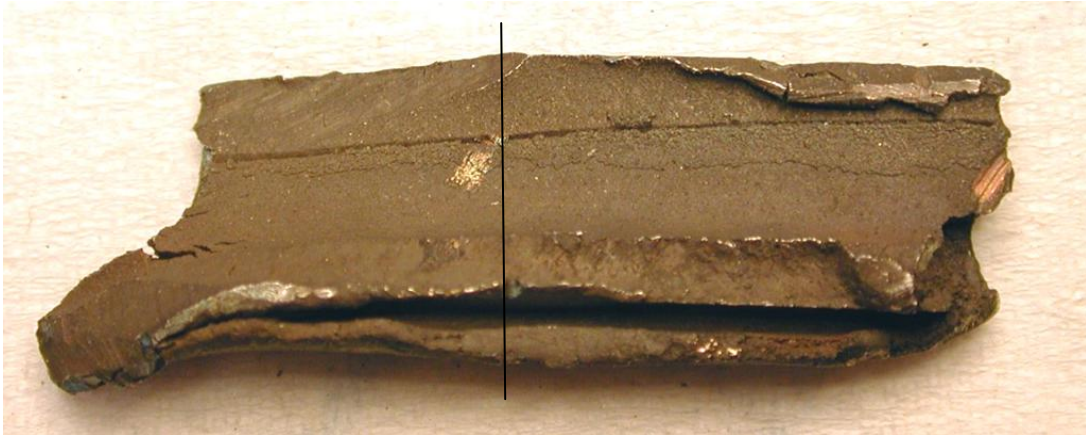
Photo No 7. The most interesting piece of the ones in photo No 1 is this 30 mm long fragment (labeled A) of the aft tooth of the seal (FWD surface shown on photo). This is the only piece of a seal tooth which is rather undamaged.

The line shows where a metallographic section was cut.

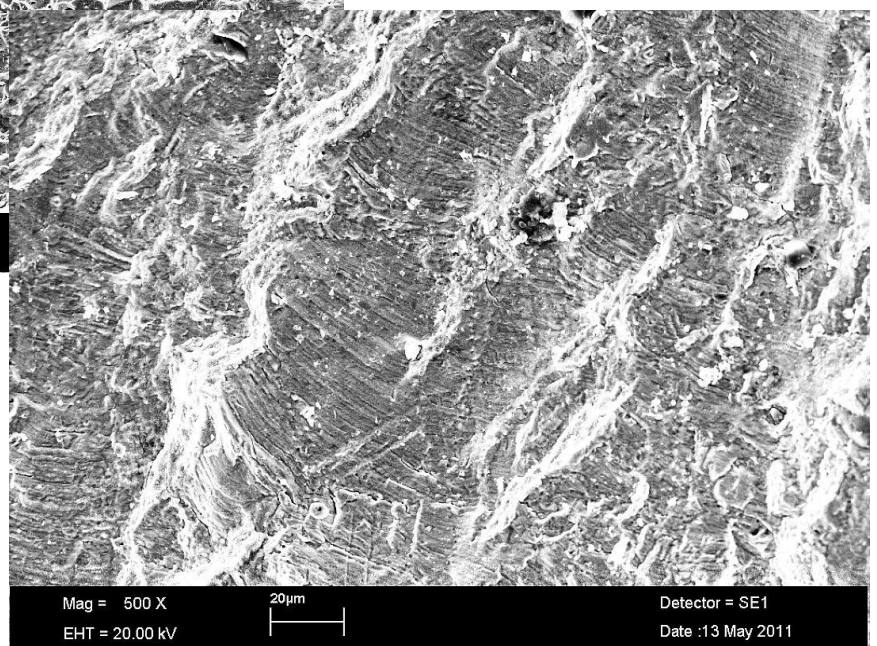
Photo No 11. Fatigue striations in a comparatively oxide free surface.

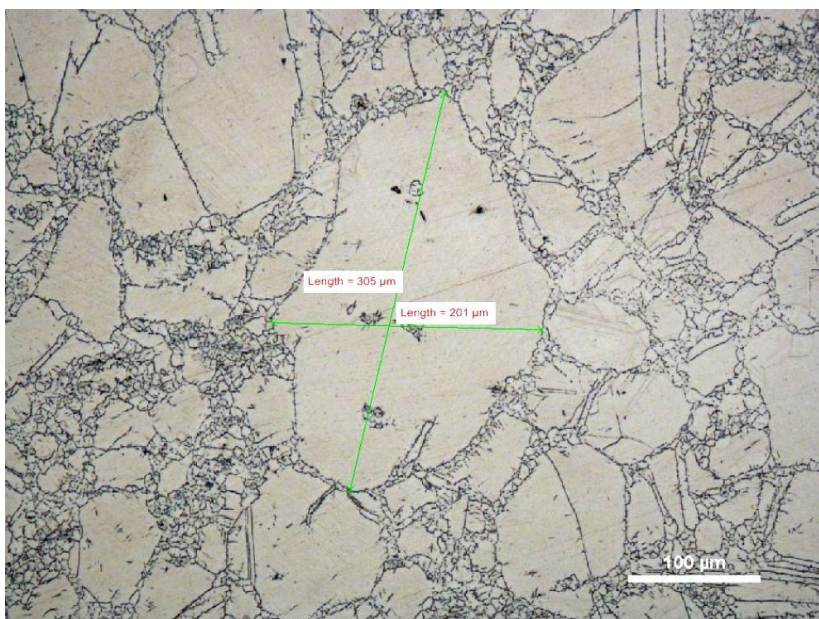
Photo No 18. The grain size of the seal tooth base material, about 3 mm from the weld interface, was evaluated per GE C50TF37 CL B per ASTM E 112.

Requirements: Forgings shall have an average size of ASTM No 4 or finer, with occasional grains as large as 0.18 mm permissible. Grain size shall be predominantly uniform without pronounced segregation of fine and coarse grained areas.
All requirements per GE C50TF37 CL B rev. S29.

Duplex, necklace structure is not permitted according to the requirements.
The largest grain in photo No 18 is 0.30 x 0.20 mm which is not permitted.
