TAKE-OFF FROM TAXIWAY

Amsterdam Airport Schiphol
10 February 2010

The Hague, December 2011

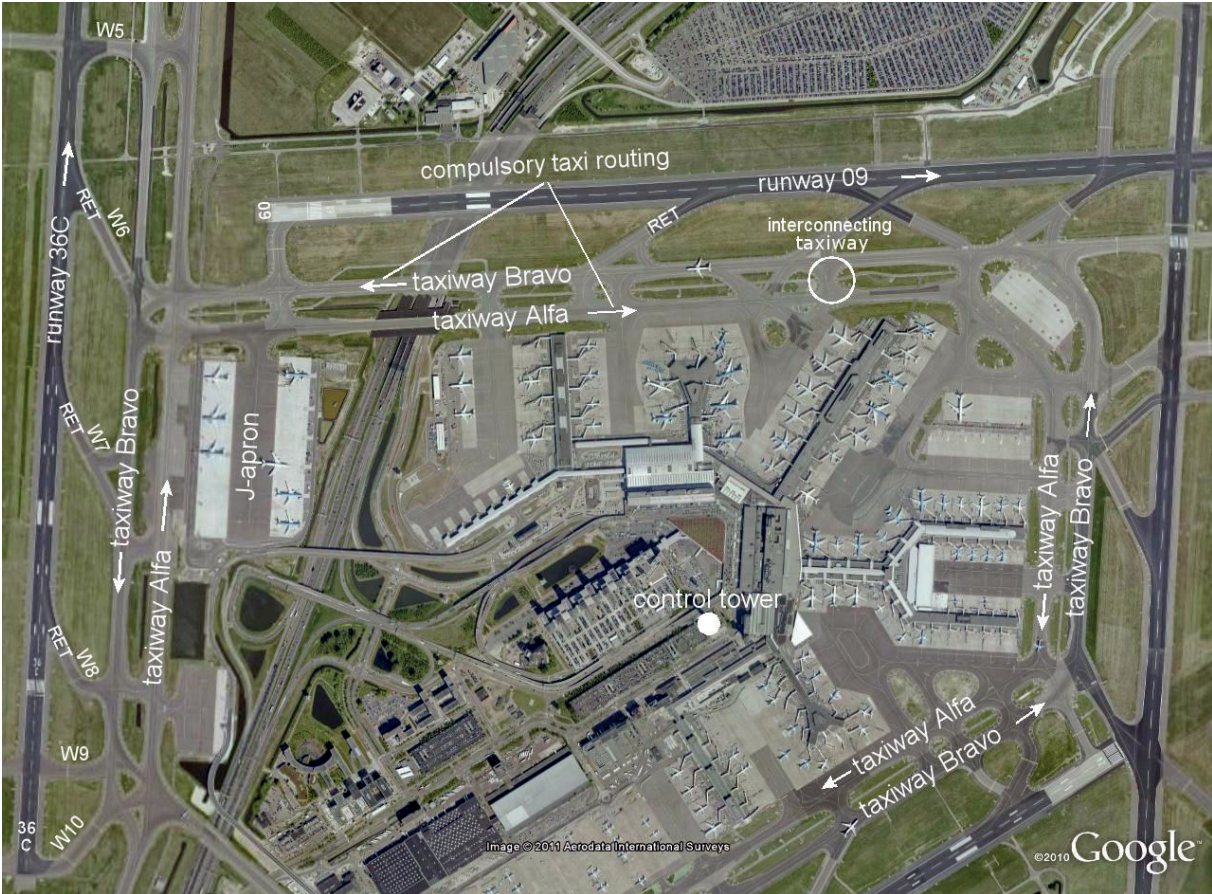
Figure 1: Part of the runway and taxiway system

All runways have entries and exits, markings⁴ and stop bars.⁵ These short taxiway sections have a unique identifier consisting of a combination of numbers and letters, and connect the taxiway system with the relevant take-off or landing runway. If the runway is being used for take-offs, the section is referred to as an entry. If the runway is being used for landings, it is referred to as an exit. See W8 in figure 1.

This is referred to as an intersection take-off. Air traffic control can use intersection take-offs to configure outbound traffic in a more efficient take-off sequence. The entries and exits are often located perpendicular to the direction of the take-off runway. Some are positioned at a 30-degree angle to the runway direction. These particular exits have a special function and enable aircraft that are still at a relatively high speed during the landing roll out to exit the runway. They are referred to as rapid exit taxiways (RET), also see figure 1.

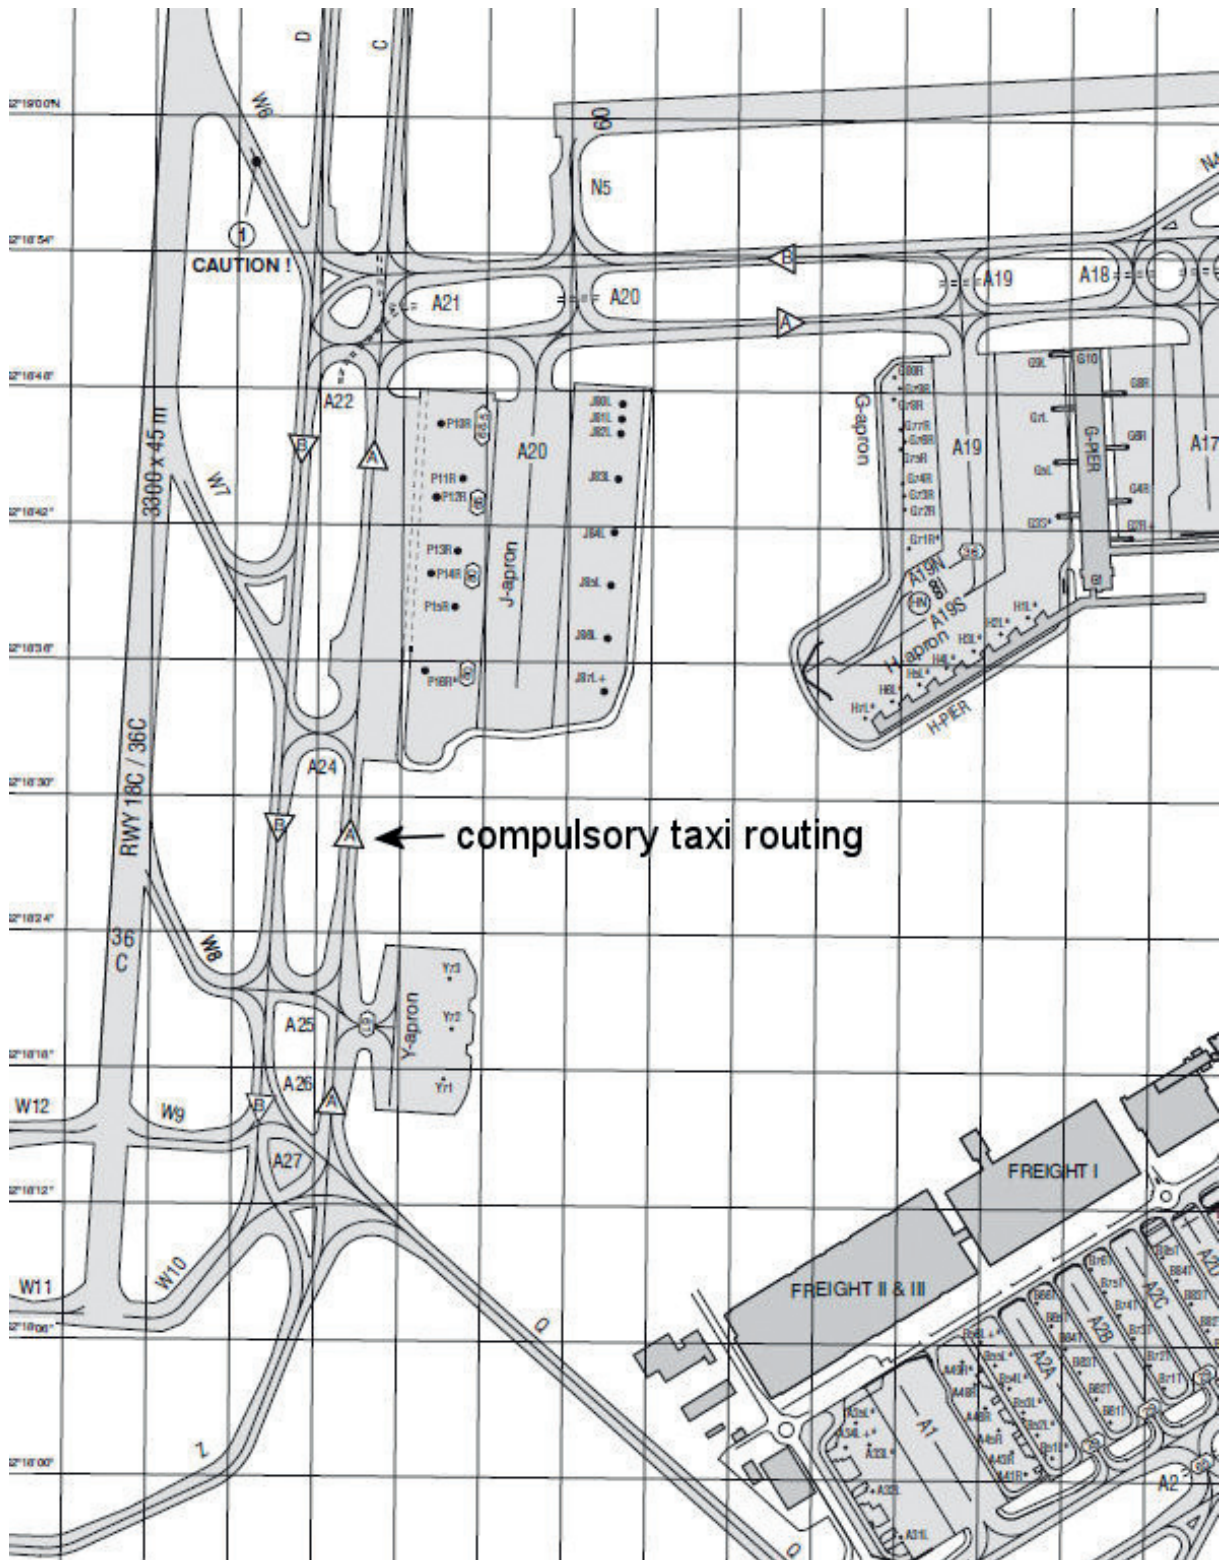
Figure 2: Compulsory direction of travel on taxiways Alfa and Bravo (Source: AIP)

Pilots taxiing at Amsterdam Airport Schiphol must follow the compulsory direction of travel (see figure 2) when taxiing along taxiway Alfa taxiway (clockwise) and taxiway Bravo (anti-clockwise). The compulsory direction of travel is published in the Aeronautical Information Publication (AIP). The AIP is an internationally recognised publication⁷ that serves as a source of information for airport operators, pilots and organisations that use or publish aviation documents. The taxiways may also be used in the opposite direction if deemed necessary by air traffic control. The ground controller will inform pilots in advance if their flight is to be routed against the compulsory direction of travel.⁸ ICAO does not provide any guidelines on fixed taxi routes or the direction of travel, and has not specified any conditions regarding deviations. In more general terms, ICAO has specified that traffic should be handled in accordance with all applicable procedures and traffic rules, as determined by the responsible air traffic control services.

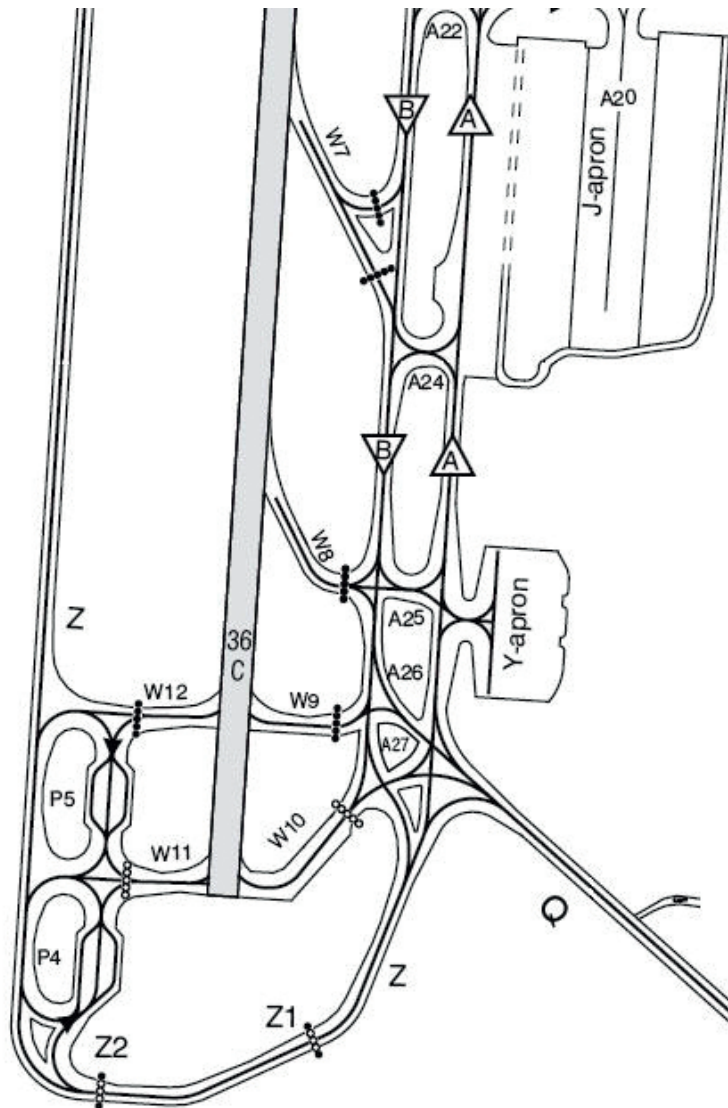
Figure 6: Overview of the entries and layout of the taxiways near runway 36C (source: AIP)

Runway 36C is surrounded by three parallel taxiways, i.e. a taxiway west of the runway and taxiways Alfa and Bravo on the east side of the runway. In total runway 36C features twelve entries to/exits from the runway (W1-W12).

When on taxiway Alfa and turning into interconnecting taxiway 25 to get to runway 36C, pilots have to cross first taxiway Bravo and then taxi down entry W8. W8 is positioned at an angle of approximately 30 degrees to runway 36C, because W8 functions as the rapid exit taxiway (RET) in the reverse direction when runway 18C is used for landing. Intersection W9 lies further south while W10 is located at the beginning of runway 36C. There is a taxiway junction near W10 leading to entry W10, taxiways Zulu and Quebec, and taxiways Alfa and Bravo, see figure 6. Intersections W11 and W12 are located on the west side of runway 36C.

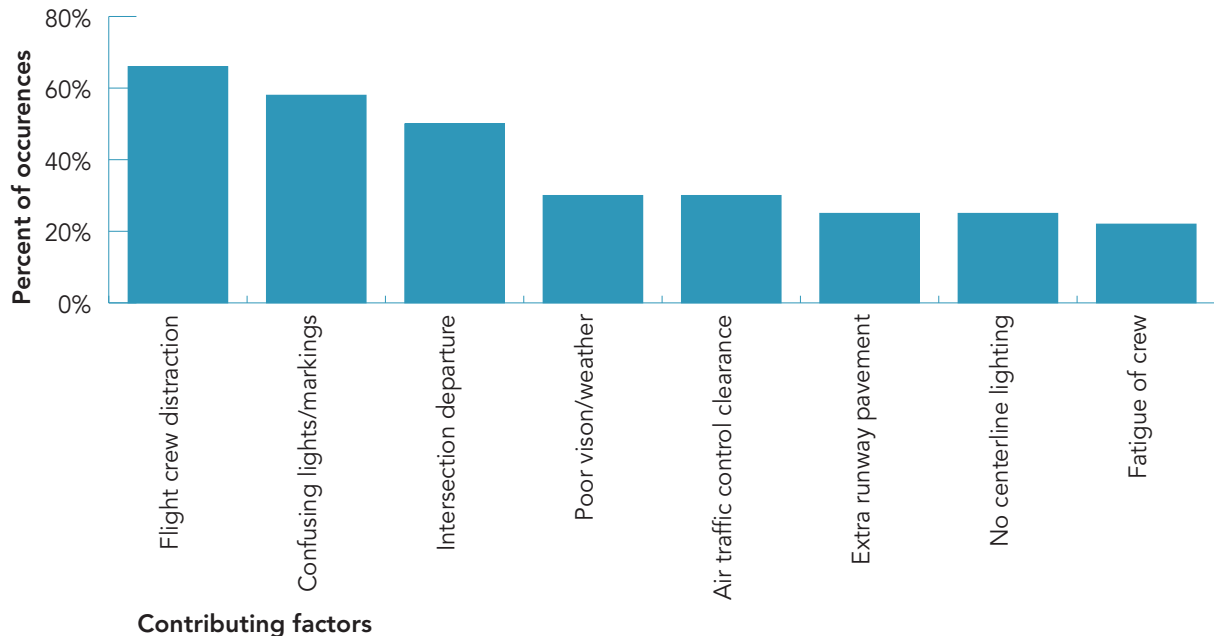
Figure 8: Factors contributing to misaligned takeoff occurrences at night (source: ATSB)

The Australian Transport Safety Bureau (ATSB) identified eight factors that contributed to the occurrence of runway confusion incidents during take-offs at night.³⁸ (see appendix L). These factors are shown in figure 8. Two factors did not contribute to the incident investigated, i.e. extra 'runway pavement' and 'fatigue of crew'. More information on the fatigue factor can be found in Section 3.3.1.

The other six factors were found to have contributed to the incident involving the PH-BDP and are discussed in the relevant chapters of the analysis, where applicable. In most cases they relate to the cockpit environment; some factors, however, apply to air traffic control. The following sections examine the relationship between these factors and the incident.

The conclusion can be drawn that the factors of 'no centreline lighting' and 'confusing lights' and consequently also 'intersection departure' (see figure 8) apply to this incident.

It can be established that the background lights at and surrounding the airport contribute to the factors of 'poor vision' and 'confusing lights' shown in figure 8 in respect of the visibility of the runway.

The simulator sessions revealed that from the time that the PH-BDP had entered interconnecting runway A25, the crew were busy steering, activating the lights, processing information and performing verifications. This meant that a great deal of attention had to be devoted to the cockpit processes. The first officer who had been busy with other tasks in the cockpit and therefore was unable to monitor the taxi route adequately, failed to notice the error. The 'flight crew distraction' factor described in figure 8 applied.

It proved to be crucial to monitor the aircraft's exact position while it was taxiing; the more so as the crew had received take-off clearance while the aircraft was taxiing on interconnecting taxiway A25 and were able to commence the take-off run immediately after having lined up on the taxiway. During taxiing the crew lost their positional awareness causing them to take-off from a taxiway instead of the take-off runway. From a human factor point of view, take-off clearance probably played a role in terms of timing. The 'air traffic control clearance' factor in figure 8 therefore applies to the incident involving the PH-BDP.

The Australian Transport Safety Bureau (ATSB) identified eight factors in the occurrence of runway confusion incidents during take-offs at night, see figure 8. As the previous analysis shows, six of the eight factors contributed to the incident involving the PH-BDP. The risks or the effects of these factors would have been eliminated if the PH-BDP had taxied along the compulsory direction of travel on taxiway Bravo.
