AIRCRAFT ACCIDENT REPORT AND EXECUTIVE SUMMARY

Reference:	CA18/2/3/8779	
Aircraft Registration	ZU-BMX	Date of Accident	12 April 2010		Time of Accident	1300Z
Type of Aircraft	KIS TR-1		Type of Operation	Private		
Pilot-in-command Licence Type		Private	Age	57	Licence Valid	No
Pilot-in-command Flying Experience		Total Flying Hours	399,5		Hours on Type	Unknown
Last point of departure		Petit Aerodrome (FARA)				
Next point of intended landing		Petit Aerodrome (FARA)				
Location of the accident site with reference to easily defined geographical points (GPS readings if possible)						
Petit Aerodrome (FARA) at the GPS coordinates S26° 05' 169" E028° 23' 436"						
Meteorological Information		Surface wind: light and variable; Temperature: 25°C; Visibility: > 10 km				
Number of people on board	1 + 0	No. of people injured	0	No. of people killed	1	
Synopsis						
<p>A witness assisted the pilot to move the aircraft, from which the engine cowling had been temporarily removed, from the hangar at Petit aerodrome. The pilot then taxied the aircraft on runway 21 to check the engine parameters, and afterwards taxied back at speed. The aeroplane lifted from the ground and stalled, and the left wi

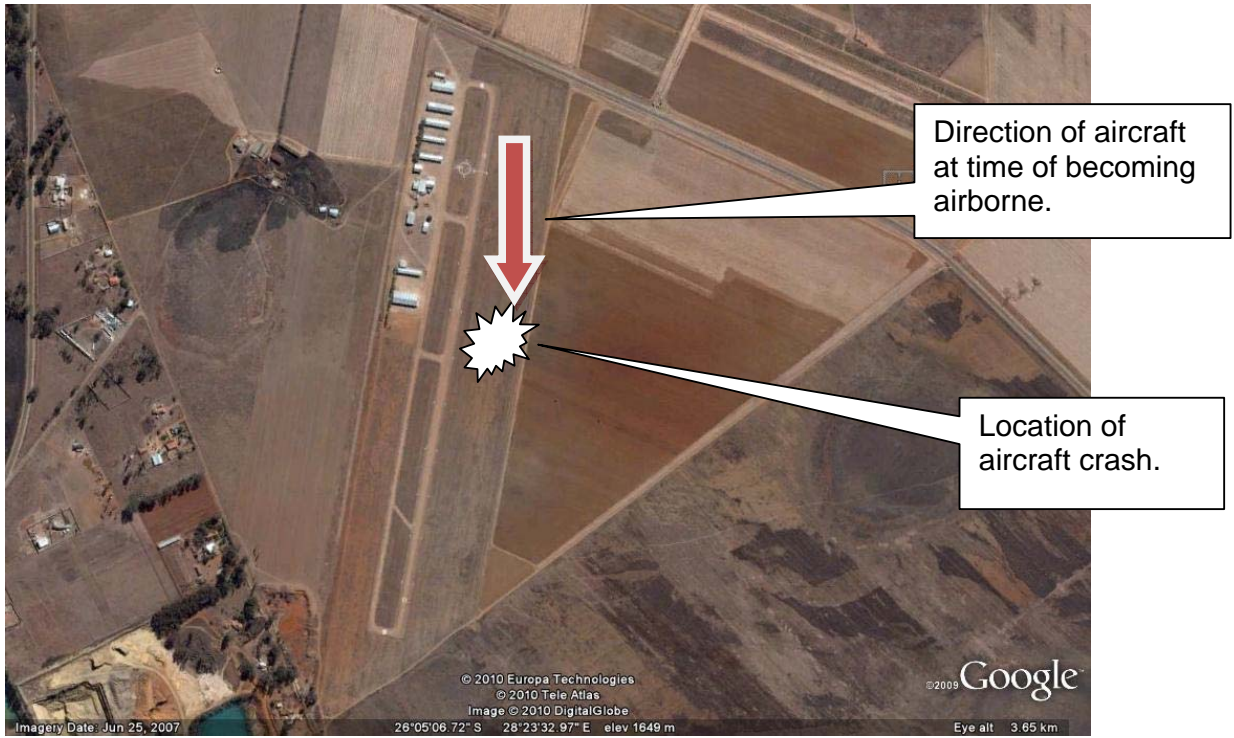
Figure 2. Satellite view of aerodrome.

1.12.2 The distance from the runway to the wreckage was approximately 40 m. The aircraft came to rest about 7,5m from the first point of impact.
