## AIRCRAFT ACCIDENT REPORT AND EXECUTIVE SUMMARY

Reference:	CA18/2/3/8805	
<b>Aircraft Registration</b>	ZS-NLY	<b>Date of Accident</b>	16 July 2010		<b>Time of Accident</b>	1715Z
<b>Type of Aircraft</b>	De Havilland Dash 8-300		<b>Type of Operation</b>	Domestic Scheduled Flight		
<b>Pilot-in-command Licence Type</b>		Airline Transport	<b>Age</b>	26	<b>Licence Valid</b>	Yes
<b>Pilot-in-command Flying Experience</b>		Total Flying Hours	4 575.4		Hours on Type	1 524.9
<b>Last point of departure</b>		O.R. Tambo International Aerodrome (FAJS)				
<b>Next point of intended landing</b>		Kimberley Aerodrome (FAKM)				
<b>Location of the accident site with reference to easily defined geographical points (GPS readings if possible)</b>						
On runway 20 at FAKM (GPS position; South 28° 48.545' East 024° 45.868' elevation 3 910 feet AMSL)						
<b>Meteorological Information</b>		Surface wind; 310°/2kt, Temperature; 3°C, Visibility; +10 km				
<b>Number of people on board</b>	2+2+40	<b>No. of people injured</b>	0	<b>No. of people killed</b>	0

<b>Synopsis</b>						
<p>On 16 July 2010 at 1715Z flight SA1107, a de Havilland Dash 8 with registration ZS-NLY, collided with a wild animal (aardvark/

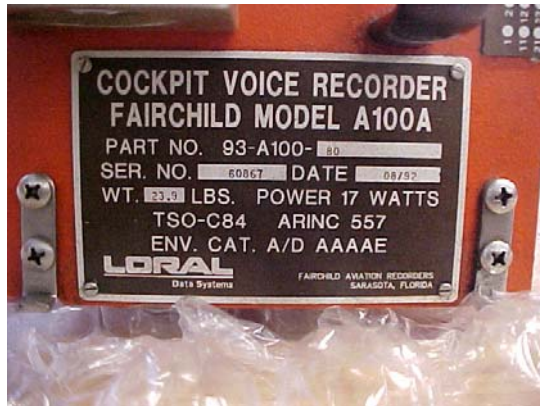
The cockpit voice recorder (CVR) was recovered from the accident aircraft. The CVR was a Fairchild Model A100A, part number 93-A100-80 and serial number 60867. An external examination of the CVR revealed that overall it was in a good condition. The underwater locator beacon (ULB) or pinger was undamaged.

Figure 2. A view of the cockpit voice recorder recovered from the aircraft.

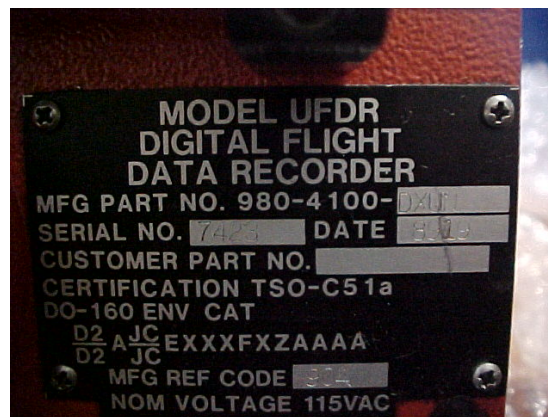
The aircraft was equipped with a Honeywell solid state flight data recorder part number 980-4100DXUN, serial number 7423. The unit was undamaged and there was no apparent impact damage to the ULB, which remained attached to its bracket. The unit showed no signs of external damage.

Figure 3. A view of the flight data recorder recovered from the aircraft.
