AIRCRAFT ACCIDENT REPORT AND EXECUTIVE SUMMARY

Reference:	CA18/2/3/8810	
Aircraft Registration	ZU-ESB	Date of Accident	24 July 2010		Time of Accident	1030Z
Type of Aircraft	A-22L Foxbat		Type of Operation	Private		
Pilot-in-command Licence Type	NPL		Age	17	Licence Valid	Yes
Pilot-in-command Flying Experience	Total Flying Hours		47,2		Hours on Type	47,2
Last point of departure	Light Flight aerodrome near Cato Ridge, KwaZulu-Natal					
Next point of intended landing	Light Flight aerodrome near Cato Ridge, KwaZulu-Natal					
Location of the accident site with reference to easily defined geographical points (GPS readings if possible)						
On a sugarcane field in the Wartburg area. GPS position: S 29° 26.185' E 030° 33.684'						
Meteorological Information	The weather was fine. Temp: 22°C; Wind: calm					
Number of people on board	1 + 1	No. of people injured	0	No. of people killed	2	
Synopsis						
<p>According to available information, the pilot was issued with a valid National Pilot's Licence by Recreation Aviation Administration South Africa (RAASA) on 14 July 2010 after passing his flight test on 8 July 2010. He received his pilot's licence by courier post on the morning of 24 Jul

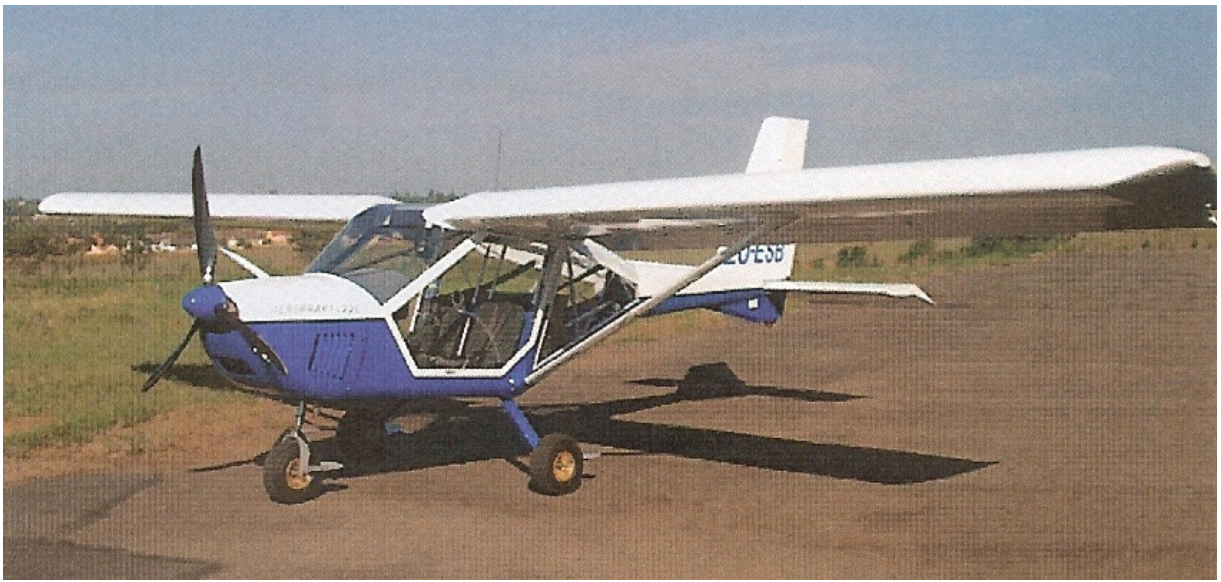
Figure 1. The accident aircraft shortly after it was built.

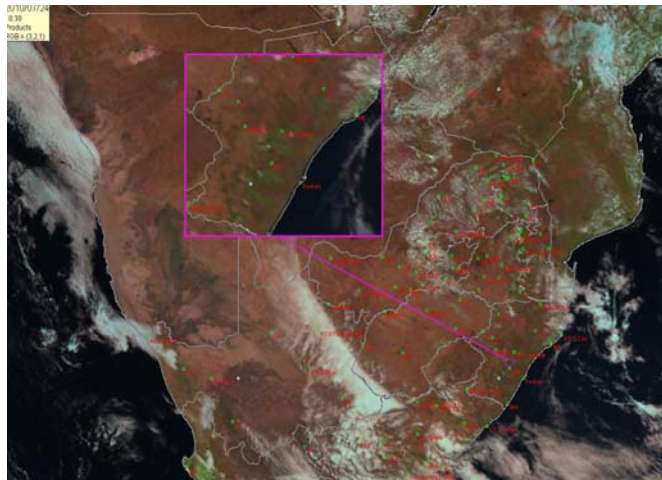
There is no official observation in the Wartburg area, but reports from Pietermaritzburg and Greytown were considered. The official report from Pietermaritzburg by 1000Z shows the visibility at about 8 000 m in haze. The temperature and dew point at the time suggests dry conditions closer to the ground whilst light winds with a northerly component were measured at the time. Although the conditions were good over the area surrounding Wartburg on the day closer to the time of incident, there were clouds in the vicinity, but dry conditions indicate that the base of those clouds from ground level was significantly high.

Figure 6. Satellite image valid for 1030Z 24 July 2010.
