AIRCRAFT ACCIDENT REPORT AND EXECUTIVE SUMMARY

Reference:	CA18/2/3/8829	
Aircraft Registration	ZU-FEZ	Date of Accident	03 September 2010		Time of Accident	1130Z
Type of Aircraft	Sportsman GS 2		Type of Operation		Private	
Pilot-in-command Licence Type		Private Pilot	Age	48	Licence Valid	Yes
Pilot-in-command Flying Experience		Total Flying Hours	292.4		Hours on Type	24.1
Last point of departure		Knysna				
Next point of intended landing		Plettenberg Bay				
Location of the accident site with reference to easily defined geographical points (GPS readings if possible)						
Private airstrip at Jakalskraal district - Plettenberg Bay.						
Meteorological Information		Surface Wind: Southerly, Wind Speed: 3 - 5kts; Temperature: 24°C, Visibility: Good				
Number of people on board	1 + 0	No. of people injured	0	No. of people killed	0	
Synopsis						
<p>During approach for landing the pilot pulled back on the control stick to initiate flaring in order to touch down on the runway. The pilot realised that the control stick was not moving back as required, but had somehow got stuck. His observation at the time was that the aircraft was experiencing a control lock condition. The result was that

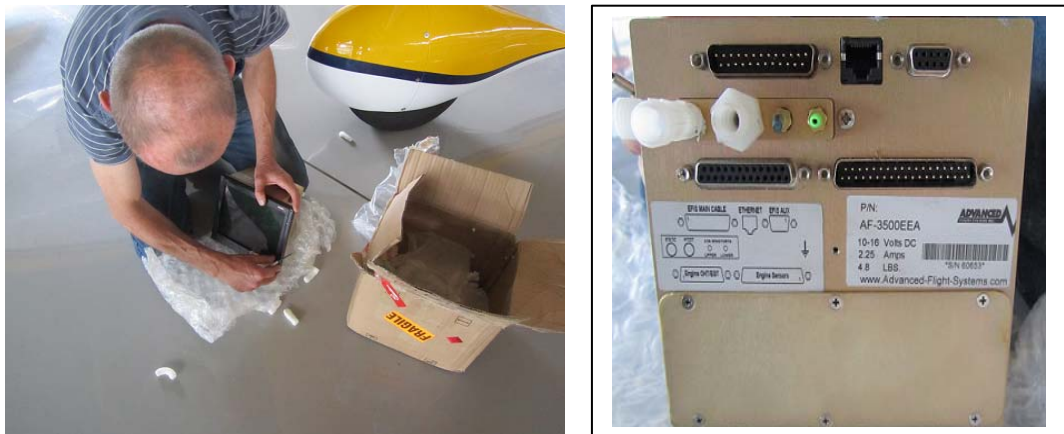
1.11.2 The aircraft had an EFIS component (P/N AF-3500EEA, S/N 60653) fitted. The EFIS was in a serviceable condition. According to the calibration label, the component was last calibrated on 1 December 2009. The EFIS was removed from the aircraft to download the flight and performance information of the accident flight. The downloading of the information transpired in the presence of the local agent.

Figure 2 shows the EFIS component.

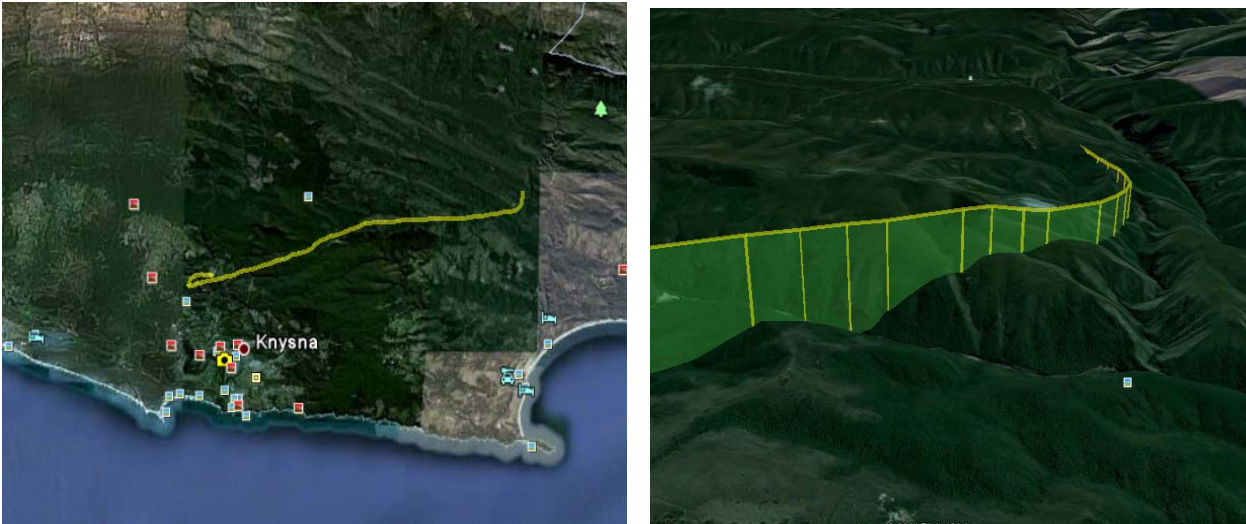
1.16.6 The flight and performance data that was downloaded from the EFIS component was used to construct the flight track and analyse the information. The track flown was found to be consistent with the information reported by the pilot. The track data was plotted on Google Earth as indicated below:

Figure 5, shows track that was flown on the day.

- (i) The EFIS data shows that the aircraft's descent and approach were normal. There was no information which suggested that the pilot caused the aircraft to climb after initial descent or to climb after initiating the approach to land.
