AIRCRAFT ACCIDENT REPORT AND EXECUTIVE SUMMARY

Reference:	CA18/2/3/8845	
Aircraft Registration	ZS-HTJ	Date of Accident	8 October 2010		Time of Accident	1245Z	
Type of Aircraft	Hughes 269C (Helicopter)		Type of Operation		Game darting operation		
Pilot-in-command Licence Type		Private Pilot	Age	47	Licence Valid	Yes	
Pilot-in-command Flying Experience		Total Flying Hours	1 594.8		Hours on Type	1 568.1	
Last point of departure		Farm Eulalie in the Marken district (Limpopo Province)					
Next point of intended landing		Farm Eulalie in the Marken district (Limpopo Province)					
Location of the accident site with reference to easily defined geographical points (GPS readings if possible)							
Farm Eulalie in the Marken district (GPS position; South 23° 25.229' East 028° 17.137', elevation 3 100 feet)							
Meteorological Information		Surface wind; 040°/4kts, Temperature; 34°C, Visibility; + 10 km					
Number of people on board	1 + 1	No. of people injured	1 + 1	No. of people killed	0

AIRCRAFT ACCIDENT REPORT

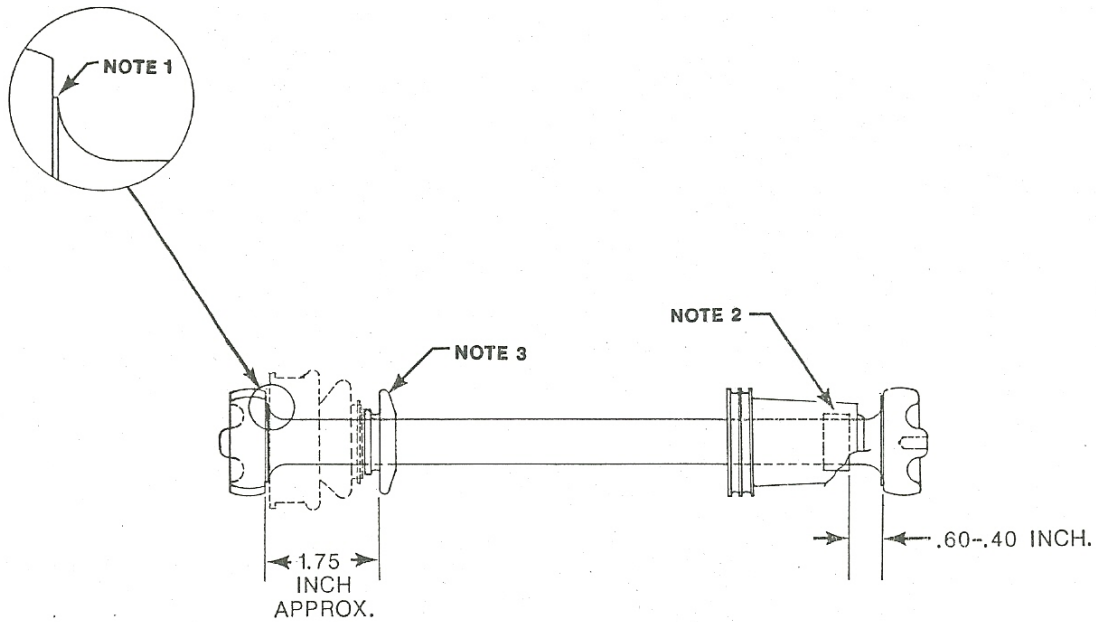
Figure B-257.1-1. Lower Coupling Drive Shaft

Engine operation in excess of 1600 rpm with the clutch disengaged is prohibited. To prevent lower coupling drive shaft damage due to overspeed in the event that the pilot inadvertently exceeds the 1600 RPM limit, SAC recommends installation of Engine Overspeed Control Kit, P/N 269A4997-1 or -3 as applicable on Model 269C Helicopters.

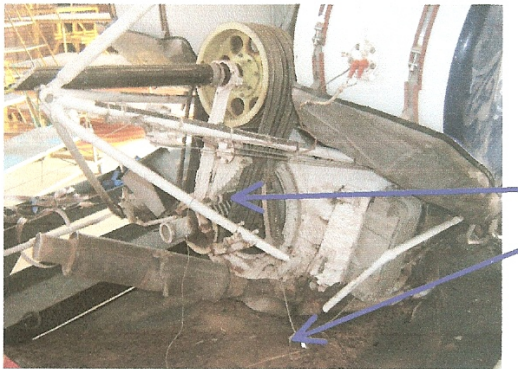
1.1. Selected components from the clutch and drive shaft assembly (Photo 1) from a crashed Schweizer Hughes 269C helicopter, aircraft number ZS-HTJ, were submitted to determine the failure modes during operation.

Photo 1: ZS-HTJ position of supplied components (courtesy SACAA)

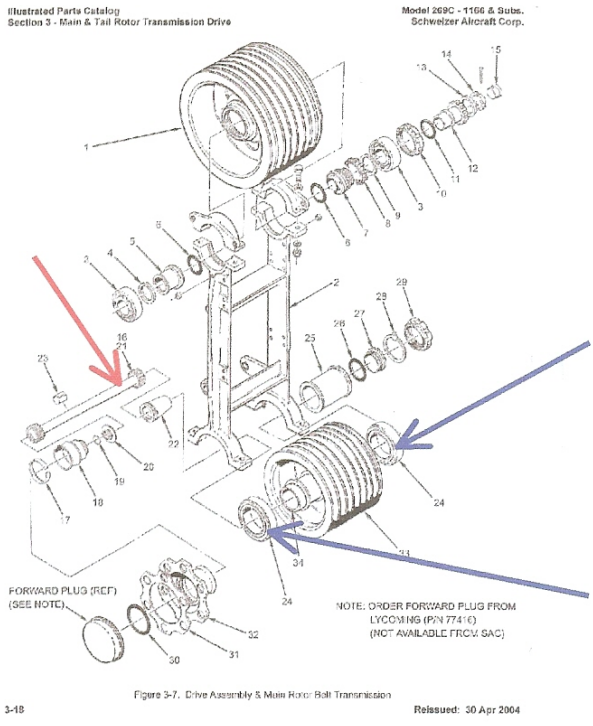
The on-site visual examination revealed the drive shaft (Diagram 1, red arrow) to be fractured at the pulley (AFT) end (Photo 2, red arrow) of the assembly. Lubrication remains was evident. The clutch pulley (Photo 1, blue arrow) was fractured with the clutch cable in wedged position (Photo's 15 and 16).

Both pulley bearings (Diagram 1, blue arrows) were removed and inspected but revealed no clear signs (Photo 13) of pre-impact damages, vibration or other that may have contributed to the failure of the drive shaft.

Diagram 1: IPS: Hughes 269C Drive Assembly

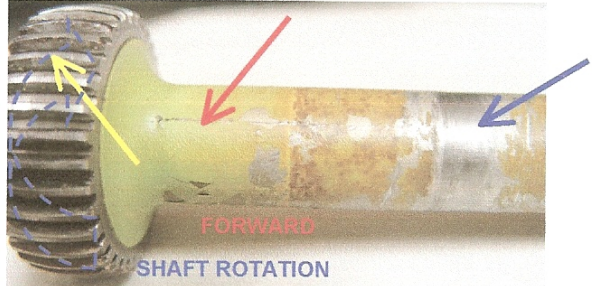
Further inspection revealed fractures to be present at the forward (engine side) end (Photo 3, red arrow) of the drive shaft. The fractures at the FORWARD end proved to be at a position 180° opposite to that of the fractures at the AFT end of the drive shaft. Some scuffing marks were noted at the FORWARD end (Photo 3, blue arrow), most probably induced during the post failure phase. The gears at both the FORWARD en AFT ends of the drive shaft revealed signs of directional damages correlating with the applied power during operation (Photo 3, yellow arrow). At both ends indications of shear orientated fracture initiation were evident (Photo 5, blue arrow). The orientation of the fractures correlated well with that of a high strength drive shaft under torsion loads, combined with possible directional loading. The AFT end drive shaft fracture surface revealed the typical 'thumbnail' geometry of a propagating fatigue fracture (Photo 4, red arrow and dashed line) with extensive 'smearing' damages (Photo 4, blue arrow). The 'smearing' damages are due to the rubbing effect of the opposed fracture surfaces during operation. All indications are that the fatigue fractures originated parallel to and at right angles to the drive shaft surface, 180° angles at opposite ends, and the progressed into a shear directed fatigue fracture before final fracture. This correlates with a typical torsion induced failure in highly strained rotating shafts.

Photo 3: Drive shaft, forward end (digital)

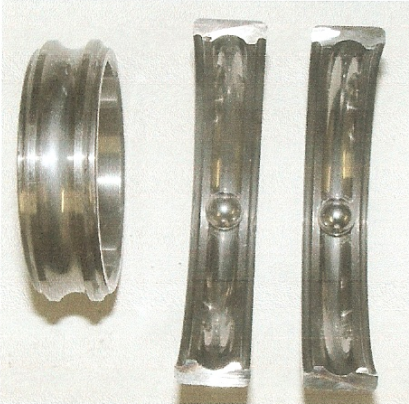
Photo 13: Lab opened bearing balls and raceway surfaces (digital)

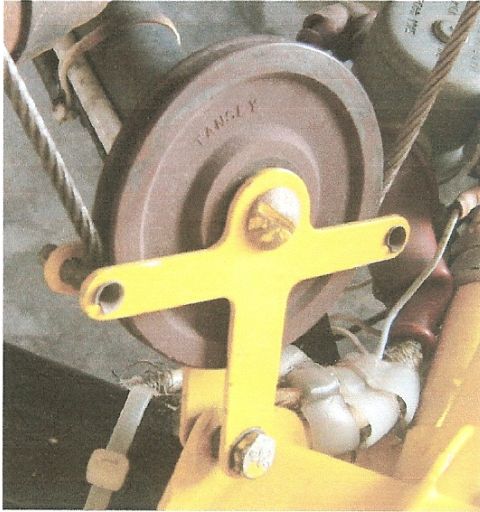
The clutch cable guide pulley (Photo 14, from similar aircraft) was found fractured with the cable wedged between the pulley and pulley frame (Photo 15). In case where the pulley should fail during operation, it may lead to the disengaging of the clutch system, the subsequent exceeding of the RPM limits and resulting in drive shaft damages and/or failure during operation. The ceramic based pulley fracture surfaces revealed no clear indications of pre-existing crack formation (Photo's 16 and 17). The pulley frame was torn apart on impact as the undercarriage was severed from the main fuselage (Photo 17). The pulley frame fracture surfaces compares with that of a single overload failure (Photo 18).

Photo 14: Similar clutch pulley assemble (digital)
