**AIRCRAFT ACCIDENT REPORT AND EXECUTIVE SUMMARY**

Reference:	CA18/2/3/8858	
<b>Aircraft Registration</b>	<b>ZS-KIN ZU-BXA</b>	<b>Date of Accident</b>	26 October 2010		<b>Time of Accident</b>	1530Z
<b>Type of Aircraft</b>	Piper PA-28-180 Jabiru SK		<b>Type of Operation</b>	Training		
<b>Pilot-in-command Licence Type</b>		Student Pilot Commercial Pilot	<b>Age</b>	25 50	<b>Licence Valid</b>	Yes Yes
<b>Pilot-in-command Flying Experience</b>		Total Flying Hours	34,4 1046,7	Hours on Type	34,4 417,9	
<b>Last point of departure</b>		Wonderboom Aerodrome (FAWB); Gauteng province Kitty Hawk Aerodrome (FAKT); Gauteng province				
<b>Next point of intended landing</b>		Wonderboom Aerodrome (FAWB); Gauteng Province Kitty Hawk Aerodrome (FAKT); Gauteng Province				
<b>Location of the accident site with reference to easily defined geographical points (GPS readings if possible)</b>						
On Runway 29 at Wonderboom Aerodrome, approximately 200 meters to the west of the intersection with Runway 06/24 at a GPS position; South 25°39'12" East 028°13'22'

## AIRCRAFT ACCIDENT REPORT

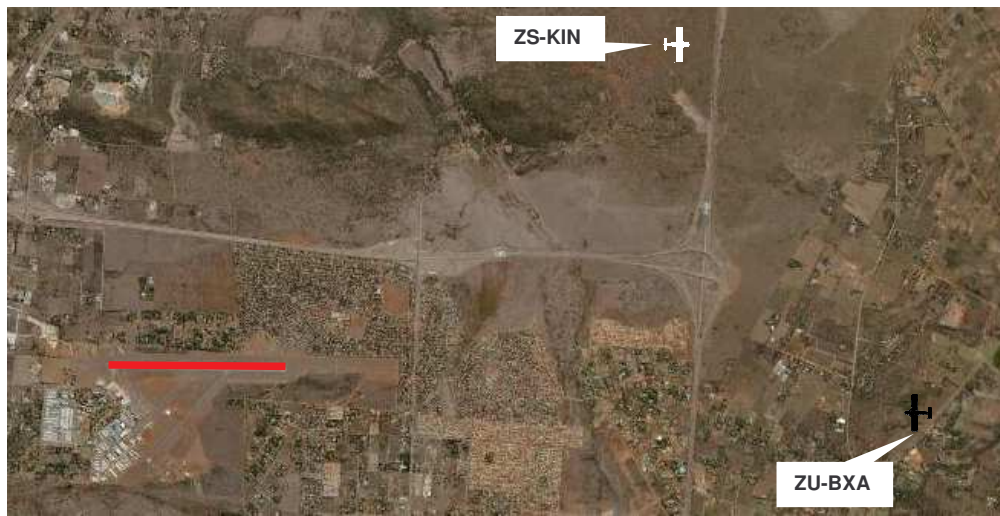
**Figure 2.** Relative position of the aircraft before ZS-KIN was cleared to turn base leg Runway 29.<sup>1</sup>

1.1.5 After ZS-KIN completed his first solo circuit, while positioned on a late downwind for his second circuit, the aircraft ZU-BXA was on long final approach for a touch-and-go Runway 29. When ZU-BXA was positioned one nautical mile east of the N1 high-way, which is located to the east of FAWB, ZS-KIN was cleared to turn onto the base leg for Runway 29. **(See Fig 2)**

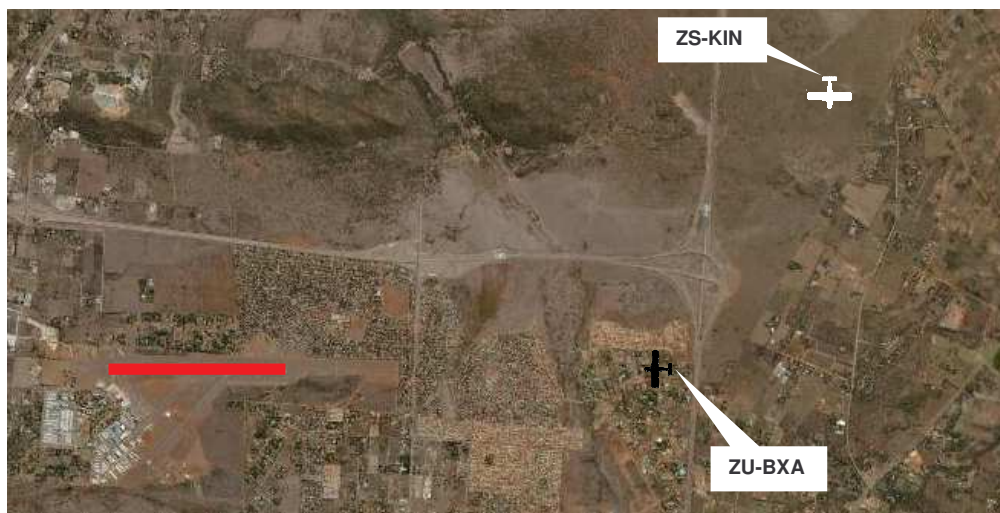
**Figure 3.** Relative positions of both aircraft, ZS-KIN was cleared to follow ZU-BXA onto final approach Runway 29.<sup>2</sup>

1.1.6 At the time ZU-BXA crossed the N1 high-way to the east of FAWB, ZS-KIN was cleared to follow ZU-BXA, number two on final approach. The student pilot acknowledged this communication and indicated to ATC that he had the aircraft ZU-BXA on final approach in sight. **(See Fig. 3)**

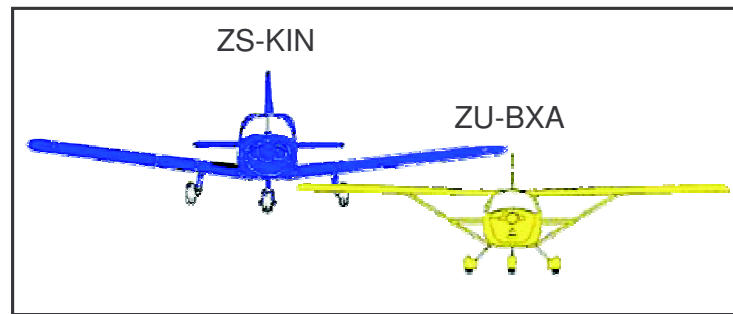
Figure 15. Approximate position of the two aircraft looking towards them.

Available evidence indicate that the propeller of ZS-KIN made contact with the outer wing surface of ZU-BXA, which caused substantial damage to the lifting surface, including destroying the right aileron as can be seen in Figure 8. This resulted in a loss of control of the aircraft ZU-BXA, which was found to have impacted with the runway surface approximately 280 m pass the intersection of the two runways. (See Fig. 11)

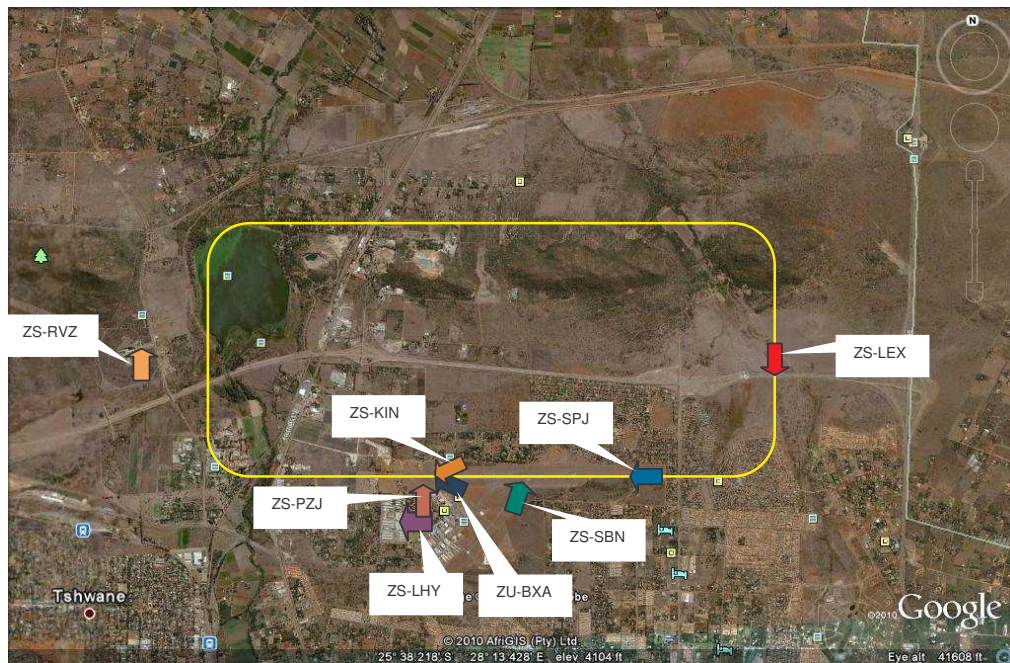
**Figure 19.** Graphic representation of circuit traffic leading up to the accident.

- (a) The aircraft ZS-KIN was conducting circuits and landings while the aircraft ZU-BXA joined the circuit on a long final approach from Kitty Hawk aerodrome, situated southeast of FAWB with the intention to perform a touch-and-go at FAWB. The intention thereafter was to fly to the general flying area, located to the north-east of the aerodrome.
- (b) At the time of the accident the following aircraft were in the circuit:
