AIRCRAFT ACCIDENT REPORT AND EXECUTIVE SUMMARY

Reference:	CA18/2/3/8861	
Aircraft Registration	ZS-RNN	Date of Accident	02 November 2010	Time of Accident	1430-1500Z	
Type of Aircraft	Robinson R22 Beta		Type of Operation	Private		
Pilot-in-command Licence Type		Commercial Helicopter	Age	38	Licence Valid	Yes
Pilot-in-command Flying Experience		Total Flying Hours	396.4		Hours on Type	Unknown
Last point of departure		Wonderboom Airport(FAWB) - Gauteng Province				
Next point of intended landing		Wonderboom Airport(FAWB) - Gauteng Province				
Location of the accident site with reference to easily defined geographical points (GPS readings if possible)						
House No. 78 Second Street, Rooiwal Approximately 5NM north of FAWB. GPS coordinates: S25° 33.526 E028° 14.862						
Meteorological Information		Surface wind: 300/03knots; Temperature: 29° C; Dew point: 09°C				
Number of people on board	1 + 1	No. of people injured	0	No. of people killed	2	
Synopsis		<p>The helicopter was flown from FAWB to the GFA with the intention to land back at FAWB when the accident occurred. According to eyewitnesses, they saw the helicopter flying very low in a southerly direction towards FAWB. The helicopter

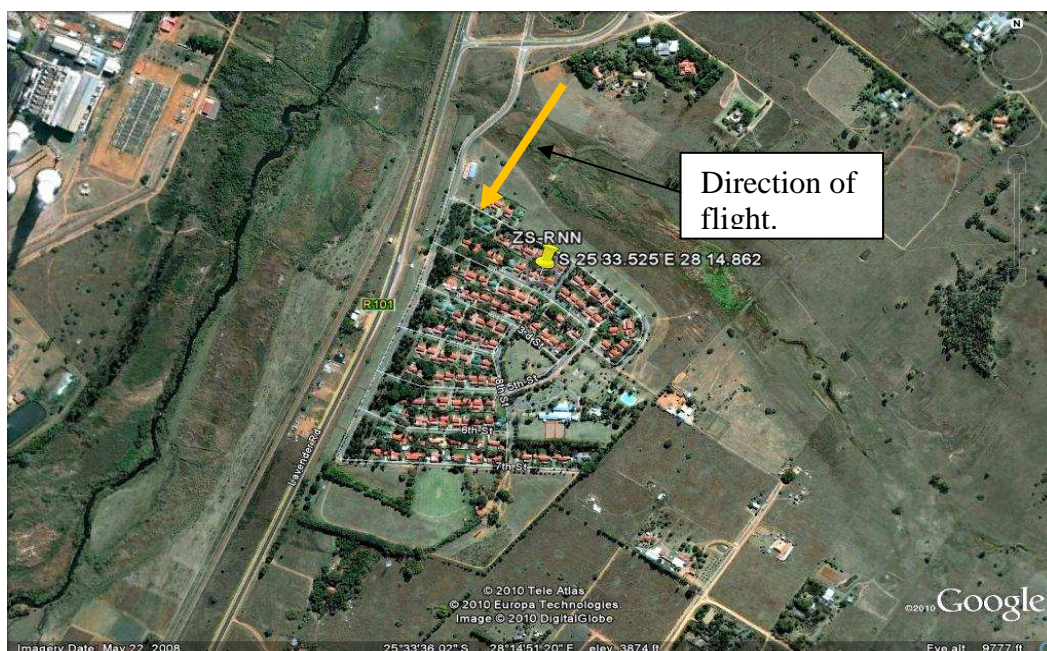
1.10.1 The location of the accident site was on private property of the back of a house in the residential area at Rooiwal, approximately 5nm north of FAWB. The GPS coordinates of S25°33.525' E 028°14.862'

Photo 2: Google view of the accident location.
