AIRCRAFT ACCIDENT REPORT AND EXECUTIVE SUMMARY

Reference:	CA18/2/3/8874	
Aircraft Registration	ZS-LLA	Date of Accident	30 November 2010		Time of Accident	1330Z
Type of Aircraft	PA 46-310P (Piper Malibu)		Type of Operation		Private	
Pilot-in-command Licence Type		Commercial Pilot	Age	46	Licence Valid	Yes
Pilot-in-command Flying Experience		Total Flying Hours	1 153		Hours on Type	560
Last point of departure		Wonderboom aerodrome (FAWB), Gauteng				
Next point of intended landing		Wonderboom aerodrome (FAWB), Gauteng				
Location of the accident site with reference to easily defined geographical points (GPS readings if possible)						
Open area of veld on the extended centreline of runway 29 at Wonderboom aerodrome (GPS position S25°39'8" E28°12'16")						
Meteorological Information		Wind: westerly at 8 kt; Temperature: 26°C; Dew point: unknown; Visibility: > 10 km; Clouds: scattered at 8 000 ft.				
Number of people on board	1 + 0	No. of people injured	0	No. of people killed	0

AIRCRAFT ACCIDENT REPORT

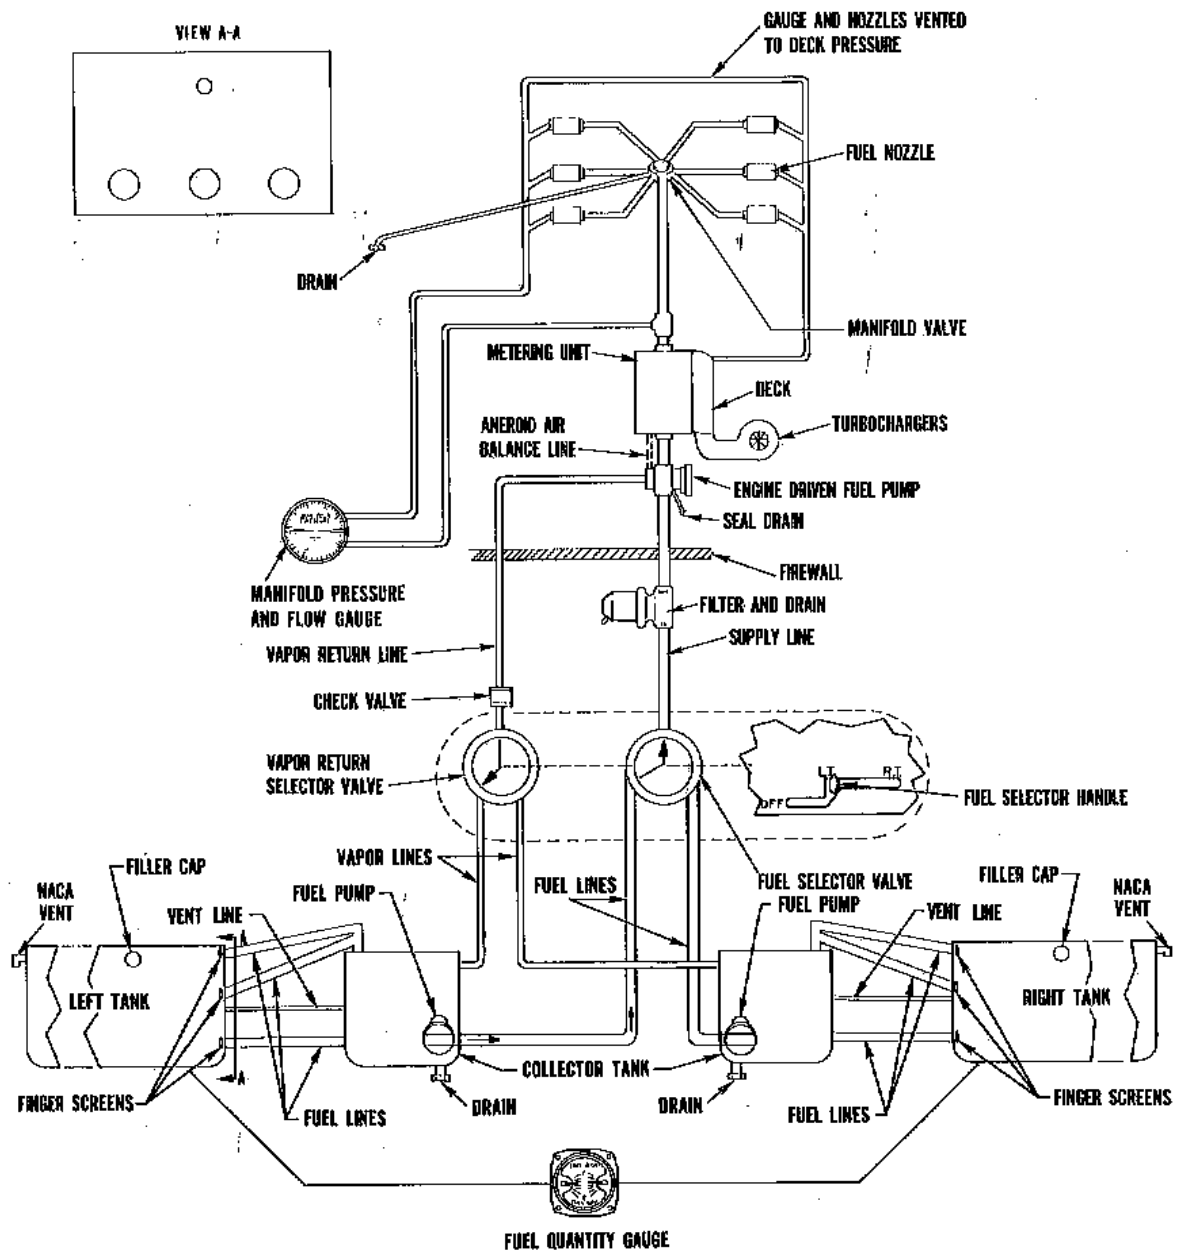
Figure 7. Diagram of Piper Malibu fuel system.

1.18.10 Fuel is stored in two main integral wing tanks, each holding 60 usable gallons and one unusable gallon. The fuel is gravity-fed to a collector tank located at the root of each wing. Reverse fuel flow from the collector tank to the main tank is prevented by two flapper check valves in each collector tank.

1.18.11 Each collector tank has a submerged, electric centrifugal pump for vapour suppression at altitude. It may be used during normal engine operation both on the ground and in the air when selected in the LOW position. An engine-driven fuel pump caters for normal fuel supply. When failure of the engine or engine-driven fuel pump is expected, the electric pump is used in the HIGH position to supply adequate fuel pressure.
