AIRCRAFT ACCIDENT REPORT AND EXECUTIVE SUMMARY

Reference:	CA18/2/3/8894	
Aircraft Registration	ZS-GAA	Date of Accident	8 February 2011		Time of Accident	1433Z
Type of Aircraft	Pilatus PC-12/47 (Aeroplane)		Type of Operation		Private (Part 91)	
Pilot-in-command Licence Type		Commercial Pilot	Age	32	Licence Valid	Yes
Pilot-in-command Flying Experience		Total Flying Hours	2 662.3		Hours on Type	582.2
Last point of departure		Queenstown Aerodrome (FAQT), (Eastern Cape Province)				
Next point of intended landing		Plettenberg Bay Aerodrome (FAPG), (Western Cape Province)				
Location of the accident site with reference to easily defined geographical points (GPS readings if possible)						
Crashed into the sea near Plettenberg Bay (GPS position; South 34°06'.954 East 023°23'.522)						
Meteorological Information		Surface wind; light/variable, Temperature; 20°C, Overcast, light drizzle/mist.				
Number of people on board	2 + 7	No. of people injured	0	No. of people killed	9

AIRCRAFT ACCIDENT REPORT

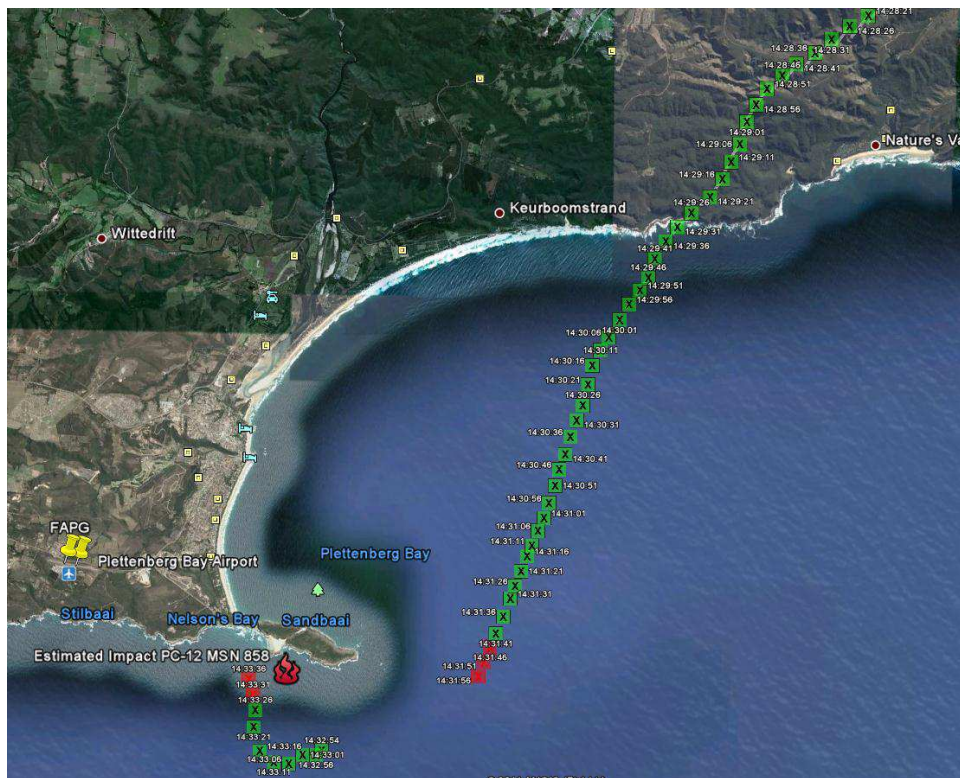
- 1.1.6 Radar footage was obtained for the accident aircraft (ZS-GAA) as well as a Cessna Citation that had landed at FAPG at approximately 1210Z, $\pm 2\frac{1}{2}$ hours prior to the expected time of arrival of the accident aircraft. It is clear from the radar track of the accident aircraft, which had approached Plettenberg Bay from the northeast that the crew had flown a different approach to that of the Cessna Citation crew, which also approached the aerodrome from the north-east (inbound from FALA to FAPG). The Cessna Citation crew joined overhead the aerodrome and then flew the cloud-break procedure for runway 30 twice prior to landing at FAPG. According to a statement that was obtained from both crew members of the Cessna Citation they initiated a go-around on their first approach due to limited forward visibility, associated with low cloud and rain while on final approach for Runway 30. The accident aircraft approached Plettenberg Bay from the northeast and between Keurboomstrand and Nature's Valley descended over the sea in a south-westerly direction for a distance of approximately 7.3 nautical miles (nm), which was followed by a right turn around the Robberg Nature Reserve point (see radar trajectory below). Prior to radar coverage being lost with the aircraft there was no indication that the crew had initiated any change in course, which could be associated with a diversion to George aerodrome (FAGG).

A clip of the radar footage reflecting the accident aircraft's approach path for an intended landing at FAPG.

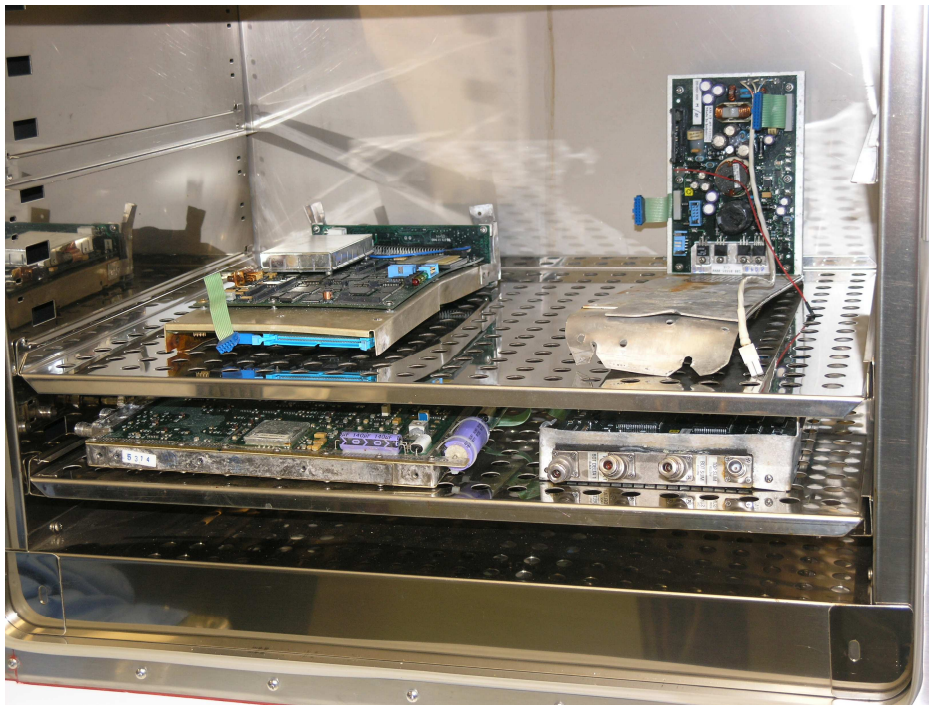
The dismantled unit being prepared for the drying out phase at the Honeywell laboratory.

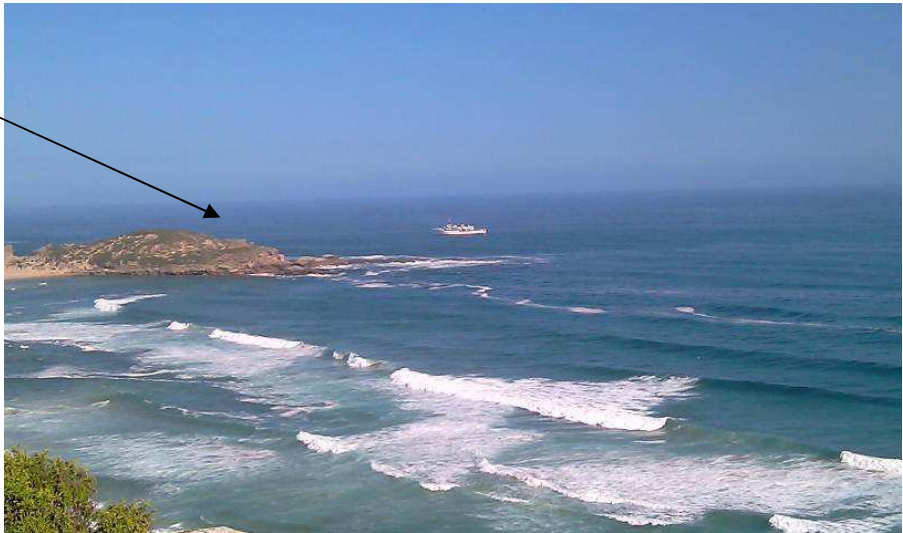
Figure 1. Estimated impact location (viewed from land).

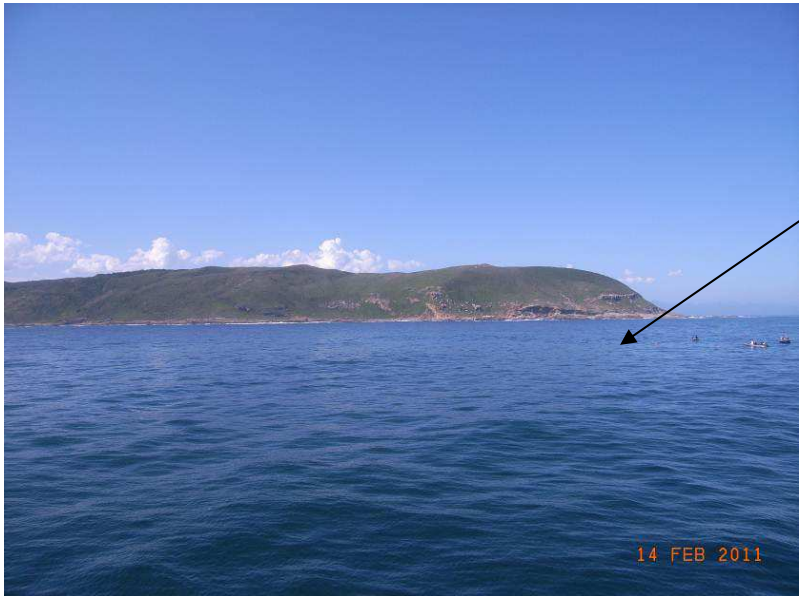
Estimated impact location

Figure 2. A view from the sea of the estimated impact location.

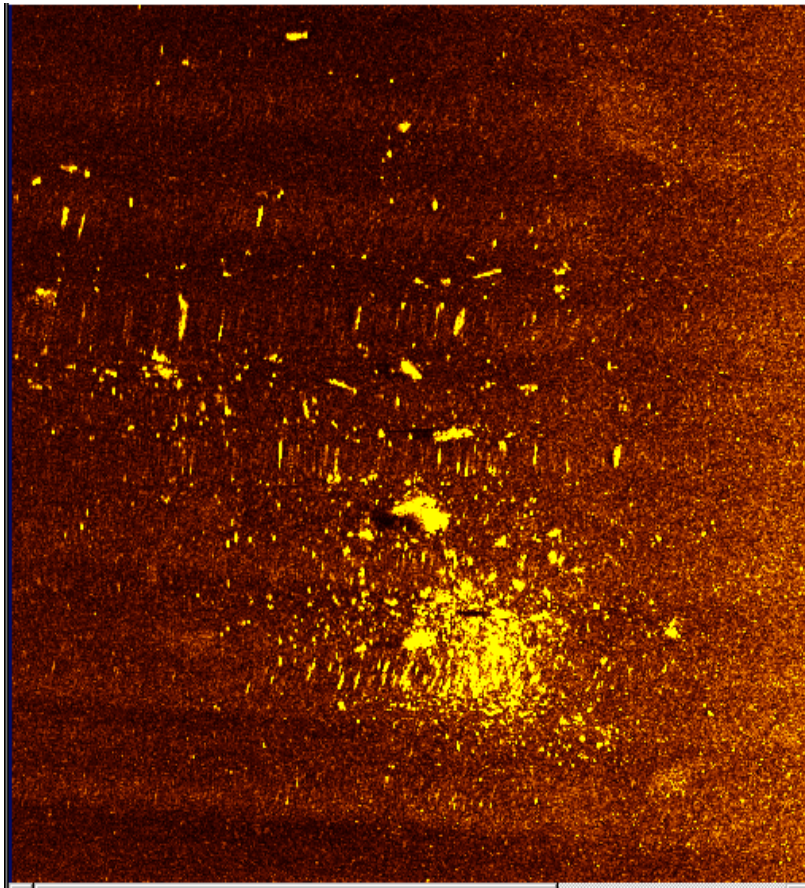
1.12.2 The image (see figure 3 on next page) was made available by the South African Navy, and indicates the images that were picked up by the side scan sonar that was being utilized in order to locate the wreckage. The image provides reflections and no actual components/parts could be allocated to a certain object as reflected, but it does provide the reader with some insight into the wreckage field.

Figure 3. Side scan sonar image of debris field under the water courtesy of SA Navy.

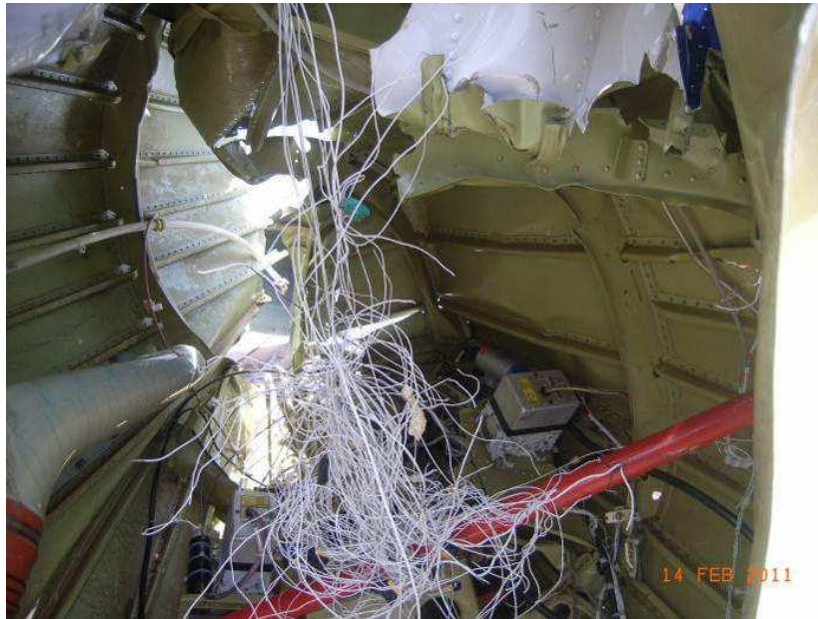
Figure 14. Forward section of the empennage.

The forward section of the empennage, the vertical stabiliser including the rudder as well as the horizontal stabiliser were recovered from the sea. The rudder and flight control cables were still attached to the horizontal stabiliser with minor damage observed. The cables were found to have fractured under tension/overload. The horizontal stabiliser had separated at its attachment to the vertical stabiliser with substantial damage observed on the right-hand surface, which could be associated with impact. The elevator was still attached to the horizontal stabilizer and the hinges were damage by impact forces. Approximately half of the left-hand surface was missing; this was associated with impact damage. The push-pull rod from the bell-crank to the elevator was found to be fractured and bent. The control cables were still attached to the bell-crank. The cables were found to have fractured in overload mode. Up to this point continuity was established. As no other pieces of

the elevator control system were found the continuity of the forward part of the system could not be established.

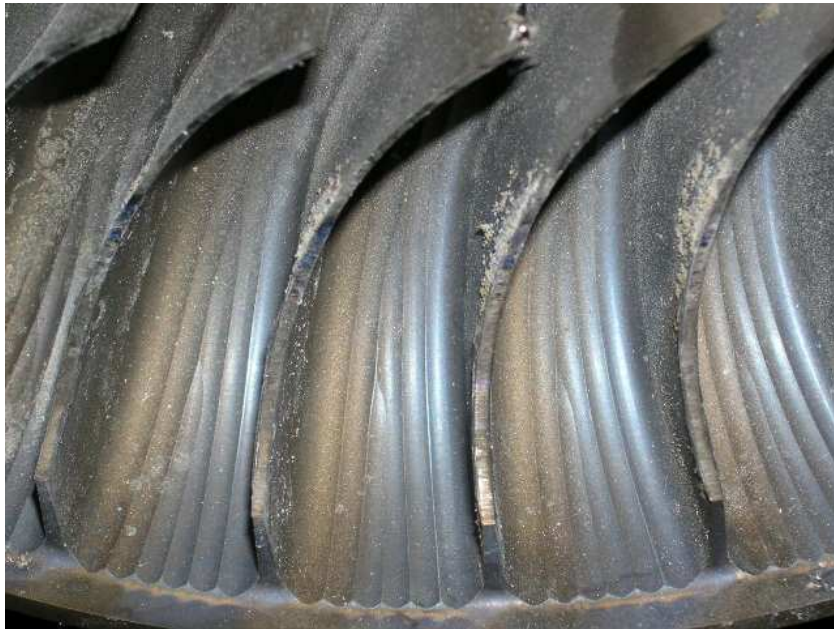
Photo No. 4
Centrifugal impeller detail.

Centrifugal Impeller: The vane airfoils tips displayed circumferential rubbing, with light frictional heat discoloration, due to contact with the impeller shroud. Refer to photo No. 4 on the next page.

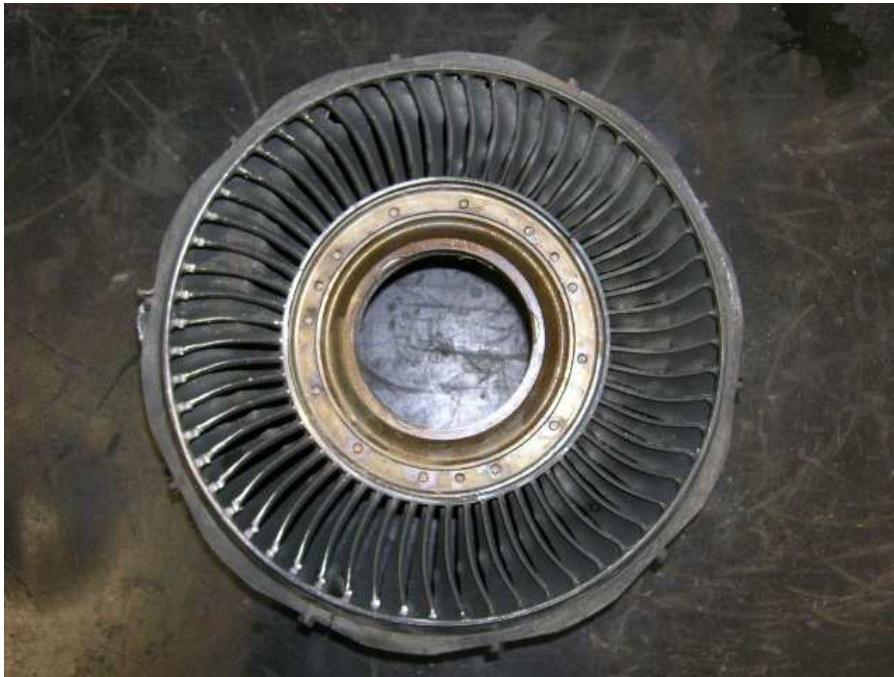
Photo No. 12
2nd stage power turbine vane ring, upstream side.

circumferential rubbing, with frictional heat discoloration, due to contact with the air seal rotor knife edges. Please refer to photos No. 12 and 13.

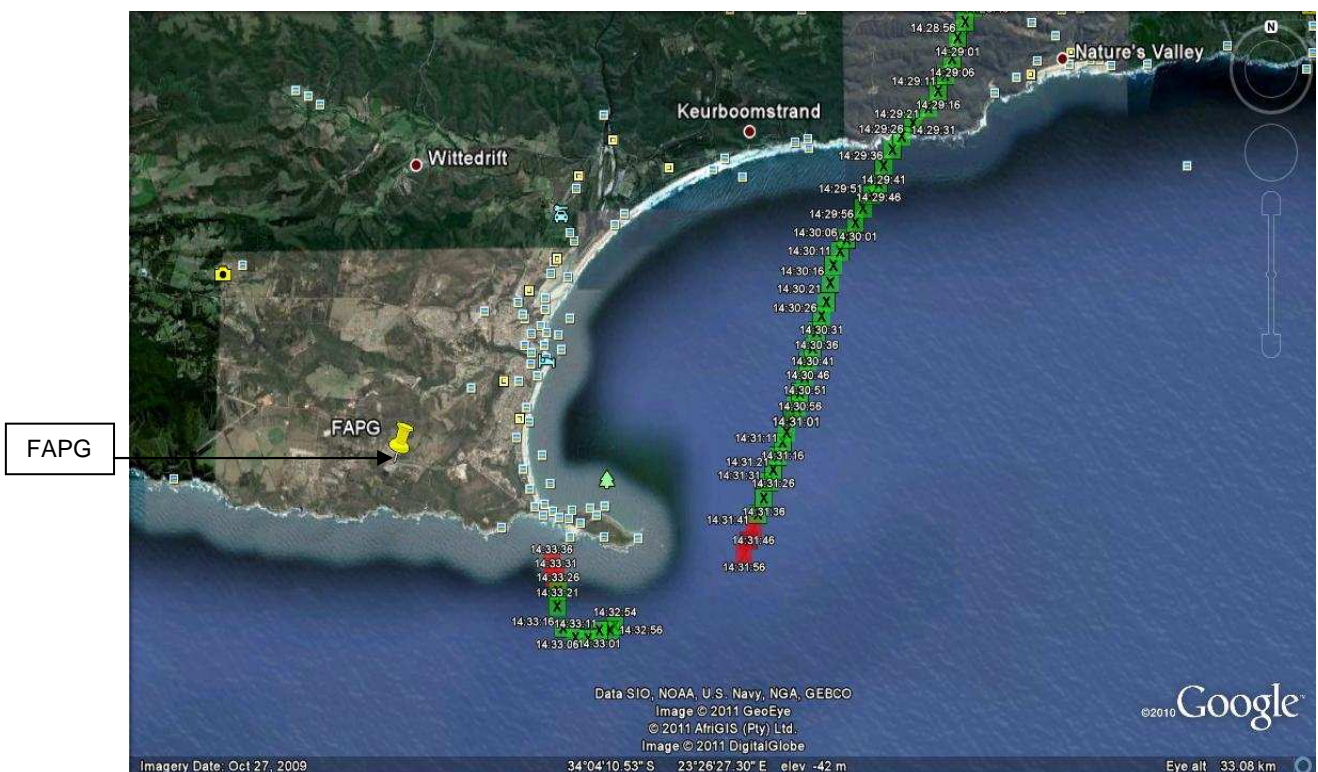
The radar pattern reflects the trajectory that was flown by the aircraft ZS-GAA before disappearing off radar.

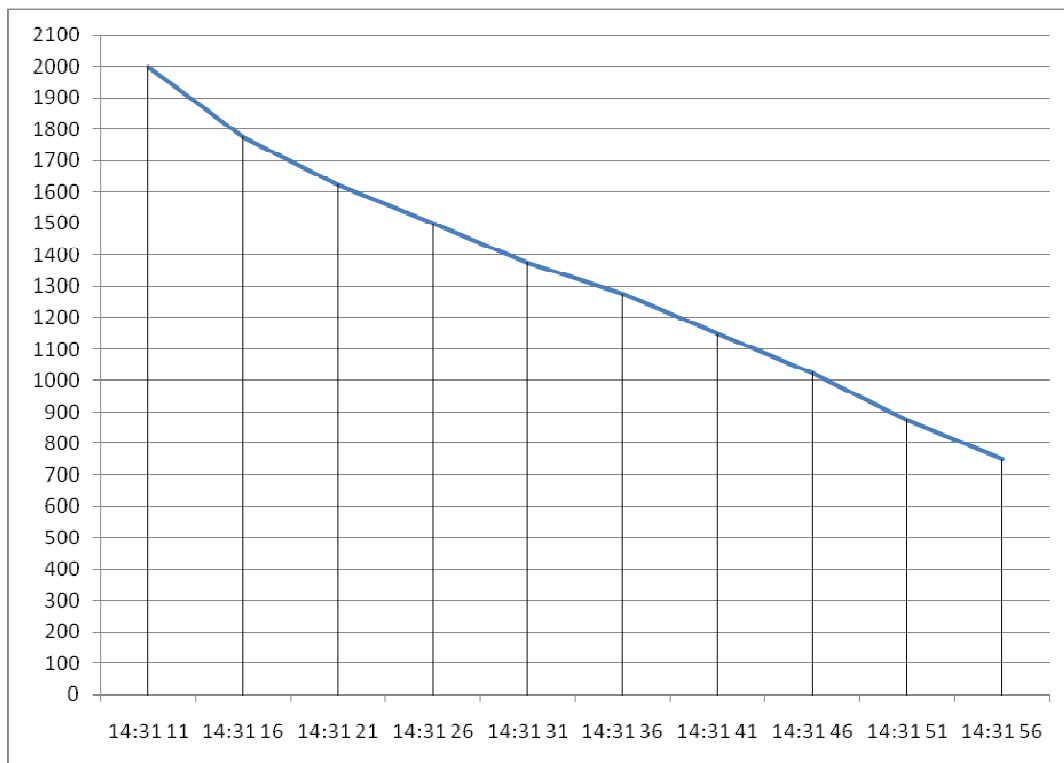
The graph below was compiled utilizing the last ten radar points while the aircraft was descending over the sea in a south-westerly direction prior to it commencing with the right turn around the Robberg Nature Reserve. From the graph it was possible to ascertain that the aircraft was indeed in a constant rate of descent.

The graph depicts the height (y-axis) of the aircraft in relation to the time (x-axis) of the last ten radar points.

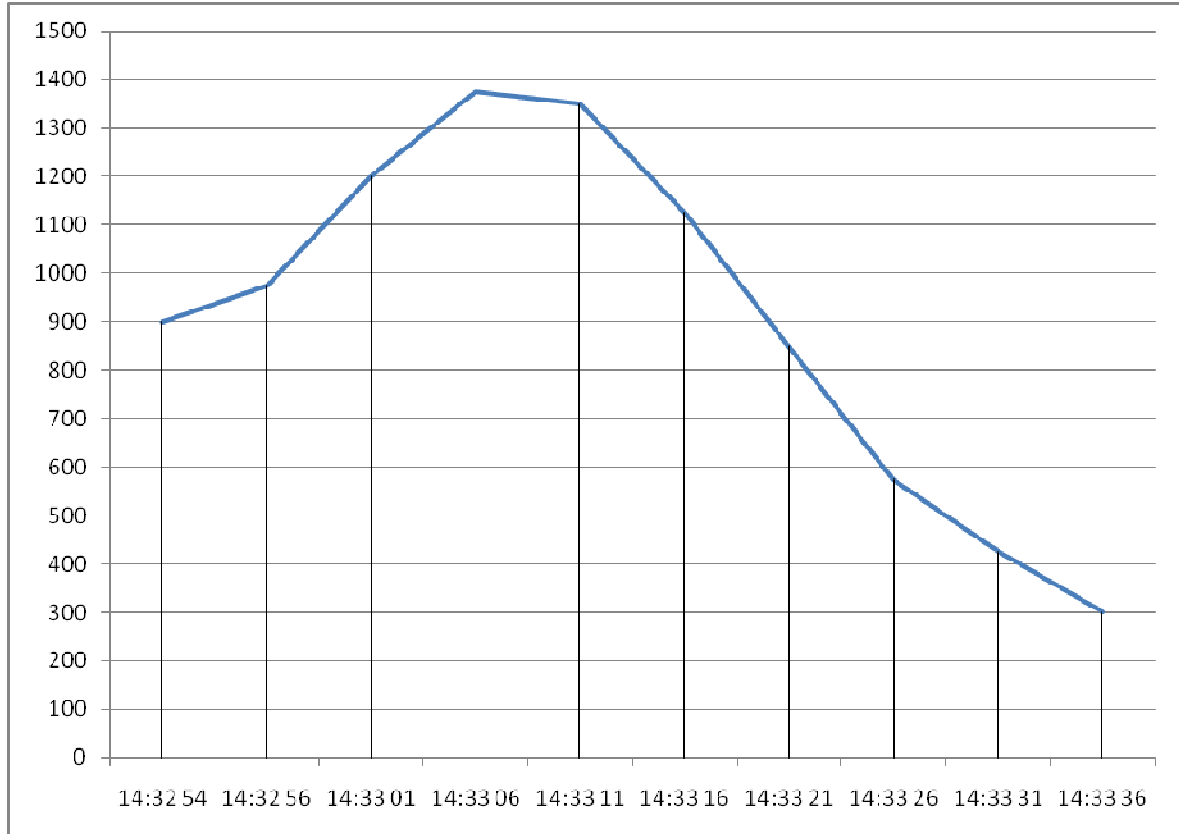
It is of interest to note that the aircraft was on the descend and during the right turn it pitched up from a height of 900 feet AMSL (position 1 of 10) to a height of 1 375 feet within a period of 12 seconds. This accounts to a rate of climb (ROC) of 39.6 feet per second or 2 375 feet/min. During these few seconds the speed decayed from 168 to 151 knots. The pitch-up event was followed by an immediate pitch-down event with an associated rate of descent (ROD) of approximately 2 400 feet/min. Between points 6 and 8 the ROD increased to 3 300 feet/min (this data was obtained by only utilizing data from the green track radar points). The aircraft continued to descend until it disappeared from radar. At no stage was the aircraft flown at or near the stall speed which may have varied between 84 to 90 knots.

The graph depicts the height (y-axis) of the aircraft in relation to the time (x-axis) of the last ten radar points.

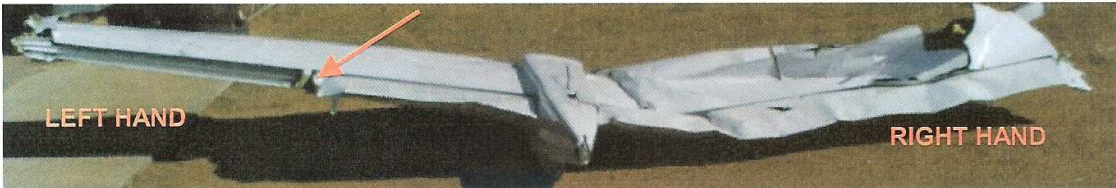
ITEM: HORIZONTAL STABILIZER, PILATUS PC-12, AIRCRAFT NUMBER ZS-GAA																							
1. INTRODUCTION & BACKGROUND																							
1.1. The remainder of the left hand elevator removed from the T-tail (Photo 1) from a crashed Pilatus PC-12, aircraft number ZS-GAA , was submitted to determine the possible fracture mode/s during operation and/or impact.

Photo 1: ZS-GAA T-tail with elevator orientation (digital)

The left hand elevator failed adjacent to the mid-span bracket position (Photo 1, red arrow). The remainder could not be retrieved. Closer inspection revealed the direction of failure to be upward and inboard (Photo 3, blue arrow). The indications of buckling (Photo 3, red arrow) can be attributed to the initial (inboard and aft direction) failure of the outboard hinge (Photo 4, blue arrow). This left the lightweight elevator exposed resulting in the position of fracture at the weakest point - adjacent to the mid-span hinge. Both left and right hand outboard elevator hinge brackets revealed extensive impact damages (Photo's 4 and 5). The fracture surfaces revealed no clear indications of pre-impact crack formation or other material discrepancies (Photo 6).

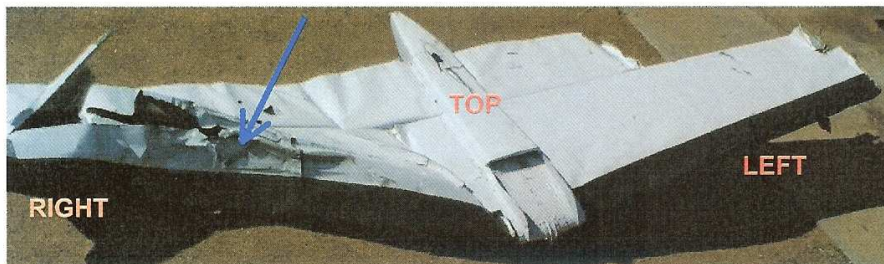
The on-site visual examination revealed the horizontal stabilizer assembly severed from the remainder of the T-tail on impact. The right-hand leading edge of the horizontal stabilizer revealed damages typical of a water impact (Photo 2, blue arrow). The position thereof point towards a right wing down orientation for the T-tail horizontal stabilizer on impact. However, further investigation will be necessary to determine if this impact orientation, related to the horizontal stabilizer, is reminiscent of the actual aircraft orientation on impact.

Photo 2: ZS-GAA horizontal stabilizer (digital)

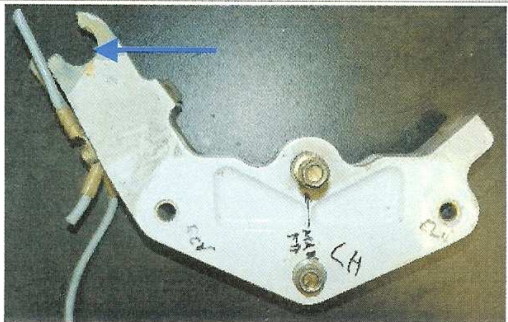
The elevator control bracket fractured at the connection point (Photo's 7 and 8, blue arrows). The fracture surface revealed no clear indications of pre-impact crack formation or indications of unusual wear. The top and bottom stop positions (Photo's 8 and 9, red arrows) revealed no clear indications of excessive impact damages or wear. The elevator counter weight, still attached to the vertical section of the T-tail, proved to be in good condition with no clear indications of mechanically induced damages during operation (Photo 10, blue arrow).

Photo 7: Elevator control bracket (digital)

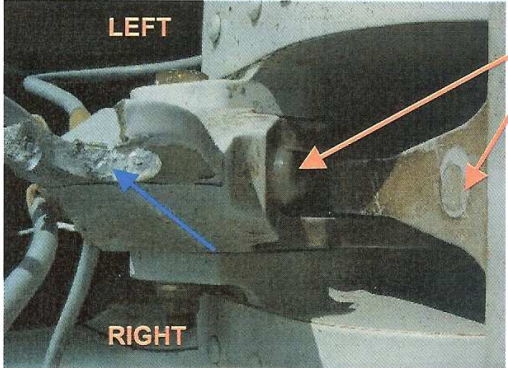
Photo 8: Elevator control bracket stop, bottom (digital)

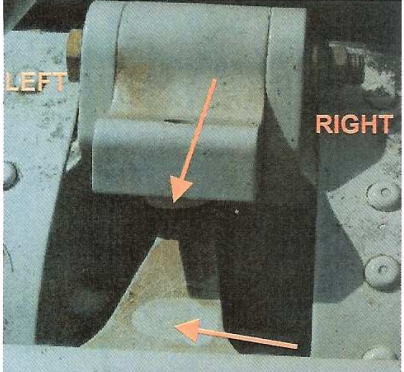
Photo 9: Elevator control bracket stop, top (digital)

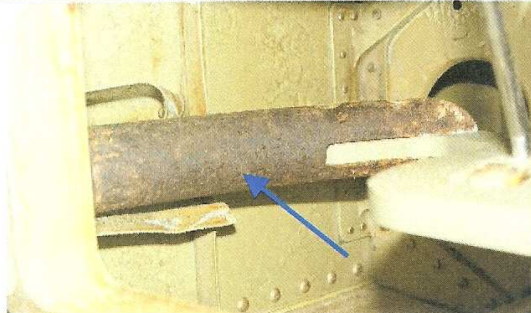
Photo 10: Elevator counter weight (digital)

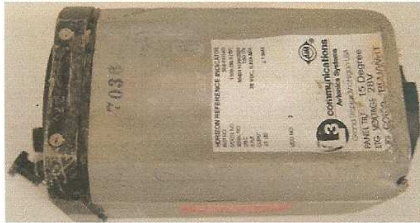
6. INVESTIGATION RESULTS		
6.1.1. Attitude Indicator (AI) P/N 504-01110-930 S/N 504011193025230. The visual examination revealed extensive impact damages (Photo 2) on the ZS-GAA AI rendering the inner gyroscopic parts unmovable, particularly in the roll plane. The as found indication (Photo 3) corresponds with a right wing down ($\pm 110^\circ$), nose-up ($\pm 25^\circ$) attitude.		
A serviceable attitude indicator (not the exact model) was opened (Photo 4) for reference purposes to the AI from ZS-GAA as well as a basic layout diagram (Diagram 1). X-ray photographs were taken of the ZS-GAA AI from a top- and side view perspective (Photo's 5 and 8).		
The x-ray photograph of the ZS-GAA AI designating the side view (Photo 5) clearly revealed two distinct features (Photo 5, red arrows) that correspond with the attachment positions (Photo 6, red arrow) between the roll- and pitch gimbals (Diagram 1). These reference positions were exploited to determine the corresponding roll indication (Photo 9) of $\pm 100^\circ$ right wing down.

Photo 2: ZS-GAA Attitude Indicator (digital)

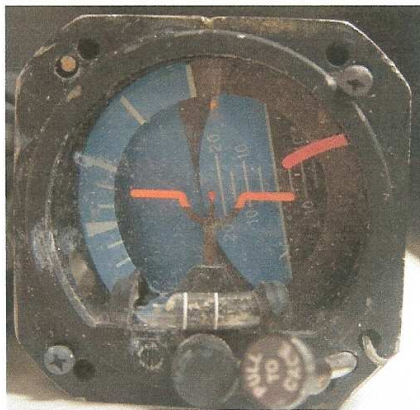
Photo 3: ZS-GAA Attitude Indicator, faceplate indication, as supplied (digital)

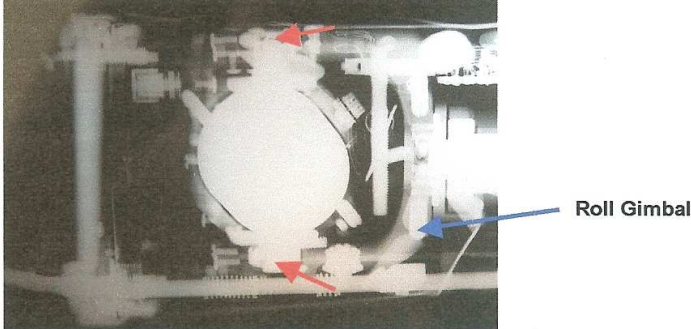
Photo 5: X-ray side view, ZS-GAA AI (X-ray)

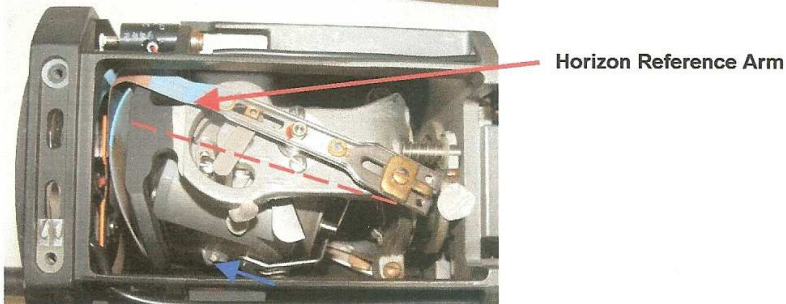
The x-ray photograph of the ZS-GAA AI designating the top view (Photo 8) revealed two distinct screw positions (Photo 8, blue arrows) to be found on both sides of a pitch gimbal (Photo 7, blue arrow). These reference positions, combined with the perceived angle of the pitch gimbal (Photo's 7 and 8, red dashed line), were exploited to determine the corresponding pitch indication (Photo 9) of $\pm 40^\circ$ nose-down.		
Comparatively the two indications (Photo10) reveals that although the two roll indications associate favorably, the pitch indications do differ extensively. This can be attributed to the possible movement of the pitch gimbal from ZS-GAA after impact as the induced damages only arrested the larger, and outer, roll gimbal on impact.

Photo 7: Top view, reference AI (digital)

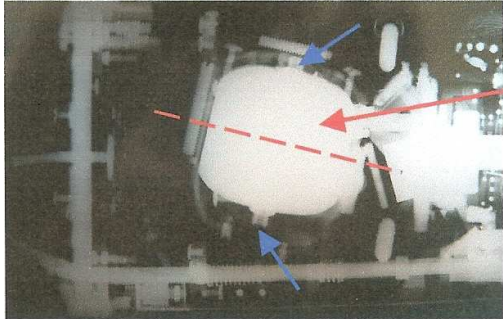
Pitch Gimbal

Photo 8: X-ray top view, ZS-GAA AI (X-ray)

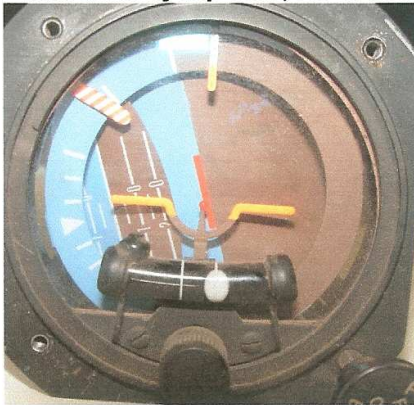
Photo 9: Corresponding reference AI indication (digital)

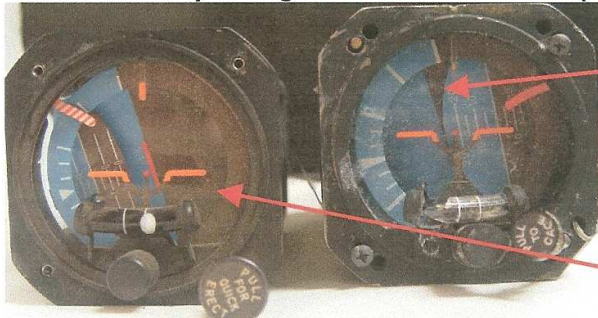
ZS-GAA Attitude Indicator,
as found

Photo 10: Comparative AI indications (digital)

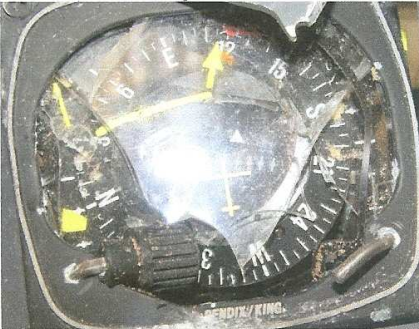
6.1.2. Direction Indicators x2 (DI) NAV 1: P/N 066-3060-01 S/N 12080, NAV2: P/N 066-3046-07 S/N ----96910. Although the visual investigation revealed extensive impact and corrosion damages to both ZS-GAA DI's (Photo's 1 and 11), the extent of damages proved to be insufficient to arrest the inner gyroscopic parts for impact analysis purposes. However, both DI's revealed comparable readings of 115° (Photo 12) and 105° SE. This could not conclusively be confirmed as the actual direction of impact.

Photo 12: Direction Indicator, NAV 2 (digital)

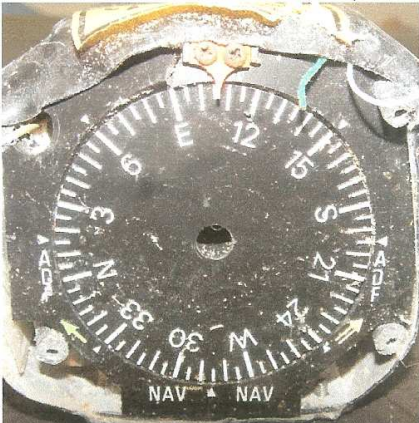
Photo 13: Direction Indicator, NAV 1 (digital)
