AIRCRAFT ACCIDENT REPORT AND EXECUTIVE SUMMARY

Reference:	CA18/2/3/8896	
Aircraft Registration	ZS-HWR	Date of Accident	20 February 2011		Time of Accident	1425Z
Type of Aircraft	Enstrom 280 FX Helicopter		Type of Operation		Private	
Pilot-in-command Licence Type		Private Pilot	Age	55	Licence Valid	Yes
Pilot-in-command Flying Experience		Total Flying Hours	293,0		Hours on Type	104,1
Last point of departure		Kitty Hawk Aero Estate Airstrip (FAKT)				
Next point of intended landing		Kitty Hawk Aero Estate Airstrip (FAKT)				
Location of the accident site with reference to easily defined geographical points (GPS readings if possible)						
Open stretch of veld on southern side of Kitty Hawk Aero Estate Airstrip at GPS co-ordinates S25°24 45.2 E028°17 30.9.						
Meteorological Information		Temperature: 25°C; Visibility and clouds: CAVOK.				
Number of people on board	1 + 1	No. of people injured	0	No. of people killed	0	
Synopsis		<p>The pilot, accompanied by a passenger, was engaged on a private flight from Kitty Hawk Estate Airfield. During the flight, the engine spluttered and suddenly lost power. The pilot began executing an autorotation emergency landing on an open stretch of veld,

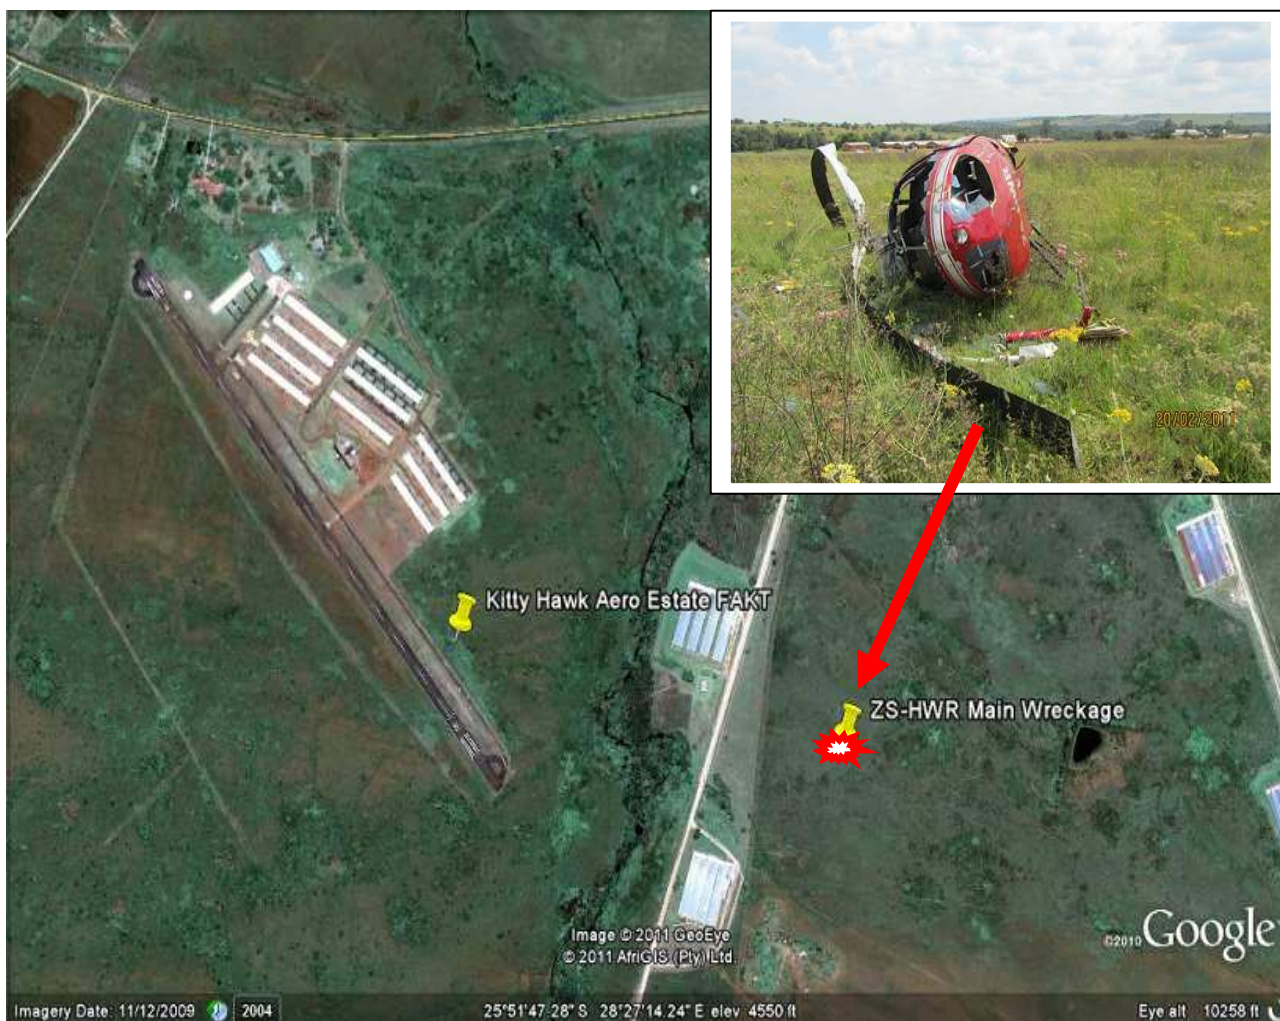
Figure 2. The location of the accident site.

1.12.1 The pilot flew the helicopter on a private flight in the area of Kitty Hawk Aero Estate Airstrip. The pilot was flying in southerly direction when a sudden loss of engine power led to an autorotation emergency landing on an open stretch of veld on the southern side of the airfield.
