AIRCRAFT ACCIDENT REPORT AND EXECUTIVE SUMMARY

Reference:	CA18/2/3/8923	
Aircraft Registration	ZS-PGT	Date of Accident	18 April 2011		Time of Accident	09:00Z
Type of Aircraft	Air Tractor 401		Type of Operation	Agriculture (Aerial Crop Spraying)		
Pilot-in-command Licence Type		Commercial	Age	33	Licence Valid	Yes
Pilot-in-command Flying Experience		Total Flying Hours	2458.0		Hours on Type	1841.0
Last point of departure		Monzi – FAMU (Mkuze)				
Next point of intended landing		Monzi – FAMU (Mkuze)				
Location of the accident site with reference to easily defined geographical points (GPS readings if possible)						
At a soccer field approximately 5 NM north of FAMU						
Meteorological Information		Wind: Light & Variable, Temperature: 22°C, Cloud cover: 6/8, Cloud base: 2500 ft, Dew point: 20°C, Visibility: Good.				
Number people on board	1 + 0	No. of people injured	0	No. of people killed	0	
Synopsis						
<p>The pilot flew the aircraft on an agriculture - crop spraying detail. The pilot completed five spray runs which were uneventful with the aircraft performance being satisfactorily. The pilot reported that during the sixth spray run, the aircraft suddenly developed a severe vibr

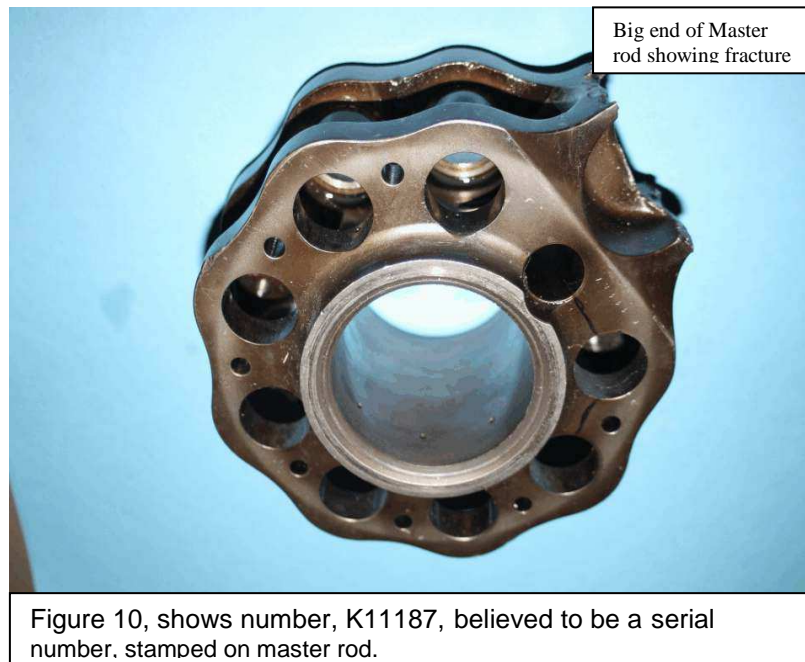
Figure 8, shows broken piston (#5 and #6) skirts.

1.16. 1.11 The engine teardown examination was concluded as follows: The master rod was the first part to fail. The reason is that the piston skirts were all damaged due to the scraper rings of each piston pulled out of the cylinder barrels. This situation can only occur during master rod failure.
