**REPORT
OF ACCIDENT TO
PAWAN HANS HELICOPTER LTD Mi-172 HELICOPTER
VT-PHF ON 19TH APRIL 2011 AT
TAWANG, ARUNACHAL PRADESH**

**GOVERNMENT OF INDIA
MINISTRY OF CIVIL AVIATION**

**REPORT
OF ACCIDENT TO
PAWAN HANS HELICOPTER LTD
Mi-172 HELICOPTER VT-PHF
ON
19TH APRIL 2011 AT
TAWANG, ARUNACHAL PRADESH
BY
COMMITTEE OF INQUIRY
COMPRISING**

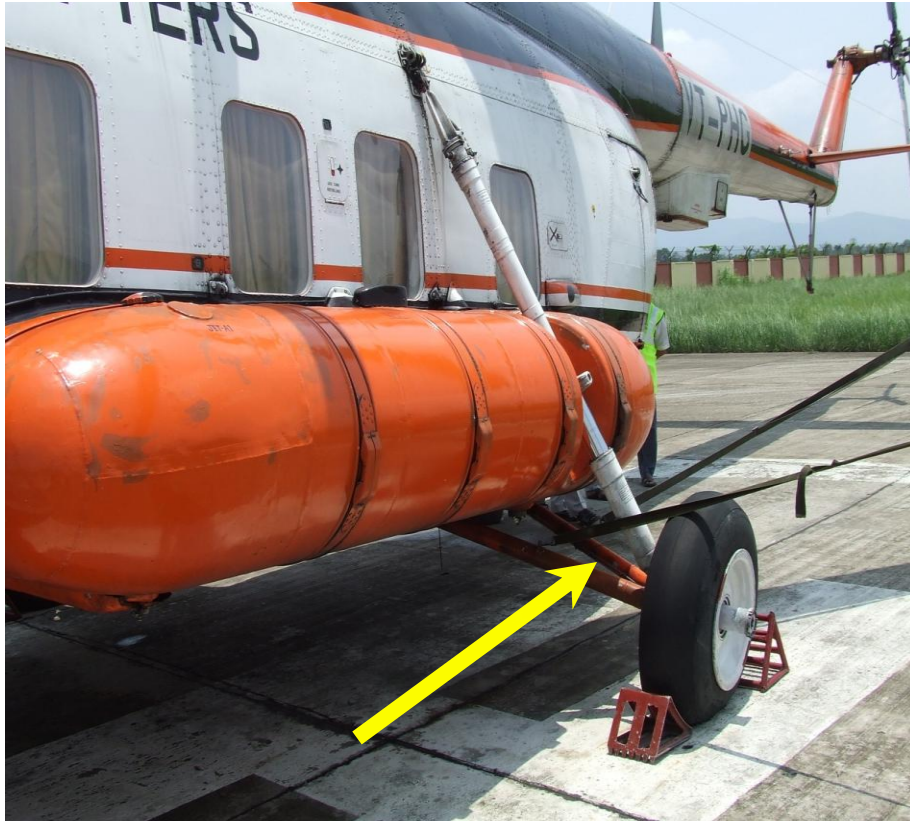
Photo:5

The main landing gear consists of an oleo-pneumatic shock absorber (Oleos/Oleo leg), a radius rod (at the leading edge) and a side strut at the rear end. The Oleo leg is a welded tubular steel structure with a two-chamber shock absorber forming the vertical leg of the pyramid. It is attached at the top with bolts to the side of the fuselage and at the bottom to the axle of the main wheel. The radius rod and the side strut form the base triangle of the pyramid. The eye lug welded to one end of the rod is secured to the bottom of the fuselage. Welded to the other end of the radius rod are a wheel brake attachment flange, side strut attachment eye lug, the eye lug used for attachment of a shock strut universal joint and the eye lug for attachment of a towing gear. Press fitted on to the radius rod is the wheel axle, which is secured in position with two tapered bushings tightened with bolts. The thread cut on one end of the axle serves to receive a wheel attachment nut. The side strut is also a welded tubular structure, which at one end is secured to the bottom of the fuselage.

The other end is fitted to the eye lug on the radius rod. The side strut internal space is used as a compressed air bottle operating at a pressure of 500 Kpa (50kgf/cm<sup>2</sup>). The air is used for wheel brakes and can also be used for inflating the wheels through special connections provided at the side strut.

### Landing Gear

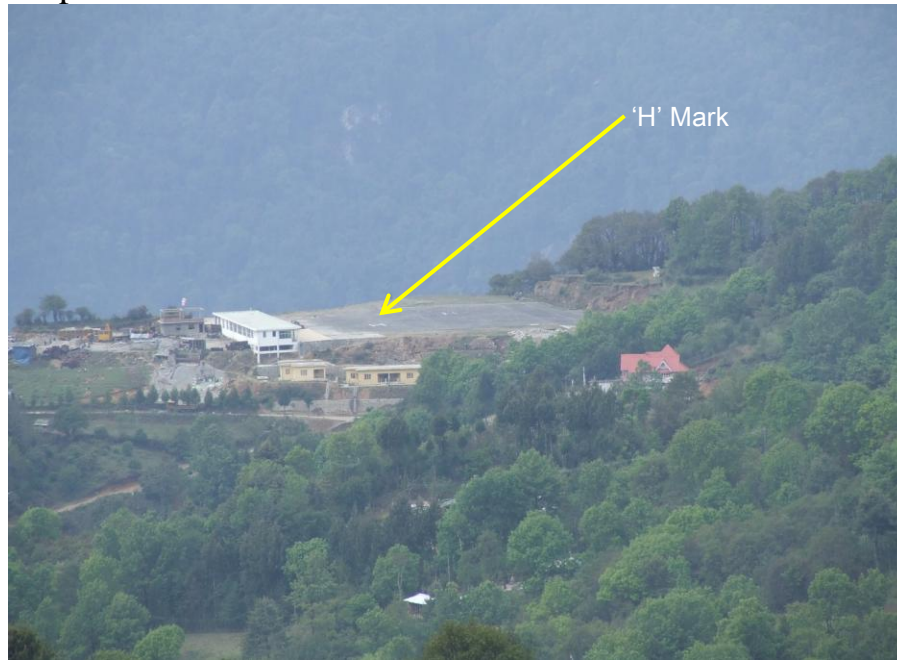
Photo: 6 Tawang Helipad as seen from Army Helipad

The windsock installed on the western side of helipad at times gives conflicting speed and direction of wind compared to the main windsock on the Eastern side. However some pilot contended that while making approach to the H marking on the Western side, that windsock is more relevant.

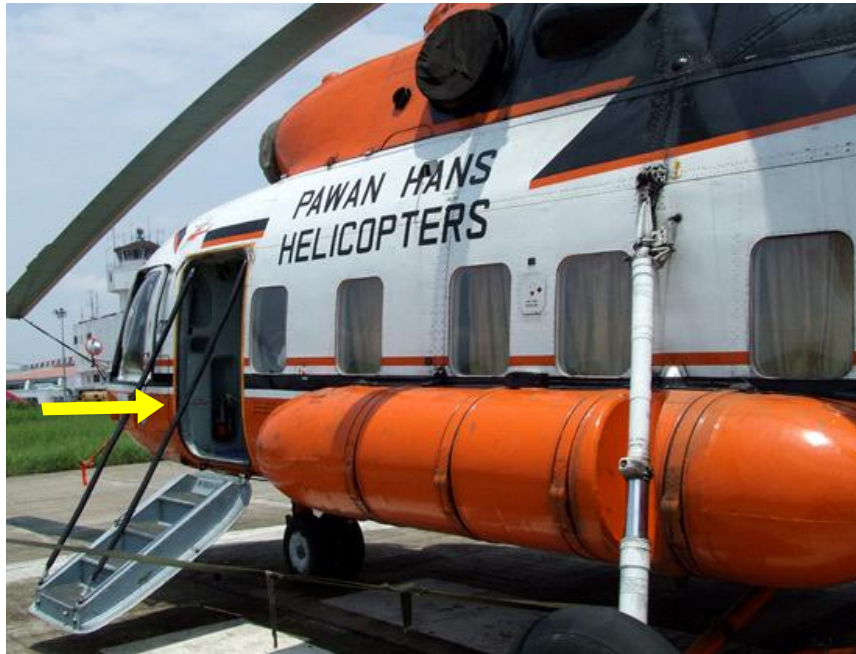
Photo : 15

Passenger Entry Door/Emergency Exit

The helicopter has four emergency exits. One is the passenger entry door itself on the port side.

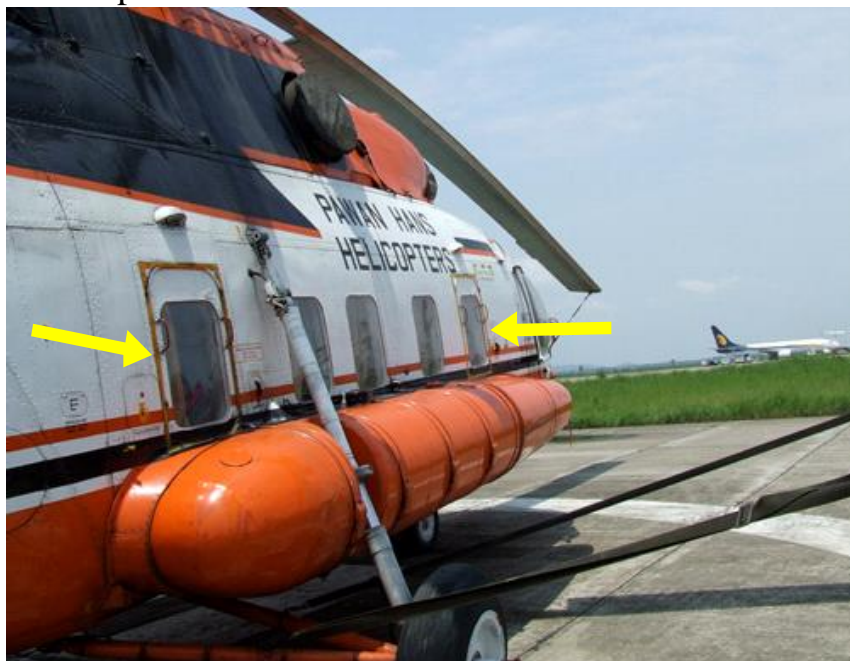
Photo : 16

Emergency Escape Starboard

Two windows on the starboard side are also emergency exits. In addition an area marked for cutting open from the outside also exists.

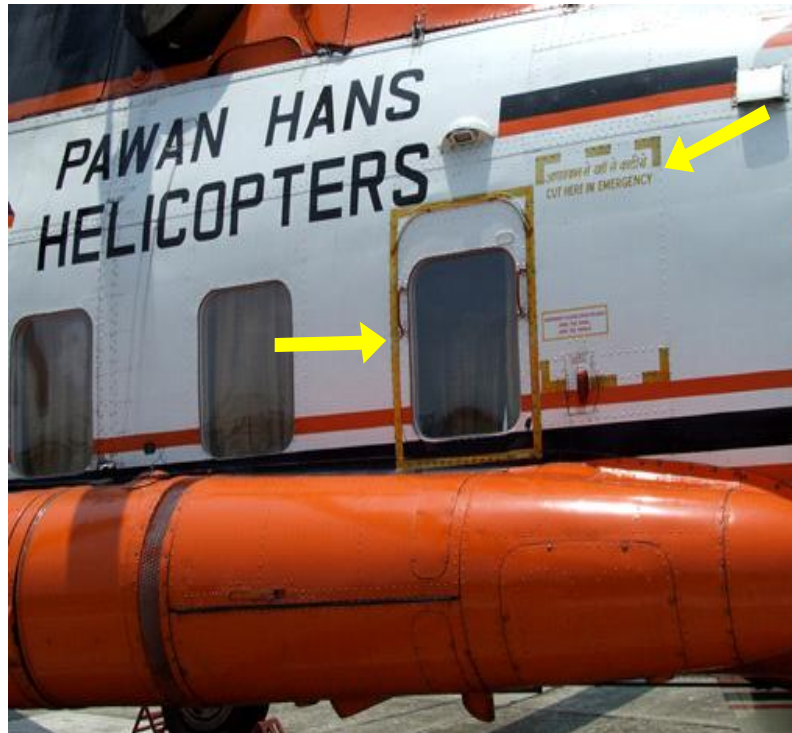
Photo : 17 Emergency Starboard Escape(Forward) and Cut Away

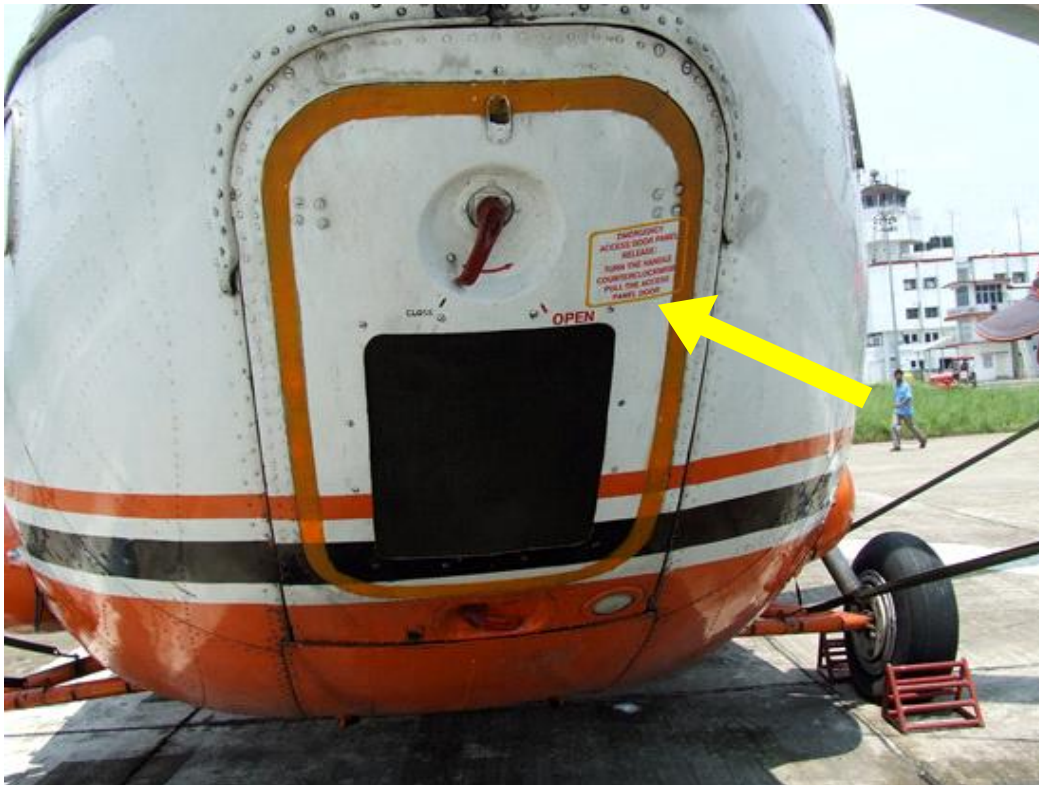
Photo : 18

The baggage-handling door at the rear is also an emergency exit.

Rear Emergency Exit
