<b>AIRCRAFT ACCIDENT REPORT AND EXECUTIVE SUMMARY</b>
---

Reference:	CA18/2/3/8930	
<b>Aircraft Registration</b>	ZS-KSZ	<b>Date of Accident</b>	28 May 2011		<b>Time of Accident</b>	0901Z
<b>Type of Aircraft</b>	Cessna R182		<b>Type of Operation</b>	Private (Air Race)		
<b>Pilot-in-command Licence Type</b>	Private	<b>Age</b>	68	<b>Licence Valid</b>	Yes	
<b>Pilot-in-command Flying Experience</b>	Total Flying Hours	1 924		Hours on Type	Unknown	
<b>Last point of departure</b>	Mafikeng Aerodrome, Mafikeng, Northwest Province					
<b>Next point of intended landing</b>	Mafikeng Aerodrome, Mafikeng, Northwest Province					
<b>Location of the accident site with reference to easily defined geographical points (GPS readings if possible)</b>						
At Blokkloof Farm, Koster, Northwest Province (GPS: S25°42.689 E026°50.348 at 4553 feet elevation)						
<b>Meteorological Information</b>	Temperature: 17°C; Dew point: -03°C; Wind: 360°08k nots; Cloud cover: None; Visibility: 10km

## AIRCRAFT ACCIDENT REPORT

**Name of Owner/Operator** : Wally Brink Property Investments  
**Manufacturer** : Cessna Aircraft Company  
**Model** : R182  
**Nationality** : South African  
**Registration Marks** : ZS-K

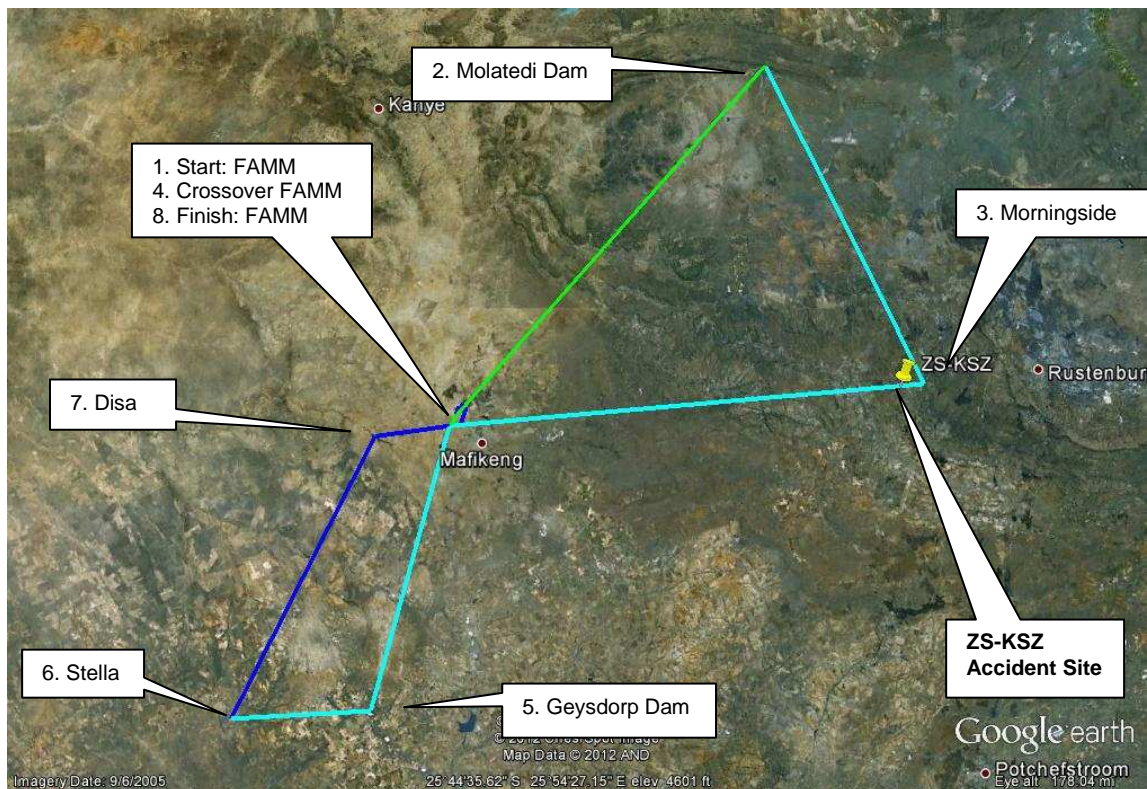
**Photo 1:** Google Earth photo of the race path.

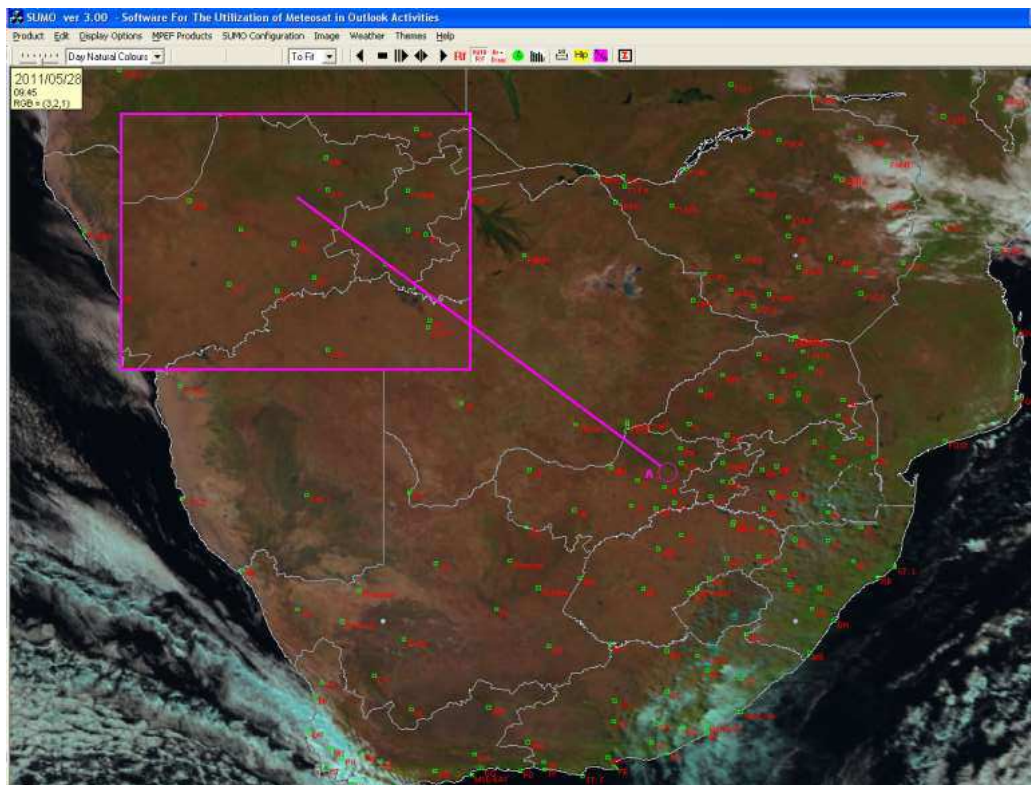
- SATELLITE IMAGE (09:45Z 28th May 2011)  
*The satellite image shows clear sky over the area of incident/accident (Photo 6).*
- WEATHER CONDITIONS IN THE VICINITY OF THE INCIDENT  
*METARs from the selected stations show light winds close to the ground and very dry conditions over the surrounding areas.*

**Photo 6:** Satellite image of the weather.

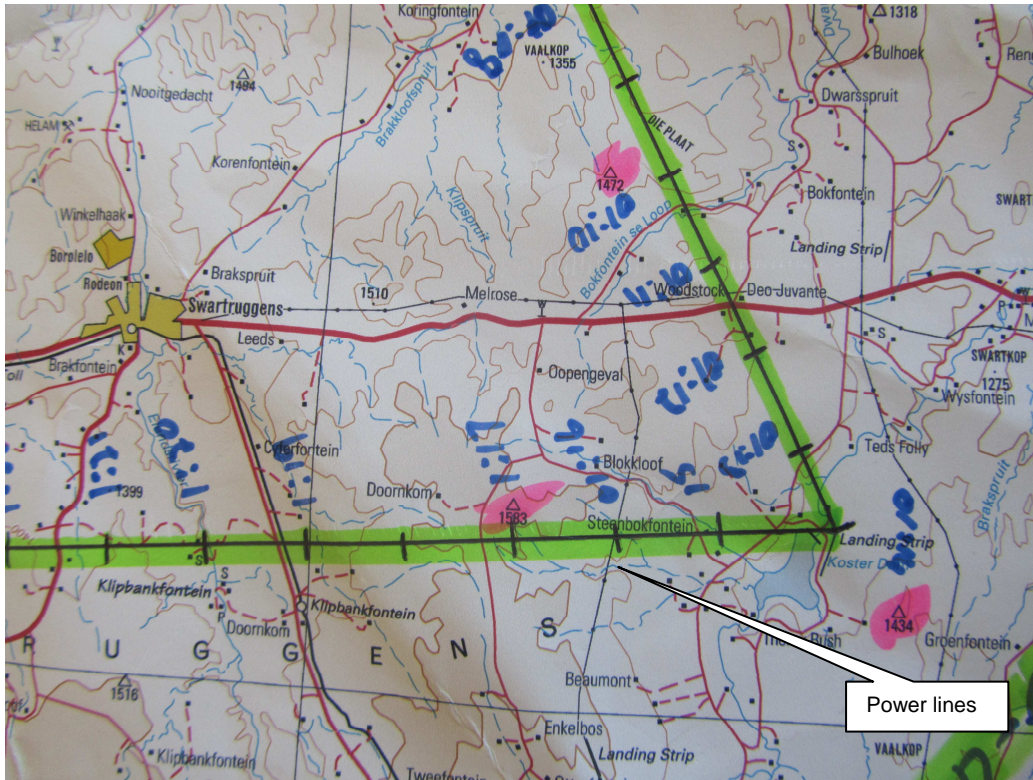
- (a) Earth wire to Aircraft landing gear – 2.68 m
- (b) Aircraft landing gear to Main high tension wire – 1.32 m
- (c) Earth wire and Main high tension wire – 4 m

Consequently the aircraft was at a height of 44.82 m (147 feet) AGL when it impacted the earth wire.

**Photo 9:** Portion of map which indicates the high tension wires
