# CIVIL AIRCRAFT FACTUAL INCIDENT REPORT

CAV/INC/BOP/11

AIRCRAFT: CESSNA 208B CARAVAN

REGISTRATION: 5Y-BOP

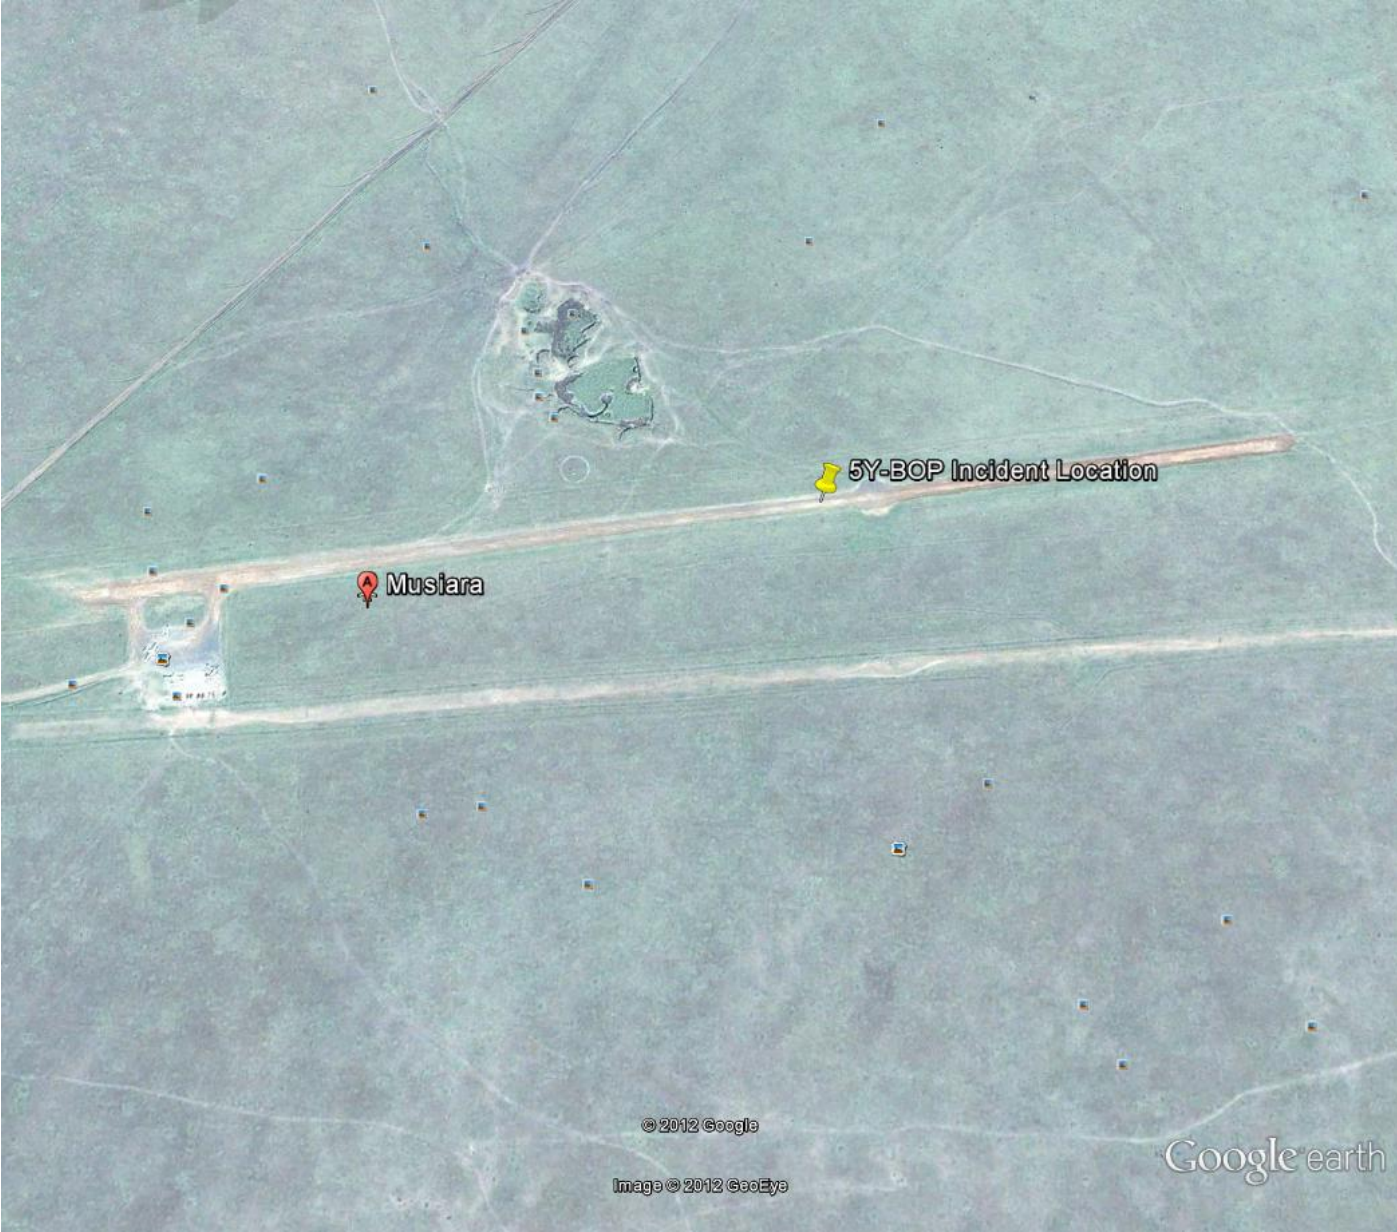
**Incident Location on Musiara Airstrip**

The flight was being conducted into an unfenced airstrip inside the Masai Mara Game Reserve. Wild animals, therefore, had free access to the runway area and posed a safety hazard to aircraft landing in such airstrips. The Authority in charge of the Game Reserve including the airstrip was Ol Kejuado County Council. The operator, the Governor's Camp, and Ol Kejuado County Council were all aware of the hazard posed by wildlife incursion or obstruction of the runway. However, fencing of the airstrips had not been considered as an option of preventing wildlife incursion because it would interfere with the wildlife ecosystem.

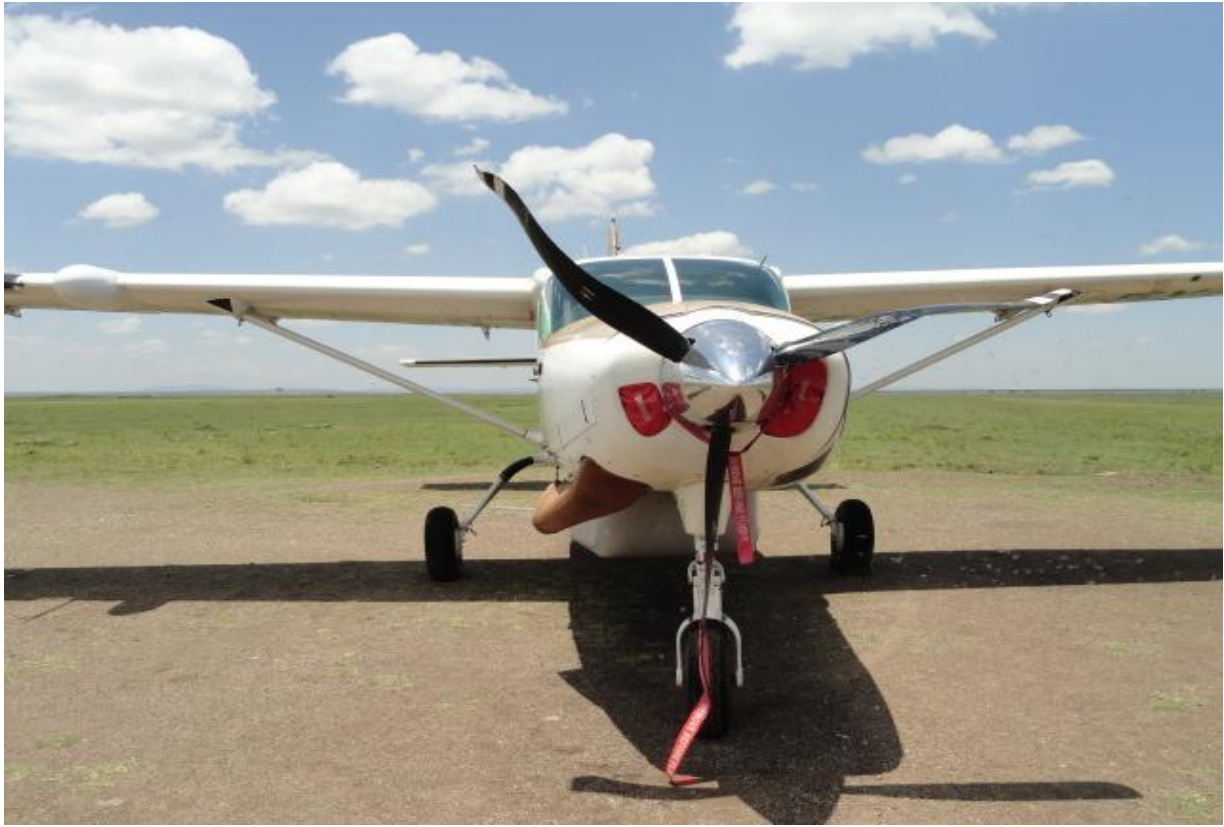
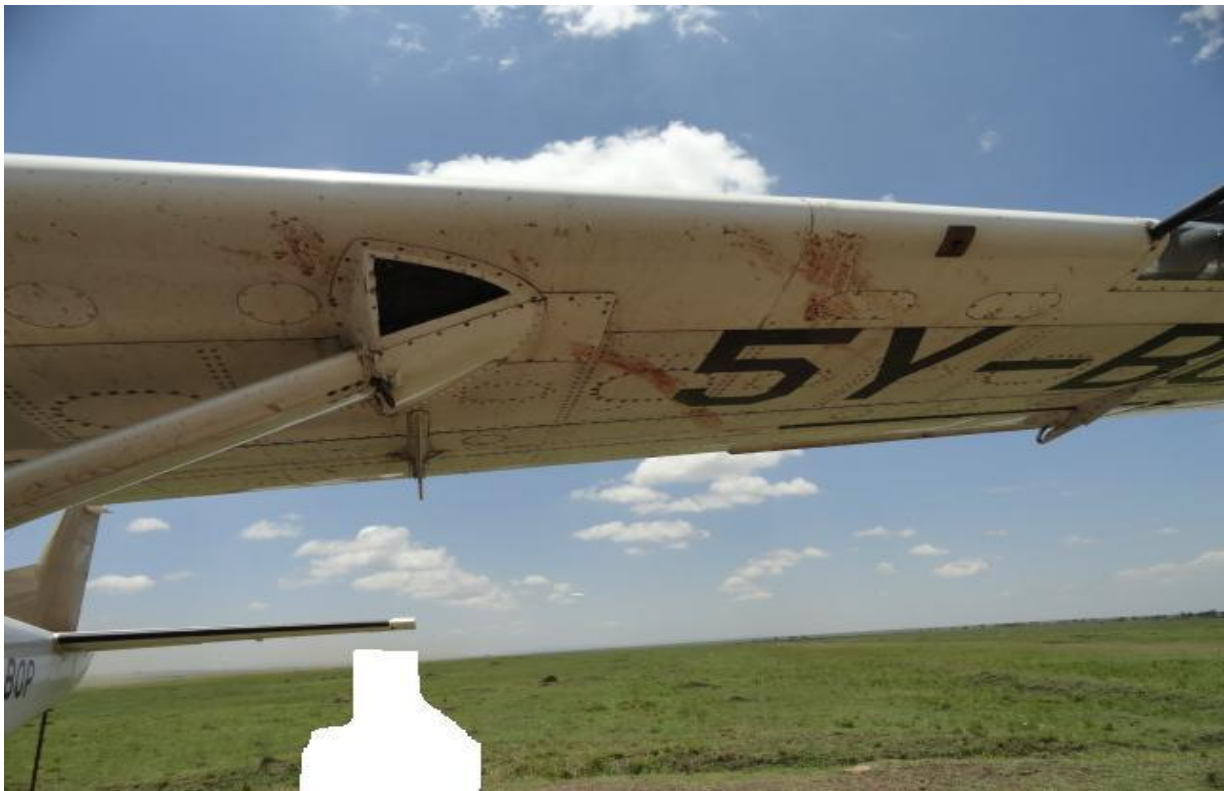
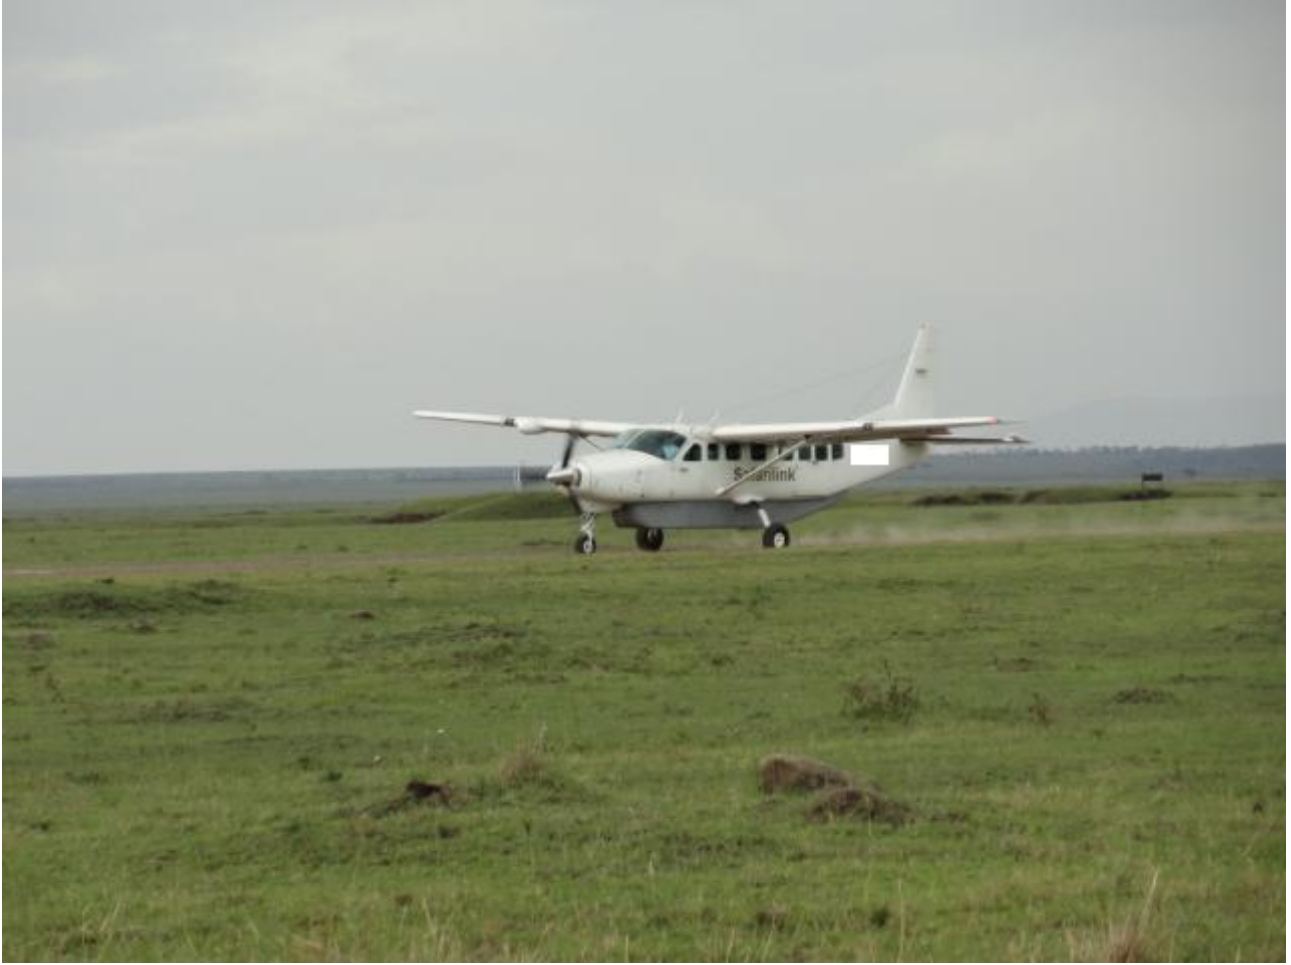
**Aircraft Photographs**

The aircraft structure remained intact after the incident except for the bending of propeller blades as a result of the animal strike. The propeller hub was damaged and the back plate broken. The starter fan belt was also dislodged.
