Occurrence Investigation

AIRCRAFT ACCIDENT REPORT AND EXECUTIVE SUMMARY

Reference:	CA18/2/3/8974	
Aircraft Registration	ZS-SRX	Date of Accident	15 October 2011		Time of Accident	0530Z
Type of Aircraft	AT- 401B (Air Tractor)		Type of Operation		Agricultural	
Pilot-in-command Licence Type		Commercial	Age	33	Licence Valid	Yes
Pilot-in-command Flying Experience		Total Flying Hours	3236		Hours on Type	1200
Last point of departure		Private field in the Riversdale area in the Western Cape				
Next point of intended landing		Private field in the Riversdale area in the Western Cape				
Location of the accident site with reference to easily defined geographical points (GPS readings if possible)						
In a wheat field in the Riversdale area at GPS position S34 07.96 E21 09.633						
Meteorological Information		Surface Wind: South-Easterly at 5 kt; Visibility: 10 km; Temperature: 16°C				
Number of people on board	1 + 0	No. of people injured	0	No. of people killed	0	
Synopsis

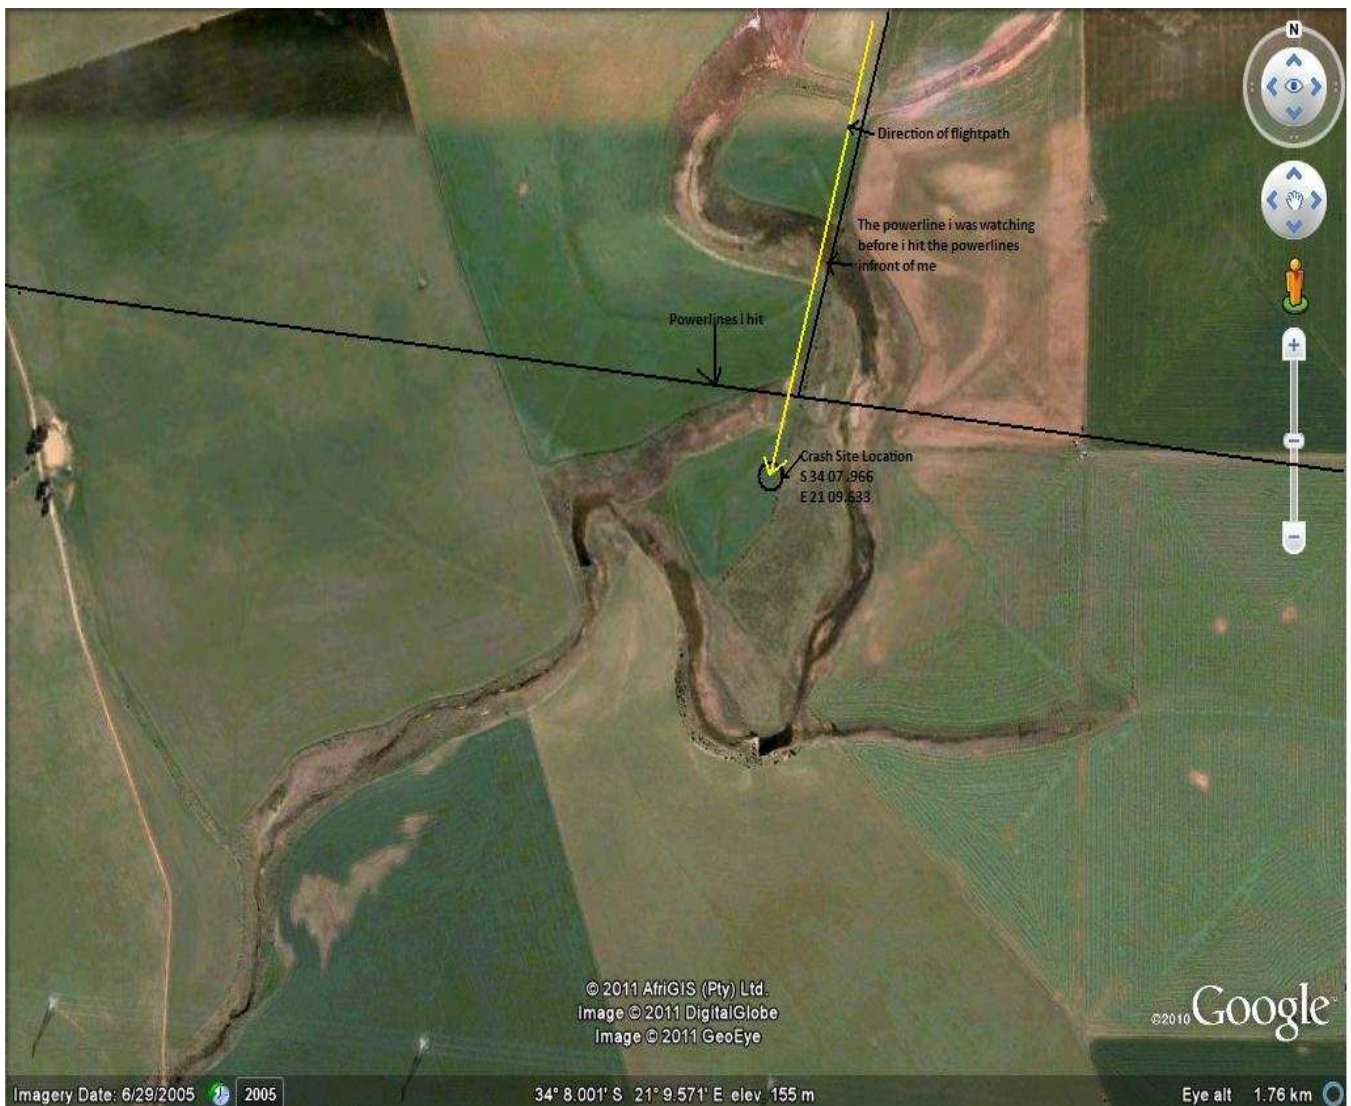
1.10.1 The accident occurred on a private farm in the Riversdale area in the Western Cape; the location of the farm was at a GPS position S 34 07.966 E 21 09.633 at an elevation of 500 ft.

Figure 2, shows a satellite image of the accident site.
