ACCIDENT REPORT

HELICOPTER AS350B2 REGISTRATION 5Y-HLI

ACCIDENT SUMMARY REPORT

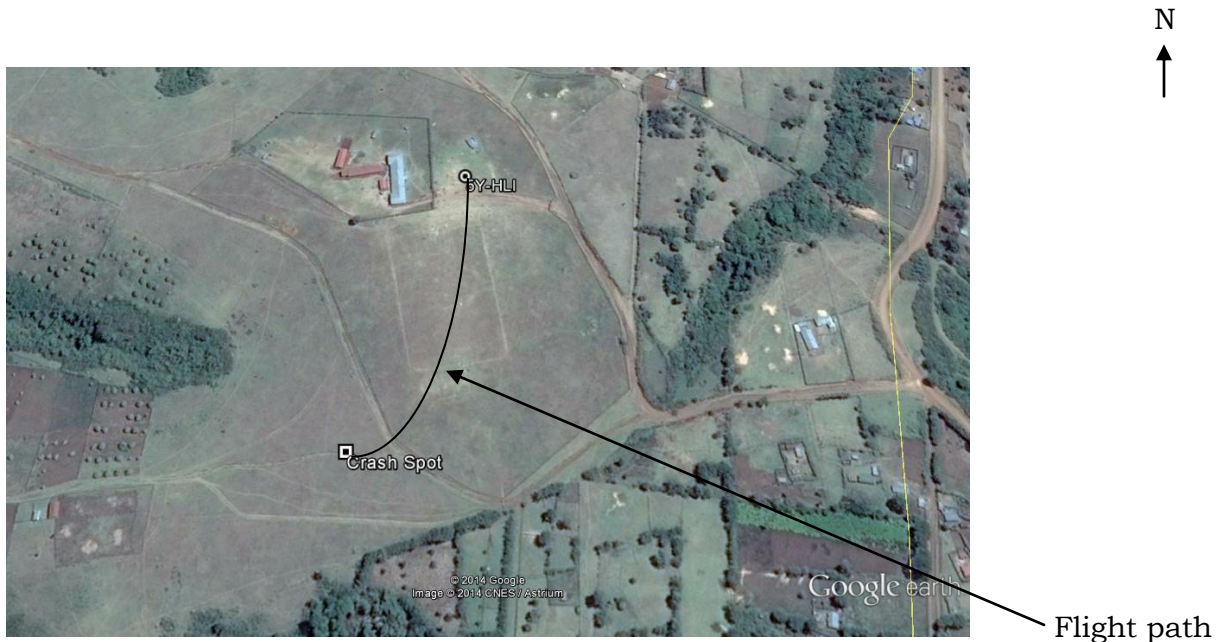
1.1.1 Location of the Accident

The accident occurred on a high altitude area, on a Kaptarkok school playing field on a small hill. The area coordinates are N 00° 26.228 and E 035° 33.899.

The elevation of the accident site is 8,500 feet above the sea level (ASL).
