AIRCRAFT ACCIDENT REPORT AND EXECUTIVE SUMMARY

Reference:	CA18/2/3/9003	
Aircraft Registration	ZU-BGD	Date of Accident	18 January 2012		Time of Accident	1700Z
Type of Aircraft	Windlass Aquilla		Type of Operation	Private		
Pilot-in-command Licence Type		Microlight Private	Age	54	Licence Valid	yes
Pilot-in-command Flying Experience		Total Flying Hours	127.3		Hours on Type	45.3
Last point of departure		Uitenhage aerodrome, Eastern Cape				
Next point of intended landing		Uitenhage aerodrome, Eastern Cape				
Location of the accident site with reference to easily defined geographical points (GPS readings if possible)						
Near Uitenhage at a GPS position determined as S 33°44' 45,75" E025°7' 48.23" at an elevation of 285m ASL						
Meteorological Information		Witnesses reported that fine weather conditions prevailed with variable wind at less than 5 kts, CAVOK A conditions, no cloud and temperature at 20°C				
Number of people on board	1+0	No. of people injured	1	No. of people killed	0

AIRCRAFT ACCIDENT REPORT

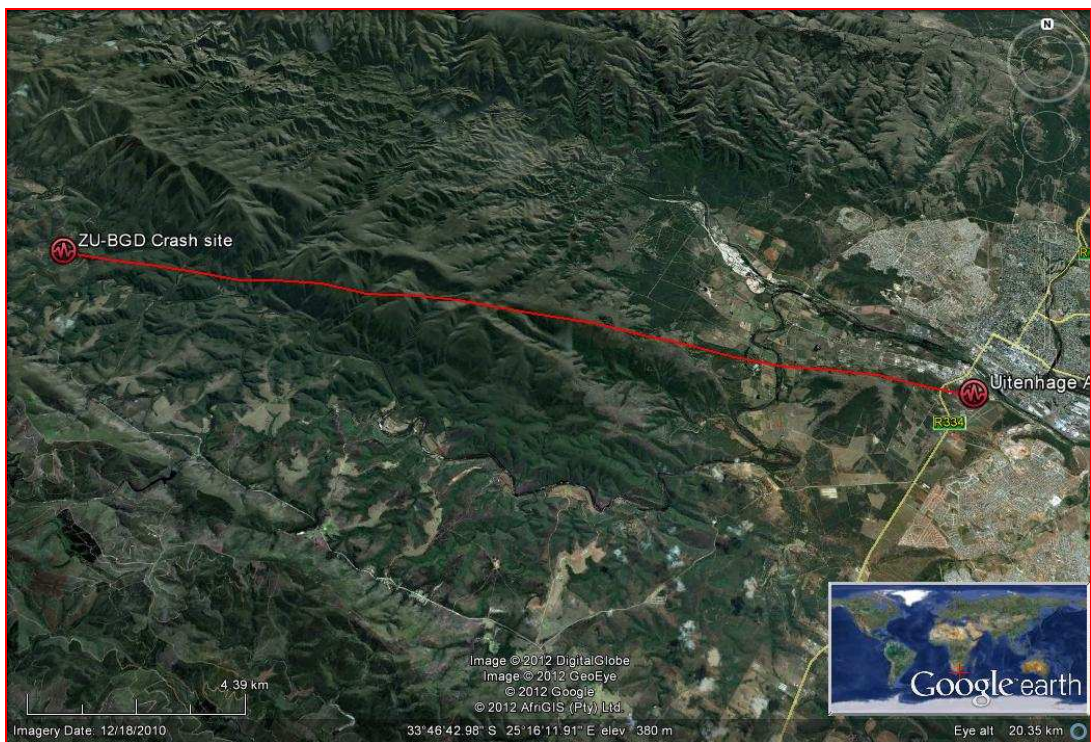
- 1.1.4 The accident occurred during daytime conditions at a GPS position determined as S 33°44' 45,75" E025°7' 48.23" at an elevation of 285m ASL.

Fig 1: Accident site in relation to Uitenhage Aerodrome
