AIRCRAFT ACCIDENT REPORT AND EXECUTIVE SUMMARY

Reference:	CA18/2/3/9007	
Aircraft Registration	ZS-LHG	Date of Accident	2 February 2012		Time of Accident	0730Z
Type of Aircraft	Piper PA-20 (Aeroplane)		Type of Operation		Private Flight	
Pilot-in-command Licence Type		Commercial Pilot	Age	24	Licence Valid	Yes
Pilot-in-command Flying Experience		Total Flying Hours	293,2		Hours on Type	6.3
Last point of departure		Angels' Way aerodrome, (KwaZulu-Natal province)				
Next point of intended landing		Angels' Way aerodrome, (KwaZulu-Natal province)				
Location of the accident site with reference to easily defined geographical points (GPS readings if possible)						
Angels' Way aerodrome near Eston (geographical co-ordinates: South 29°51'32.83" East 030°31'05.19")						
Meteorological Information		Surface wind; 045%4-5kt; Temperature: 23°C; Visi bility: +10 km				
Number of people on board	2 + 0	No. of people injured	2	No. of people killed	0	
Synopsis

AIRCRAFT ACCIDENT REPORT

Name of Owner : Angel's Way Trust
Name of Operator : Private Flight
Manufacturer : Piper Aircraft Corporation
Model : PA-20
Nationality : South African
Registration Marks : ZS-LHG
Place : Angel's Way aerodrome near

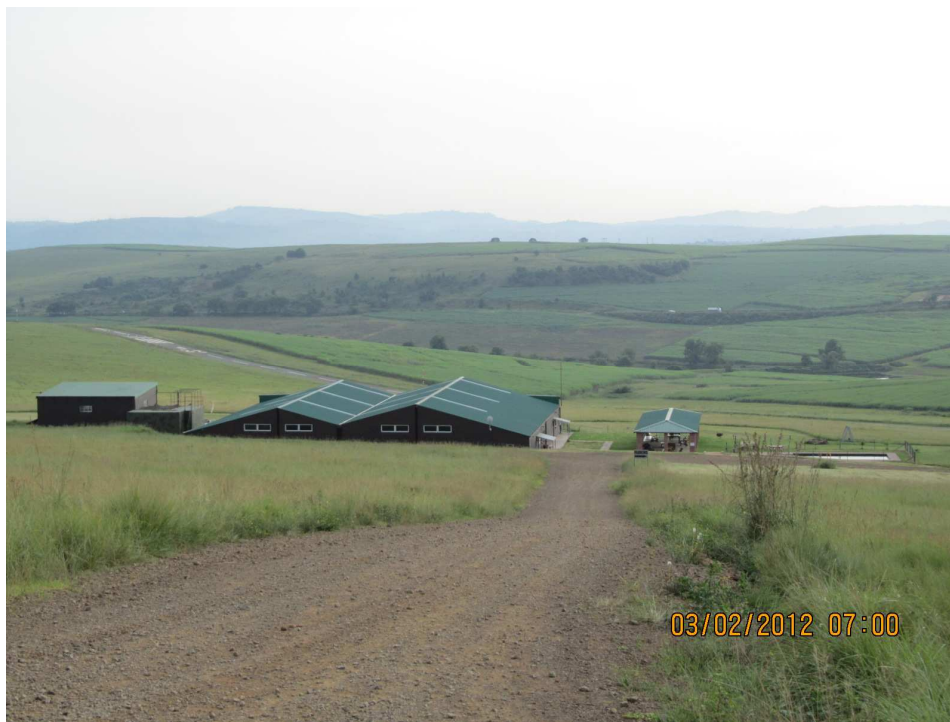
The aerodrome is constructed on sloping terrain. The runway slopes downwards from both thresholds at approximately 5°, as can be seen in Figure 4.

Figure 3: The aerodrome with the runway visible on the far side of the hangars.

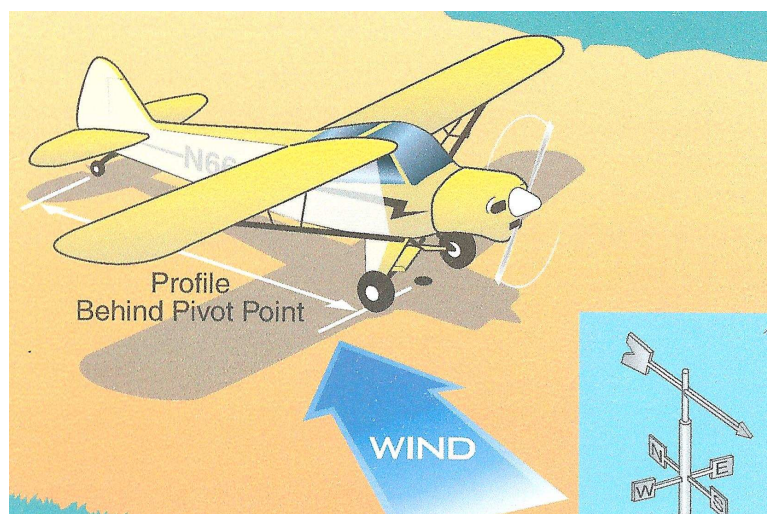
The pilot must be alert for directional control difficulties during the takeoff roll. It is important to establish and maintain the proper amount of crosswind correction prior to lift-off; that is, apply aileron pressure toward the wind to keep the upwind wing from rising and rudder pressure as needed to prevent weathervaning.

Weathervaning tendency.

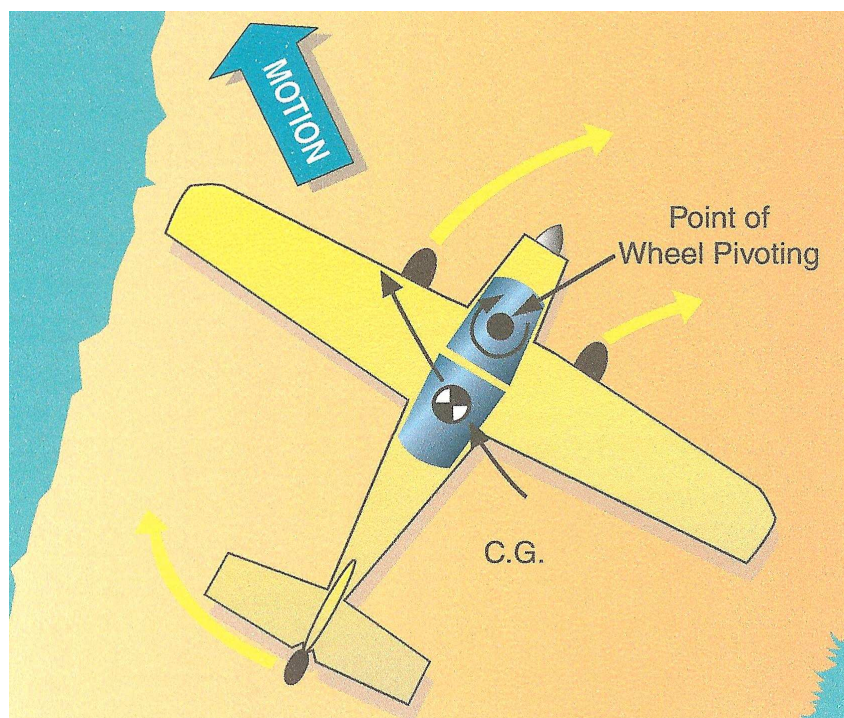
The centre of gravity (CG) of the aircraft is located behind the main wheels. Any difference between the direction the airplane is travelling and the direction it is headed will produce a moment about the pivot point of the wheels, and the airplane will tend to swerve. Loss of directional control may lead to an aggravated, uncontrolled, tight turn on the ground, or a ground loop. The combination of inertia acting on the CG and ground friction of the main wheels resisting it during the ground loop may cause the airplane to tip or lean enough for the outside wingtip to contact the ground, and may even impose a sideward force that could collapse the landing gear.

The CG has an effect on directional control.
