<b>AIRCRAFT ACCIDENT REPORT AND EXECUTIVE SUMMARY</b>
---

Reference:	CA18/2/3/ 9009	
<b>Aircraft Registration</b>	ZU-EGH	<b>Date of Accident</b>	4 February 2012		<b>Time of Accident</b>	0615Z
<b>Type of Aircraft</b>	Microlight – Windlass Aquila 582		<b>Type Operation</b>		Private	
<b>Pilot-in-command Licence Type</b>		Microlight	<b>Age</b>	42	<b>Licence Valid</b>	Yes
<b>Pilot-in-command Flying Experience</b>		Total Flying Hours	± 285.0		Hours on Type	± 285.0
<b>Last point of departure</b>		Crosswinds Airfield – Krugersdorp, Gauteng				
<b>Next point of intended landing</b>		Crosswinds Airfield – Krugersdorp, Gauteng				
<b>Location of the accident site with reference to easily defined geographical points (GPS readings if possible)</b>						
An open grass field at GPS co-ordinates: S 26°02.352' E027°42.199' in the Krugersdorp area.						
<b>Meteorological Information</b>		Wind direction:080°, Wind speed: 04 kt, Temperature: 21°C , Visibility: CAVOK.

## AIRCRAFT ACCIDENT REPORT

**Name of Owner/Operator** : Paradise Petals SA (Pty) Ltd  
**Manufacturer** : Solo Wings CC  
**Model** : Windlass Aquilla  
**Nationality** : South African  
**Registration Marks** : ZU-EGH  
**Place** :

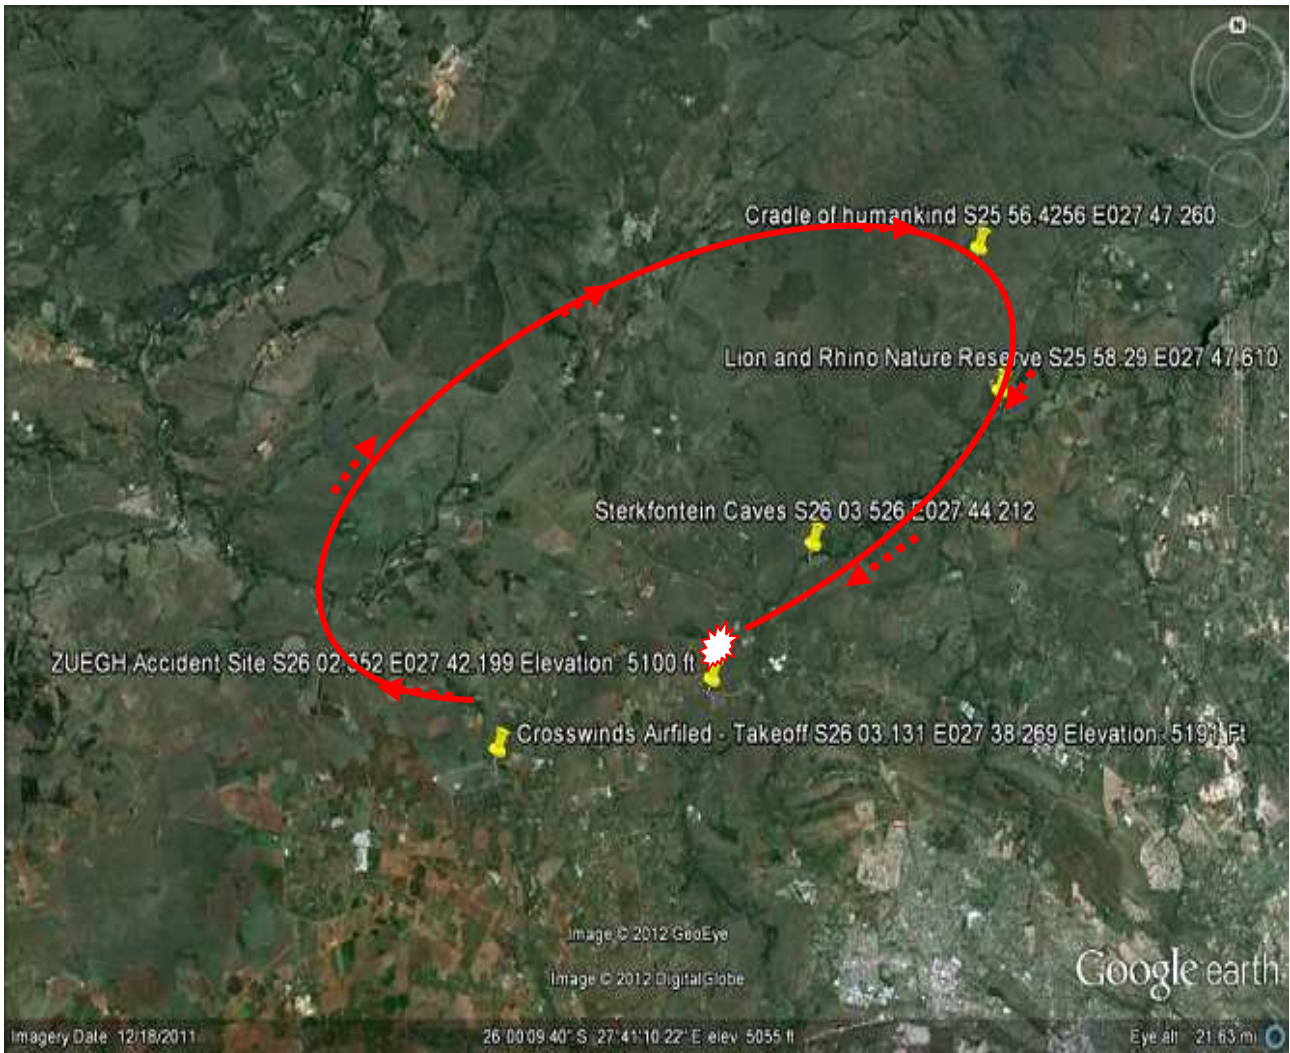
Figure 1, Google earth shows flight path of the aircraft prior to the fatal accident.

- 1.1.3 At approximately 0555Z, the pilot accompanied by a female passenger departed Crosswinds airfield on the second scenic flight to the GFA of the day. The pilot stated that after take-off he flew in a north-westerly direction and performed a clockwise turn overhead the "Cradle of Humankind" located at the GPS co-ordinates of S25°56'.425" E027° 47'.260", overhead the "Lion & Rhino Park Nature Reserve" at GPS co-ordinates of S25° 58'.290" E027° 47'.610" and the "Sterkfontein Caves" at GPS co-ordinates of S26° 03'.526" E027° 44'.212". The Google earth map below shows the flight path flown by the pilot on the second, fatal flight:

- 1.1.4 The pilot further stated that all he could remember was when he was flying overhead the Sterkfontein Caves and descending toward Tarlton Oak in order to fly past Orion Airfield at approximately 0615Z. He only became conscious whilst lying on the ground on his left hand side facing the passenger lying on her right hand side.
- 1.1.5 The pilot who was seriously injured was airlifted to hospital when the medical services arrived at the accident site. The female passenger, who was fatally injured, succumbed to her injuries at the accident site.
- 1.1.6 It was established that the microlight collided with high tension wires, approximately 12 metres high, spanned across the open field and then impacted the grass covered rocky terrain, approximately 50 metres beyond the high tension wires. The aircraft was substantially damaged during impact sequence that followed.

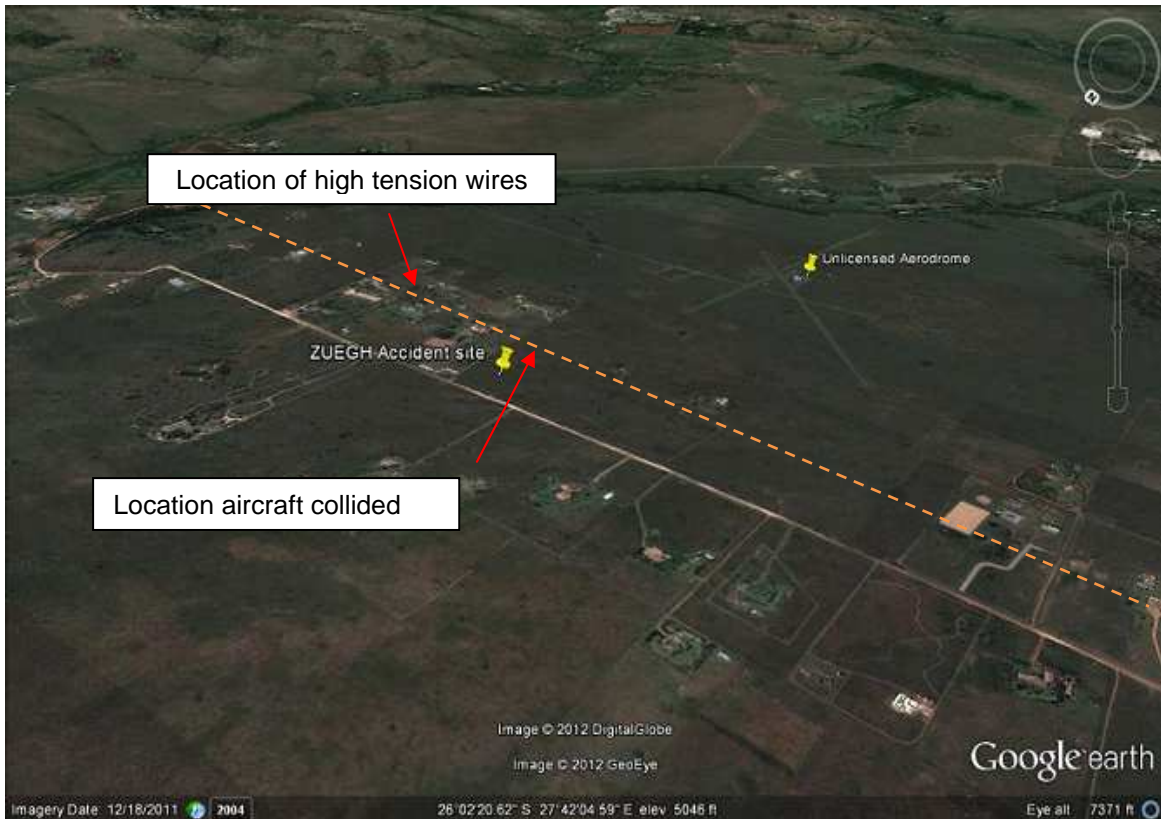
Figure 5, Google map shows location of the accident site

- 1.10.1 The location of the accident site was approximately 30 nautical miles (NM) west of Crosswinds airfield. The aircraft impacted high tension wires first before it crashed in a rocky open grassy covered field at GPS co-ordinates of S26°02.352' E027°42.199' at an elevation of 5100ft AMSL.
- 1.10.2 The pilot stated that his intention was to fly past Orient airfield en route to Crosswinds airfield and that he was aware of the high tension wires on the approach path to Runway 29. The GPS co-ordinates at Orient Airfield are S26° 20.230 and E 027° 35.390 at an elevation of 5100ft AMSL.

- (i) The distance from the high tension wires to Runway 29 at Orion airfield was measured and determined to be approximately 580 meters long.
- (ii) The distance from the high tension wires and the accident site was measured and determined to be approximately 50 metres.
- (iii) The height of the high tension wires is approximately 12 metres (33ft).
