AIRCRAFT ACCIDENT REPORT AND EXECUTIVE SUMMARY

Reference:	CA18/3/2/0909	
Aircraft Registration	ZU-BTT	Date of Incident	19 April 2012		Time of Incident	1242Z
Type of Aircraft	Falco F8L		Type of Operation		Private	
Pilot-in-command Licence Type		Private Pilot	Age	67	Licence Valid	Yes
Pilot-in-command Flying Experience		Total Flying Hours	367.5		Hours on Type	79.35
Last point of departure	Kimberley Aerodrome (FAKM) – Northern Cape					
Next point of intended landing	Beaufort West - Western Cape					
Location of the incident site with reference to easily defined geographical points (GPS readings if possible)						
Approximately 50 km south of Victoria West in the Northern Cape.						
Meteorological Information	Wind : Westerly 5 – 10 kt, Temperature: 12°C, Cloud base: CAVOK..					
Number of people on board	1 + 1	No. of people injured	0		No. of people killed	0
Synopsis	<p>On 19 April 2012 at approximately 1055Z, the pilot accompanied by a passenger departed from Kimberley aerodrome (FAKM) on a private flight to Beaufort West in the Western Cape.</p> <p>The flight en-route to Beaufort West was uneventful, but after a flight time of approximately 1.85 hours, the propeller suddenly separat

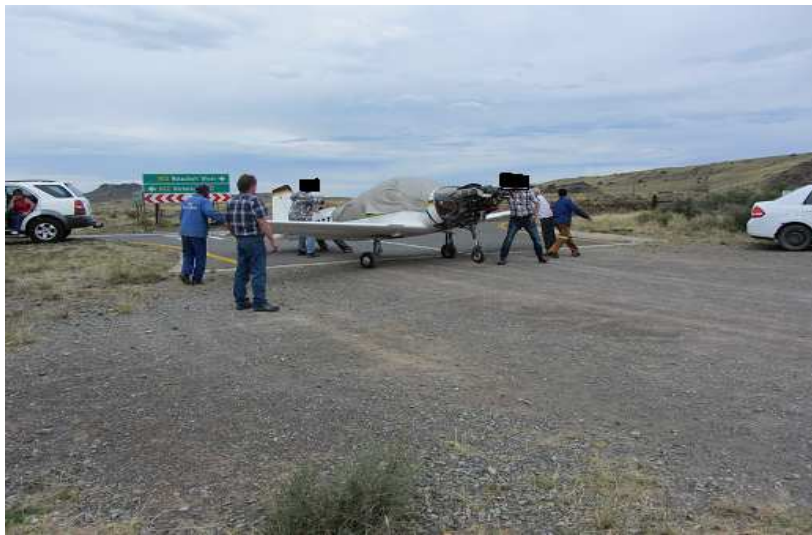
1.10.1 The aircraft was involved in the accident outside the boundaries of an aerodrome. The pilot executed a forced landing on the N12 national road and repositioned the aircraft to a private gravel road nearby.

Figure 3, shows gravel road where aircraft was repositioned

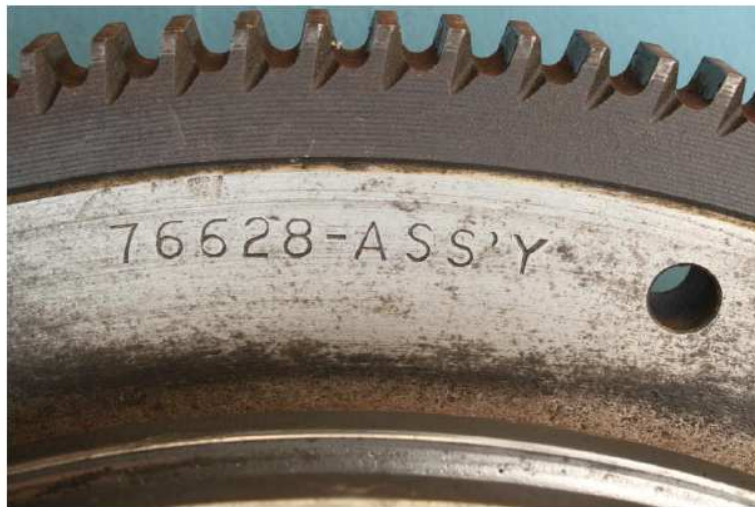
The starter disk bore a number of identifying markings, 76628-ASS'Y, presumed to be a serial or part number, LI-7 within a circle, B15 within a hexagon and L155 within a double circle, believed to be inspection marks, figures 1 to 3.

Figure 1. Assembly number stamped onto disk.

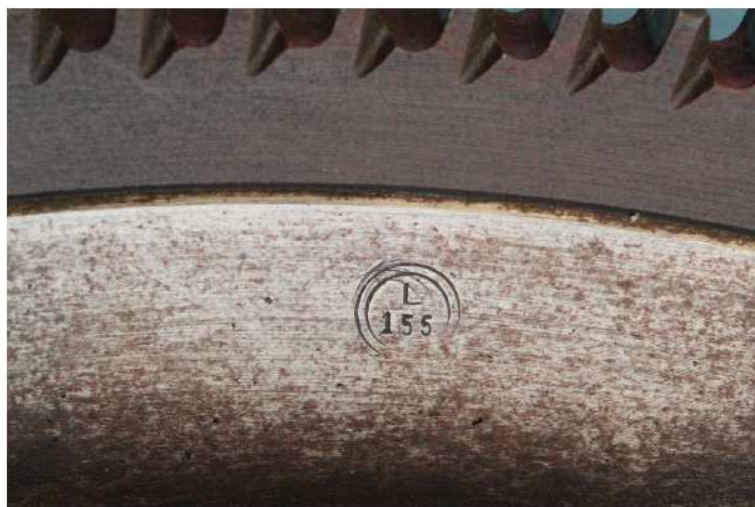
Figure 2. Inspection marks stamped onto disk.

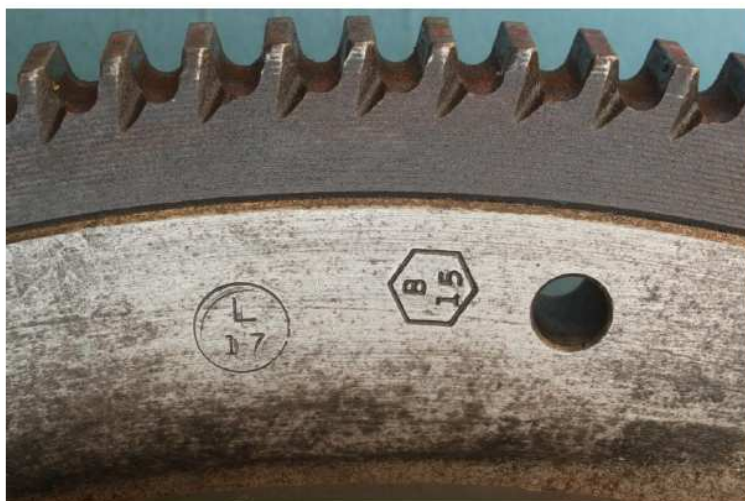
Figure 3. Inspection marks stamped onto disk.
