**AIRCRAFT ACCIDENT REPORT AND EXECUTIVE SUMMARY**

Reference:	CA18/2/3/9039	
<b>Aircraft Registration</b>	ZS-OCH	<b>Date of Accident</b>	04 May 2012		<b>Time of Accident</b>	1620Z
<b>Type of Aircraft</b>	Cessna U206G Stationair		<b>Type of Operation</b>	Private		
<b>Pilot-in-command Licence Type</b>	Private		<b>Age</b>	47	<b>Licence Valid</b>	Yes
<b>Pilot-in-command Flying Experience</b>	Total Flying Hours		Unknown		<b>Hours on Type</b>	Unknown
<b>Last point of departure</b>	Piet Retief aerodrome (FAPF): Mpumalanga province.					
<b>Next point of intended landing</b>	Greytown aerodrome (FAGY):Kwa-Zulu Natal province.					
<b>Location of the accident site with reference to easily defined geographical points (GPS readings if possible)</b>						
In the vicinity of Stanger (Kwa-Dukuza) area into the plantations at GPS position determined to be; South 29° 03.297' East 030°37.856' at an elevation of 1144 feet above mean sea level (AMSL).						
<b>Meteorological Information</b>	Low clouds (stratus and possibly fog) were observed in the vicinity of Greytown area. <b>Stratus</b> clouds are uniform, greyish clouds that often cover the entire sky.

<b>AIRCRAFT ACCIDENT REPORT</b>
-----------

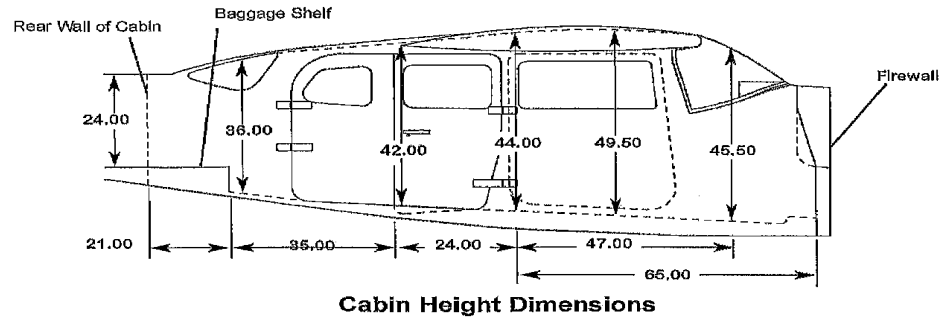
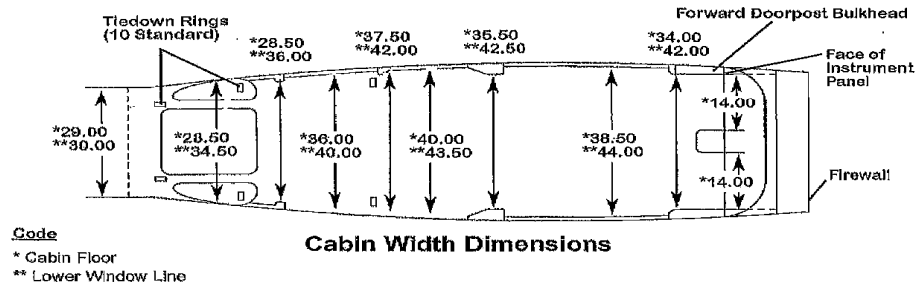
1.15.1 This was considered a non-survivable accident due to the impact forces, the destruction of the cockpit area and the post impact fire that consumed the entire fuselage. Below is the cabin layout.
