<b>AIRCRAFT ACCIDENT REPORT AND EXECUTIVE SUMMARY</b>
---

Reference:	CA18/2/3/9064	
<b>Aircraft Registration</b>	ZS-HCR	<b>Date of Accident</b>	27 July 2012		<b>Time of Accident</b>	±0605Z
<b>Type of Aircraft</b>	Garlick UH-1H (Helicopter)		<b>Type of Operation</b>		Private (Industrial Aid)	
<b>Pilot-in-command Licence Type</b>		Commercial Pilot	<b>Age</b>	32	<b>Licence Valid</b>	Yes
<b>Pilot-in-command Flying Experience</b>		Total Flying Hours	775,3		Hours on Type	314,3
<b>Last point of departure</b>		Amatole mountains near Hogsback, (Eastern Cape province)				
<b>Next point of intended landing</b>		Amatole mountains near Hogsback, (Eastern Cape province)				
<b>Location of the accident site with reference to easily defined geographical points (GPS readings if possible)</b>						
Amatole mountains (GPS position; South 32°34.256' E ast 027°05.277' elevation 5 294 feet AMSL)						
<b>Meteorological Information</b>		Surface wind; 270°37 knots, Temperature; 13°C, Vis ibility; +10 km

## AIRCRAFT ACCIDENT REPORT

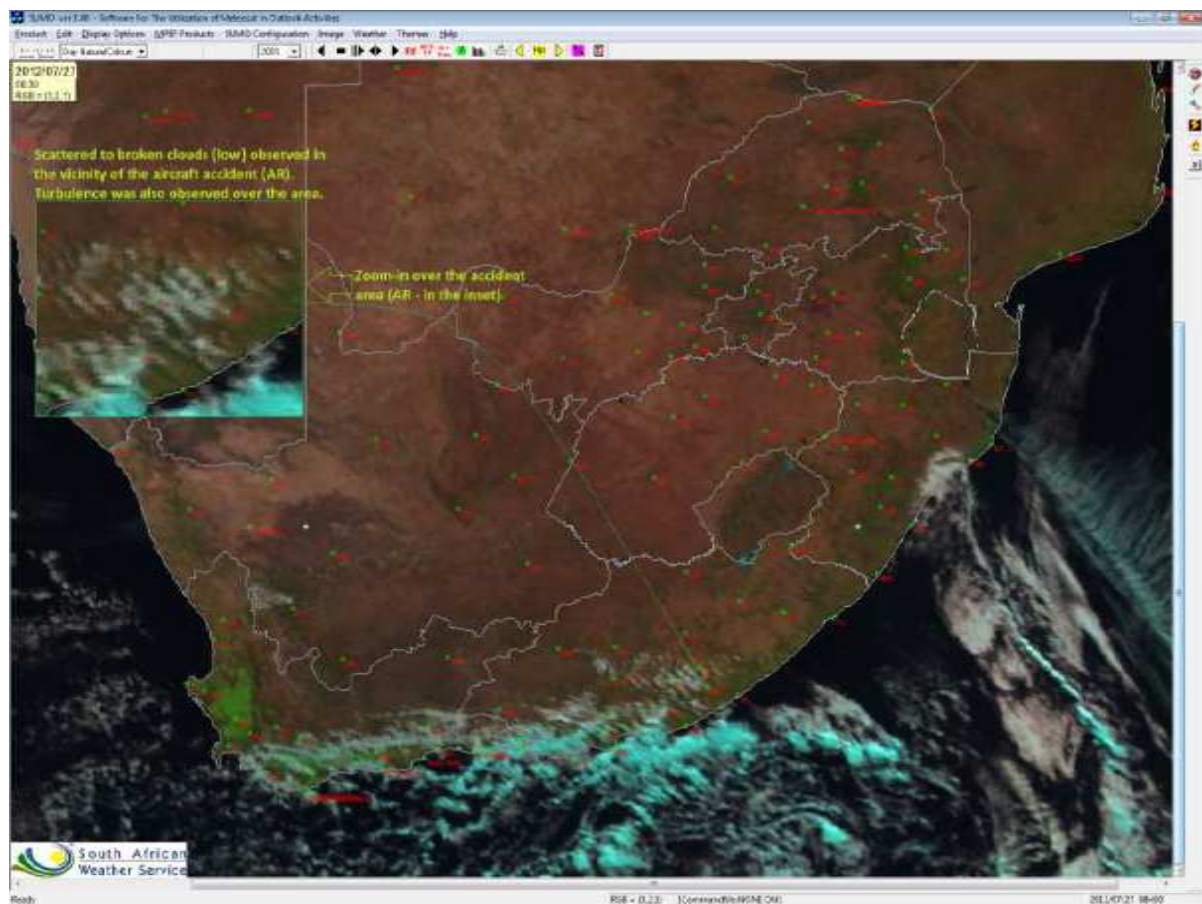
Scattered to broken clouds (cumulus and/or stratocumulus) were observed over the area of the aircraft accident. The clouds also indicated the presence of turbulence over the area. See the satellite image below.

Broken clouds with bases ranging from 2 500 – 3 000 feet and strong gusty winds were observed over the area of the aircraft accident. The satellite image also showed the presence of turbulence over the accident area.

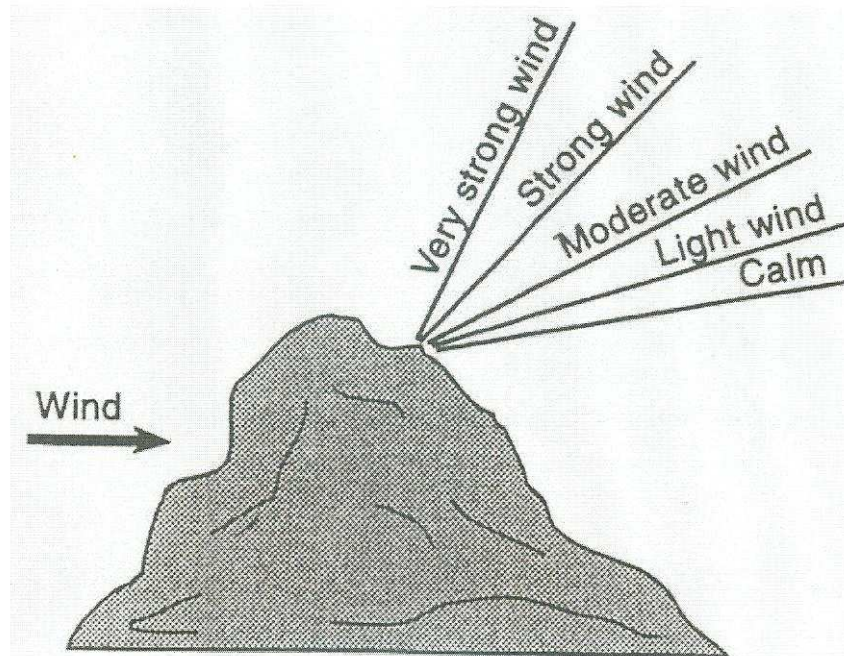
Approach angle variations with different wind speeds.

The landing is normally preceded by a hover, but zero-speed or run-on-landings are alternatives. Landings on mountain ridges into the wind may place the aircraft on a lee side of the ridge during the approach, in which case the steepness of the approach angle should be adjusted as shown in figure 11 on the next page.
