AIRCRAFT ACCIDENT REPORT AND EXECUTIVE SUMMARY

Reference:	CA18/2/3/9075	
Aircraft Registration	ZU-ODZ	Date of Accident	24 August 2012		Time of Accident	1505Z
Type of Aircraft	Aeroprakt A-22LS		Type of Operation		Ferry Flight	
Pilot-in-command Licence Type		Commercial	Age	44	Licence Valid	Yes
Pilot-in-command Flying Experience		Total Flying Hours	535.9		Hours on Type	Unknown
Last point of departure		Gariiep dam aerodrome (FAHV), (Free State province)				
Next point of intended landing		Upington aerodrome (FAUP), (Northern Cape province)				
Location of the accident site with reference to easily defined geographical points (GPS readings if possible)						
Farm Bywater – Niekerkshoop area (Northern Cape province) at GPS position S 29°16'15.8" E 023°03'01.2" .						
Meteorological Information		Wind: 320°16 gusting 26 knots, Visibility: 10 km, Temperature: 26°C, Dew point: 0°C, Cloud base: Nil				
Number of people on board		1+1	No. of people injured	0	No. of people killed	1+1

Name of Owner/Operator : African Parks Network
Manufacturer : Aeroprakt
Model : A-22LS
Nationality : South African
Registration Marks : ZU-ODZ
Place : Farm Bywater, Niekerkshoop area, Northern Cape province
Date

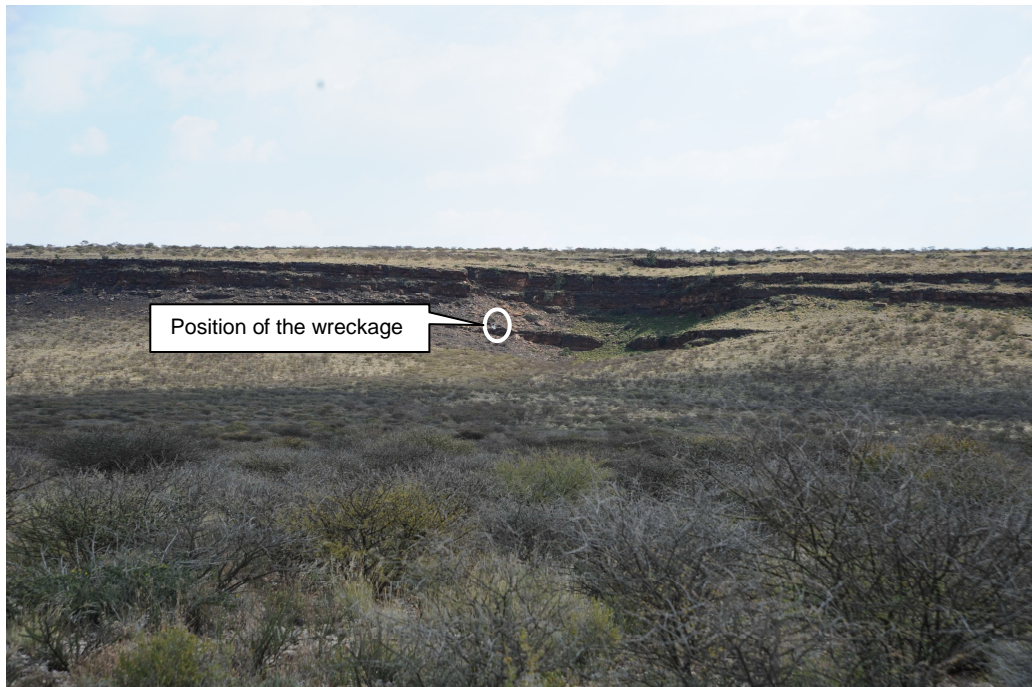
The aircraft was flying in a direction of approximately 300 degrees magnetic and collided with a ridge in a direction of approximately 260 degrees magnetic at GPS position S 29°16'15.8" E 023°03'01.2"

Figure 4 Landscape surrounding the accident site.
