AIRCRAFT ACCIDENT REPORT AND EXECUTIVE SUMMARY

Reference:	CA18/2/3/9082	
Aircraft Registration	ZS-TV R	Date of Accident	13/09/2012		Time of Accident	±1517Z
Type of Aircraft	Beech F33A (Aeroplane)		Type of Operation	Private flight		
Pilot-in-command Licence Type		Private Pilot	Age	64	Licence Valid	No
Pilot-in-command Flying Experience		Total Flying Hours	1 047,4		Hours on Type	984,9
Last point of departure		Pietermaritzburg aerodrome (FAPM), (KwaZulu-Natal province)				
Next point of intended landing		Newcastle aerodrome (FANC), (KwaZulu-Natal province)				
Location of the accident site with reference to easily defined geographical points (GPS readings if possible)						
Ophatha, near Cato Ridge (GPS position; 29°38.679' South 030°42.236' East, elevation 1 574 feet)						
Meteorological Information		Surface wind 130/10 kts; Temperature 15°C, Dew poi nt 12°C, Overcast				
Number of people on board	1 + 2	No. of people injured	0	No. of people killed	1 + 2

AIRCRAFT ACCIDENT REPORT

Name of Owner : T.J. Janse van Rensburg
Name of Operator : Private flight
Manufacturer : Beech Aircraft Corporation
Model : F33A
Nationality : South African
Registration Marks : ZS-TVVR
Place : Ophatha, nea

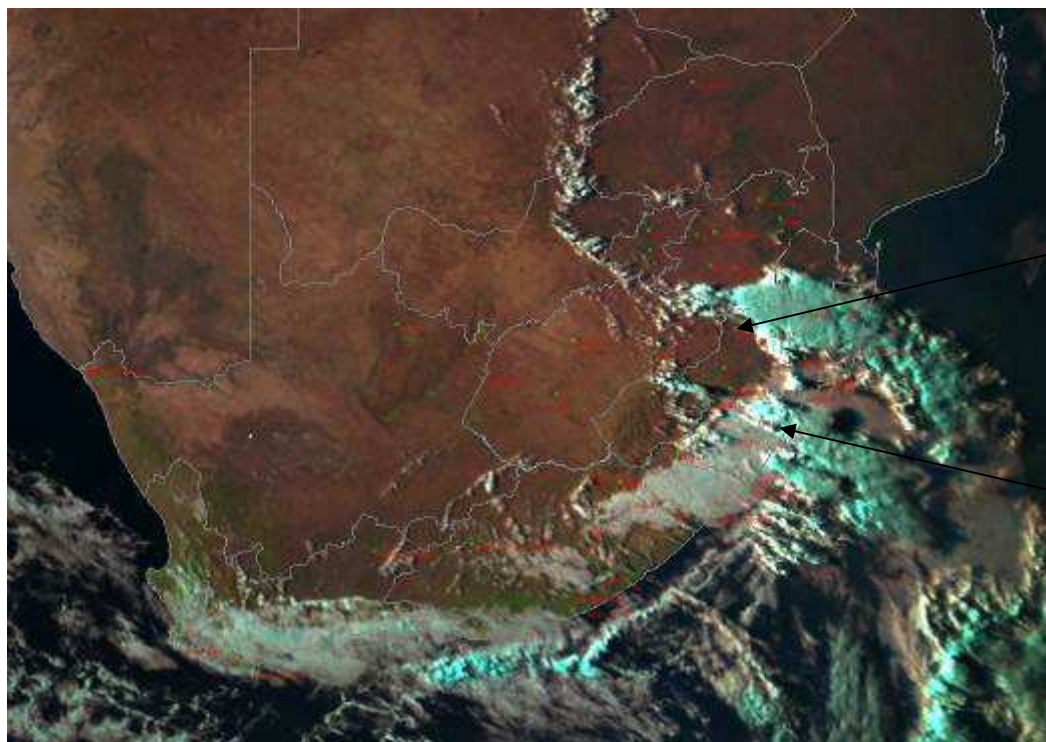
Figure 3. Satellite image of the country taken on 13 September 2012 at 1515Z

The satellite and radar data indicates broken to overcast low-level clouds in the FAPM area. In the area of the accident site thundershowers associated with poor visibility prevailed.

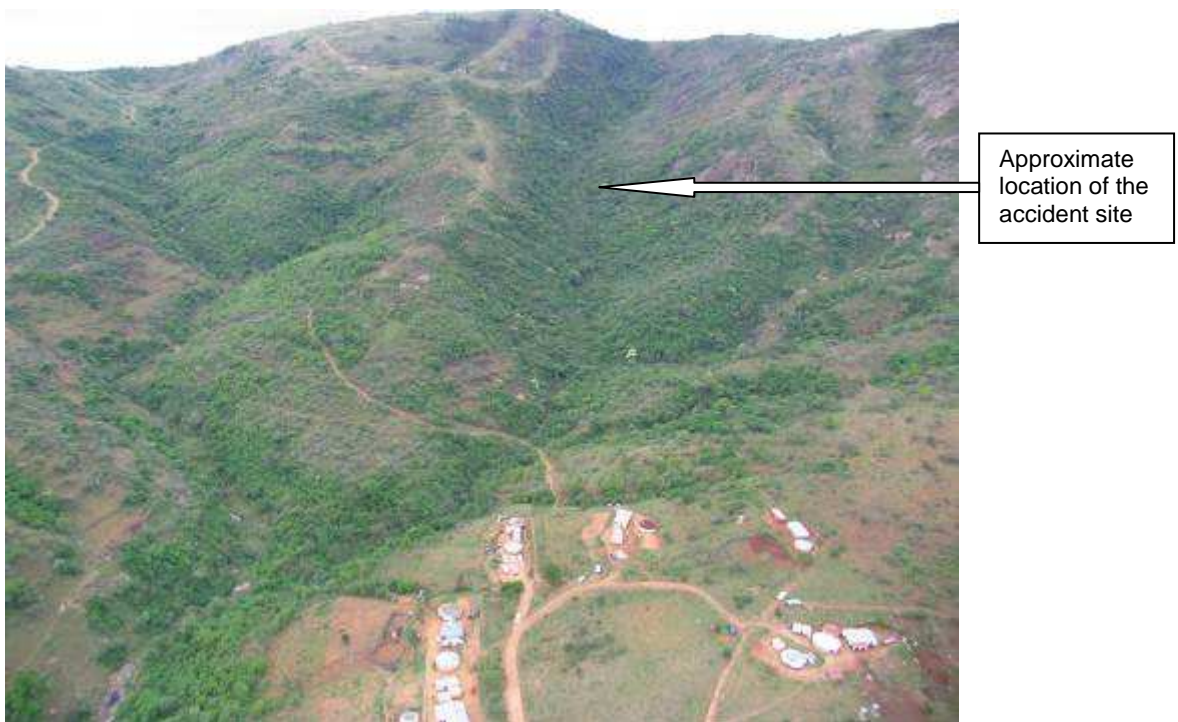
Figure 9. Aerial photo depicting the general terrain where the accident occurred.

1.12.1 The aircraft crashed in dense bush in mountainous terrain. The impact sequence damaged several trees, which were approximately 10 m in height, followed by ground impact. The damage sustained by vegetation indicates that the aircraft was in a vertical trajectory during the impact sequence. The nose section of the aircraft was orientated along a magnetic bearing of $\pm 060^{\circ}M$. The impact location was 16,2 nautical miles (nm) towards the east of FAPM (their departure aerodrome).

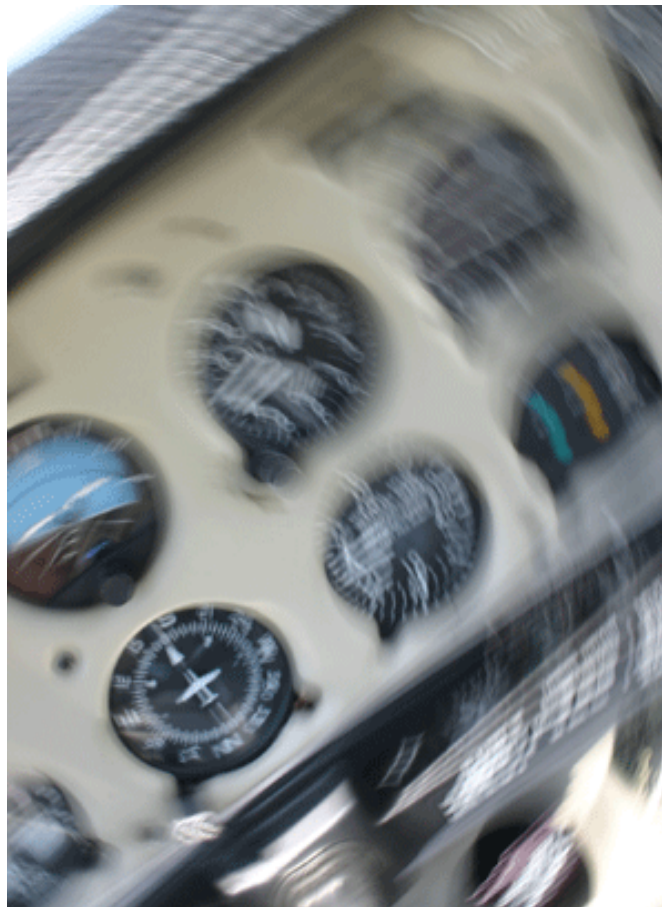
Figure 14. Illustration of blurred instrumentation with the aircraft in a spiral attitude

It became apparent during the investigation that the pilot was very reliant/dependant on flying with the assistance of automation (i.e. with the autopilot engaged). It is believed that the flight in question was not in any way different. However, due to the turbulence they encountered as a result of thunderstorm activity the auto-pilot most probably disengaged, whereupon the pilot had to fly the aircraft manually. The attitude the aircraft was in at the time could not be determined, and the detection by the pilot of such an event might not have been immediate. By the time the pilot became aware of the situation, the aircraft had most probably entered an unusual flight attitude from which he needed to recover without having any well-defined horizon/reference to the ground. With the aircraft being in a spiral dive, the instrumentation might have become blurred; in such a case additional altitude would be required to recover as well as a well-defined horizon. The first time the pilot became aware of the ground was most probably when the aircraft penetrated the clouds in a nose down-spiral, as was observed by the witness and indicated by the wreckage impact sequence. The rate of descent was considered to be high, with the pilot unable to initiate recovery action prior to ground impact. Several factors affect a pilot's ability to successfully recover from an unusual attitude; these include immediate detection of an in-flight upset and the pilots flying experience, skills and knowledge. The possibility of the pilot being spatially disorientated following the in-flight upset and subsequent loss of control cannot be ruled out. For reference to the reader the phenomena with reference to a spiral dive as well spatial disorientation had been included in the report as Annexure C and D respectively.
